Arboricultural Assessment Report

Summary Report on Trees

For:	Client:	Oriel Services Limited
	Insurer:	Zurich - UK Commercial
Site:	Policyholder:	36 Frognal Ltd.
	Risk Address:	36 Frognal, London, NW3 6AG
Refs:	OCA Ref:	56161
	Client Ref:	7711629
	Insurer Ref:	CRF4031569

Survey By:	Lee Cooper		
Title:	Surveyor	Date:	1 st July 2014
Report By:	Richard Brasnett-Mellor		
Title:	Arborist	Date:	21 st July 2014

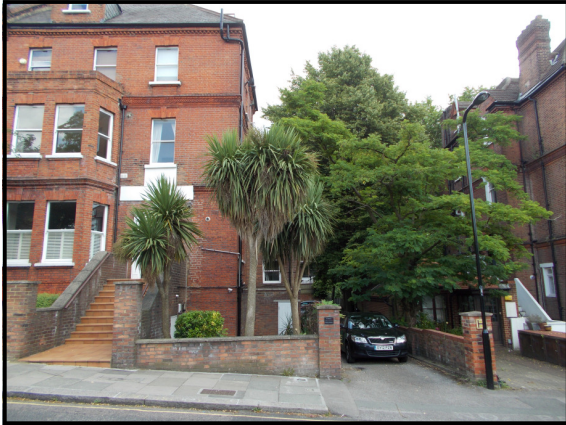
1. Front right of the property, G1 to left with T1, T2, T3, and T4 on the right.

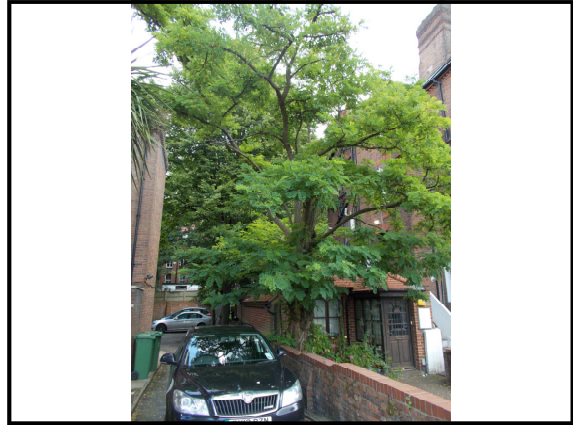
2. Close up of the trees to the right from the front, T1 at front.

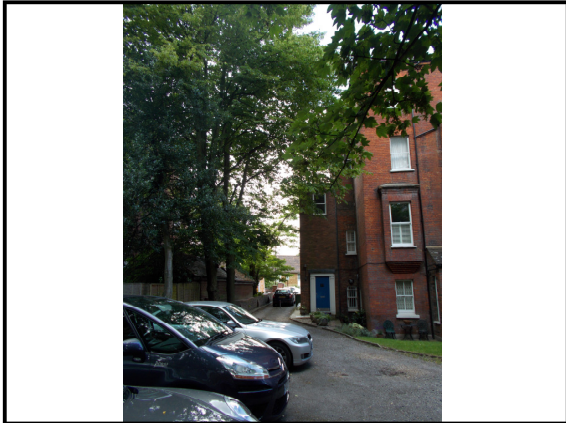
3. View of trees from the rear of the property
