Project: One Bedford Avenue

Location: Northern Line

Survey Description: Gauge Measurement & Analysis

Sal Reference: SAL-1436-01 - Report 1

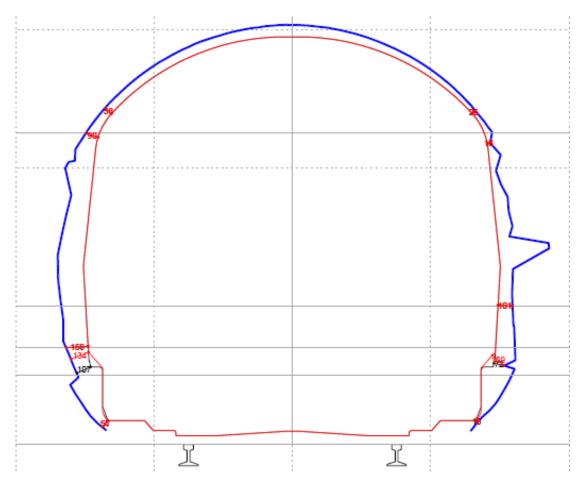
- The C1 Gauge and C3 Gauge both report Normal clearances at One Bedford Avenue at a total of 18 out of the 23 measured profiles,
- The substandard clearances are situated towards the high mileage end and where the track curvature becomes tighter. Four profiles report a clearance of less than 25mm at between 1000mm and 2250mm ARL or above 2250mm ARL,
- The tightest clearance occurs at Ring 758 (386.9m) with a clearance of 12.6mm to the C3
  Gauge and 8.8mm to the C1 Gauge at below 500mm ARL. Clearances to the C1 and C3
  Gauges should be considered when installing equipment in tunnels or when undertaking remedial works.

Figure 1 – Ring 758 @ 386.9m Tightest Clearance Location (C1 Red, C3 Black)
