**Hampstead Hill School
St Stephen's Hall
Pond Street
London NW3 2PP**

Proposed Repair of Grade II Listed Boundary Wall

Heritage & Method Statement

November 2014

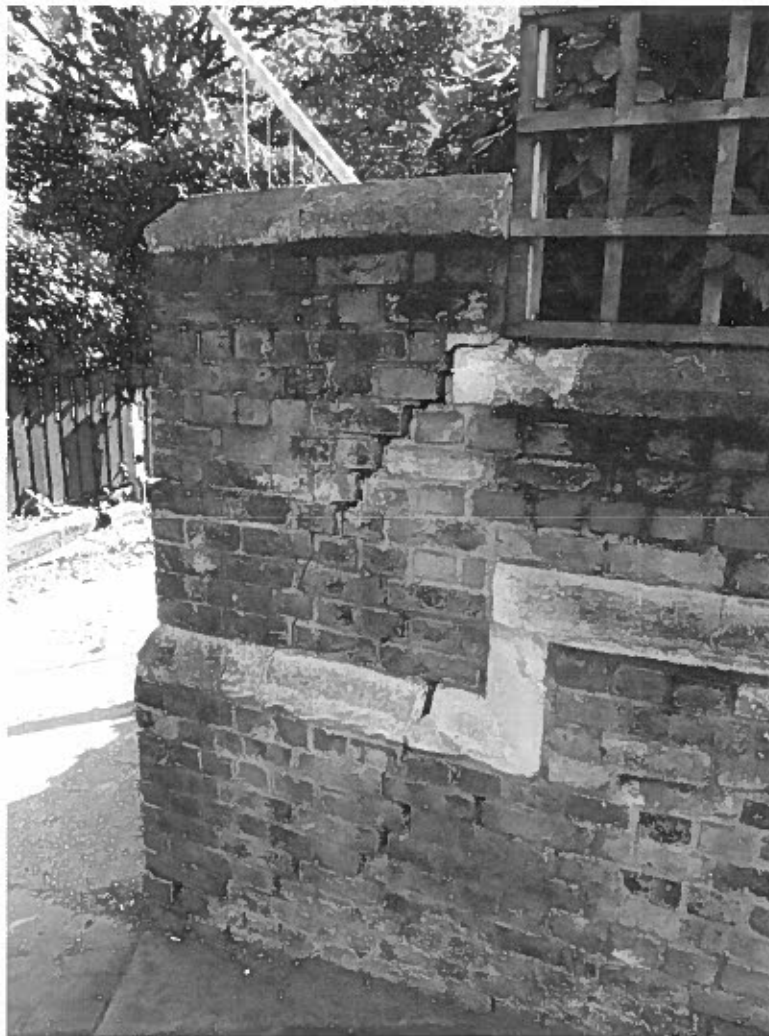
The proposed works relate to part of the boundary wall Asset at the location of the vehicular entrance to the hall along Pond Street. The Asset comprises a main pillar, which is two and a half bricks deep by two bricks wide at its upper section and thickening to three bricks deep by two and a half bricks wide at its base, and lower level wall extending from the pillar in a westerly direction along the Pond Street boundary. This wall is approximately a brick and a half wide over its upper section thickening to two and a half bricks at the base. The wall

retains approximately 900mm of earth from the hall site. The wall and pillar are of red stock brickwork with a lime mortar and incorporates a dressed stone string course and capping.

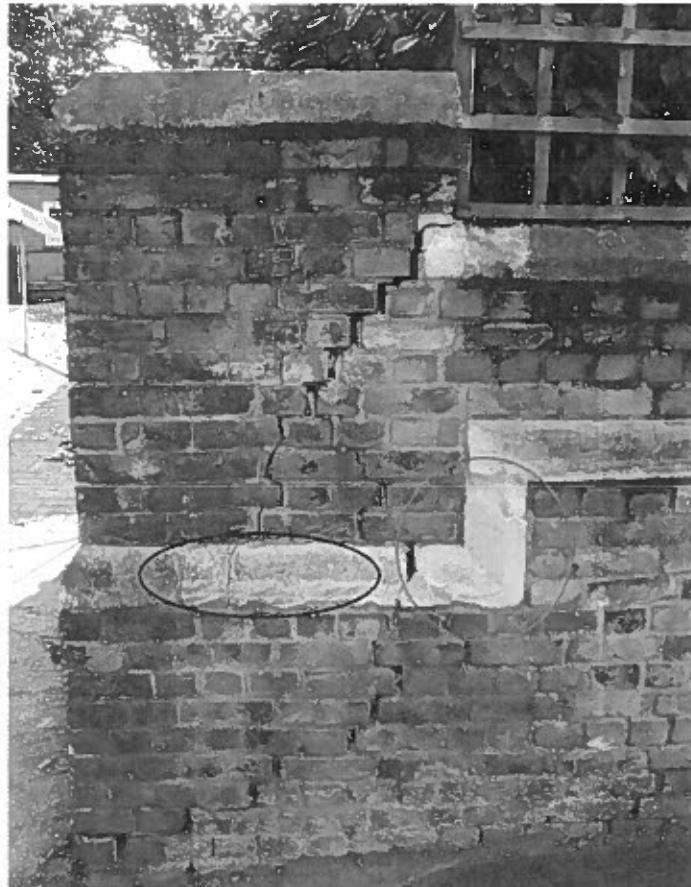
One piece of stone to the string course is cracked and is proposed to be repaired and retained by use of a stainless steel dowel, however a further piece of stone has previously been repaired and is not in a condition to be retained, and will therefore be locally replaced using a matching natural stone. This is detailed on the Structural Engineers proposed drawing and depicted on the Photoplate below, with the stone being repair highlighted by the red circle and the stone to be replaced highlight by the green circle:

The wall will be rebuilt using the same brick coursing, bond, mortar mix and pointing profile as existing. Replacement stone will be natural dressed stone, with profile to match existing.
