STRUCTURAL ENGINEERS REPORT

**HAMPSTEAD HILL SCHOOL
POND STREET
HAMPSTEAD**

PCC OF ST. STEPHENS WITH ALL HALLOWS

SEPTEMBER, 2014

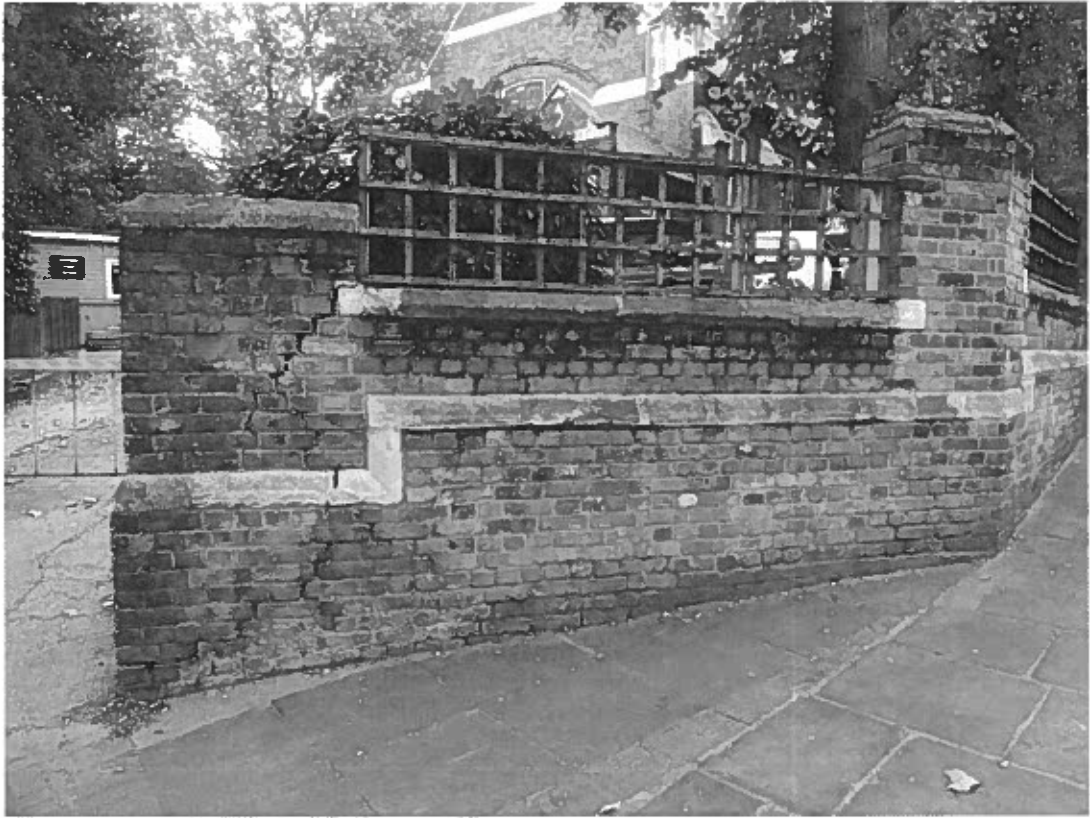
DSC00420.JPG

- 3.2 The cause of the cracking is considered to be dominantly due to thermal or moisture movement whereby the extent of the brickwork is such that this is expanding pushing the pillar out at the end and then when the wall cools or dries out and shrinks the main element of wall is reducing in its length helped by the stone band, but the brick pillar which is of mass construction is not returning and hence a crack opens up. As this crack is infilled either naturally or by repair, then it ceases to act as a movement joint, and further movement occurs. Hence the movement becomes progressive. (See Photograph 420).

- 4.2 No immediate temporary shoring is considered to be warranted.
- 4.3 It is advised that the pier is taken down and rebuilt utilising and saving much of the existing brick and stonework. Any fractured elements of stone should be repaired by doweling together or if unrepairable replaced on a like for like basis. Damaged bricks should be replaced with new bricks to match and blend in.

- 4.4 Once repaired it is likely that the movement and cracking will re-occur. This will occur over a period of time requiring regular maintenance and repair. In order to minimise the risk and extent of cracking it would be sensible to provide some “Helifix” or “Cintec” anchors in the central body of the wall drilled and anchored into the retained section of the wall by a distance of approximately 900mm. this will not necessarily stop the wall cracking, but should assist in mitigating cracks. There is a risk that the wall may simply crack in a different location. These anchors should be positioned centrally at 450mm centres vertically in the 330mm section and two number at 150mm centres horizontally and 450mm centres vertically in the lower thicker section.

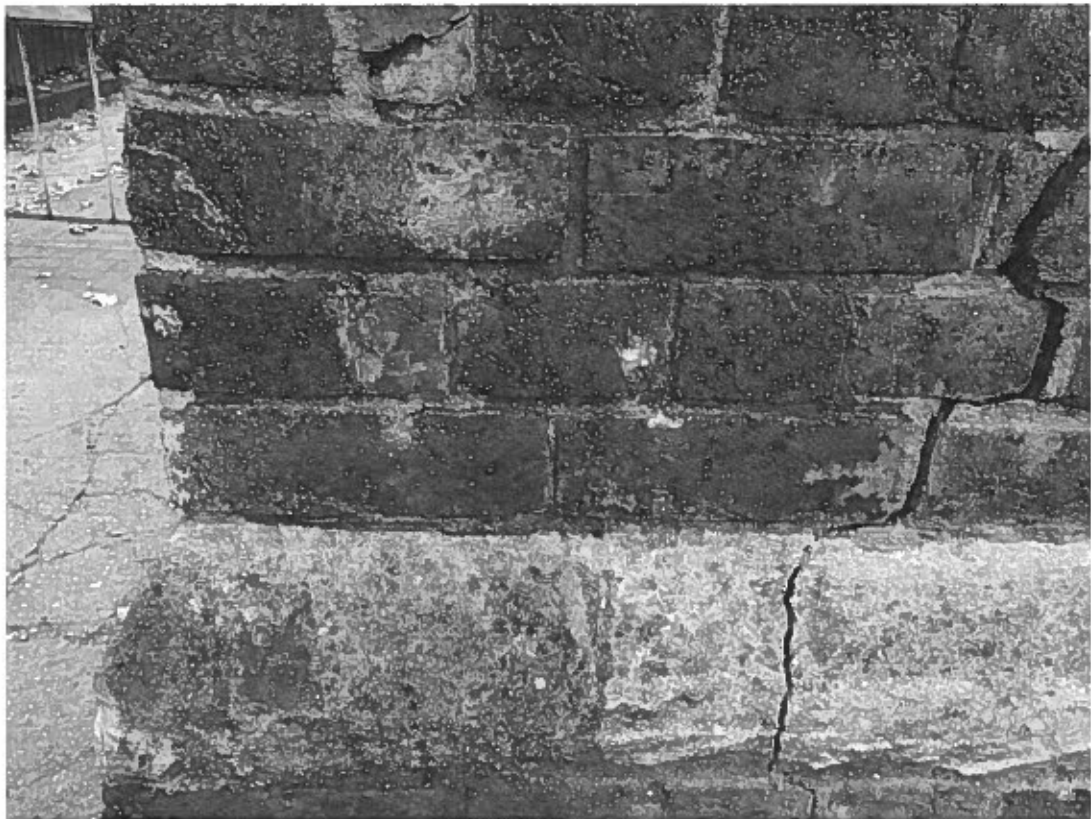
DSC00422.JPG

- 3.4 The more recent cracking which is below this level is thought possibly to be due to some vehicular impact. It is noted that just above the stone band to the front of the pier there is what appears to be fresh impact damage. This could be as a result of a lorry turning around in the road and reversing into the wall. (See photograph 422). However, we cannot be certain about this.

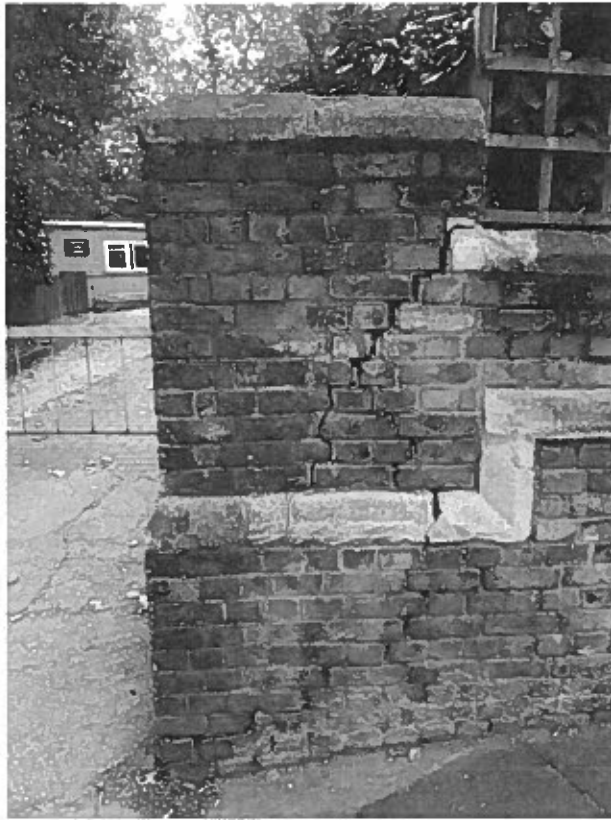
DSC00423.JPG

- 3.1 There is significant cracking to the pier as can be seen in the photographs. Much of this cracking is old and has been repaired in the past, but has re-occurred. However, there is more recent cracking towards the front of the pier itself. (See photograph 423).

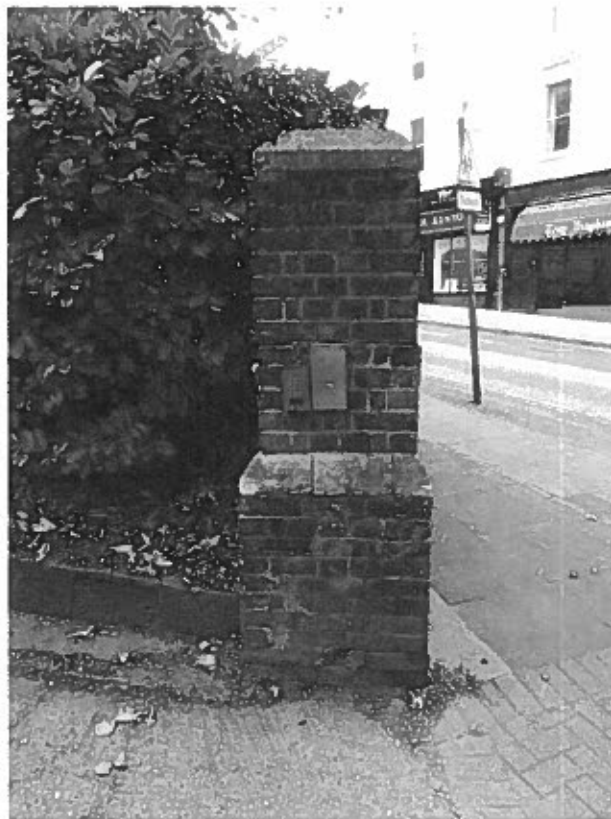
DSC00424.JPG

- 3.3 The upper seven courses of brick together with the stone capping have been displaced front to back, this is thought to be due to the main wall being aligned with the front face of the pier, and therefore, the main moving force is set towards the front causing a twisting action on the pier and hence the lateral displacement front to rear. (See Photograph 424 and 425).
