Report of an Intrusive Pre-Demolition Survey  
for asbestos containing materials at:

**258 Belsize Road,  
London,  
NW6 4BT**

On behalf of:  
Alan Power Architects Ltd,  
13 Needham Road,  
London,  
W11 2RP

**REFERENCE:** 8514A

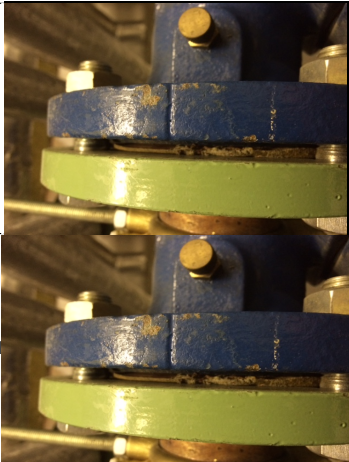
005	A005/23072014/KFB	Boiler room	Pipe joint	Gasket	x1			This item was removed 11/08/2014

<b>Sample No or Ref</b>	<b>Location</b>	<b>Product or Material</b>
A001/23072014/KFB	Roof to stairwell- Cladding- A/C	Removed 13/08/2014
A005/23072014/KFB	3 <sup>rd</sup> floor boiler room-Gasket	Removed 11/08/2014
