# Design & Access Statement including Heritage Statement

60 Carey Street, London WC2A 2JB

8 December 2014

Report No	Date
XL03593/R1	29 <sup>th</sup> July 2014
Project	<b>No. 60 CAREY: STREET VISUAL INSPECTION ON ROOF PARAPET OF FRONT ELEVATION</b>
Client	<b>The Law Society</b>

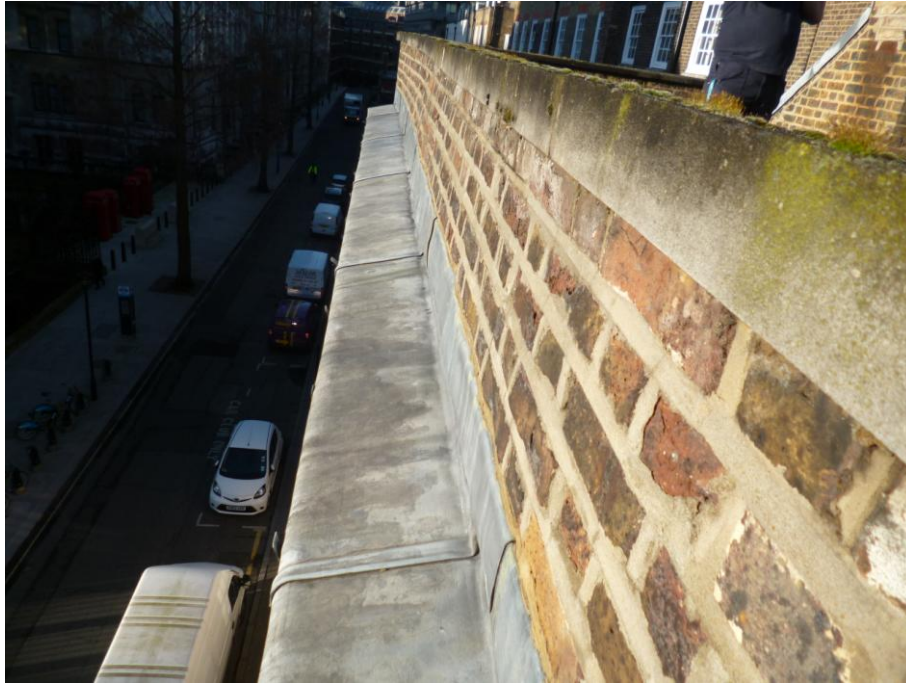
The installation of Stainless Steel tie rods to the front parapet brickwork has been recommended by a structural engineer, due to the severity of movement identified ([photograph 3](#)). The installation of ties, which will be drilled through the coping stones, will not impact upon the visual appearance of the facade. The copings themselves are not original to the building, having been installed we believe in the 1960s.

**PHOTOGRAPH 3:** Movement of front Carey Street parapet wall.

Installing stainless steel restraint rods to the parapet will result some loss of brickwork in the centre of the wall; this work will not impact upon the visual appearance of the facade. This method has been deemed preferable to re-building the parapet, which would result in significant loss of fabric and impact on appearance.

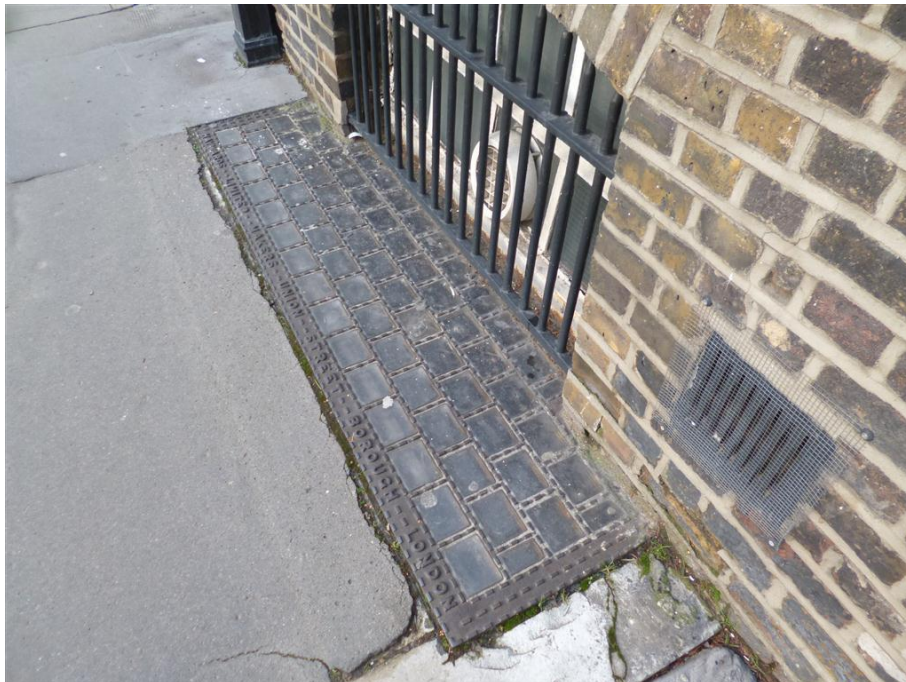
The cast iron pavement lights are corroded, which is resulting in water ingress to the original 1731 pavement vaults ([photographs 4 & 5](#)). The existing pavement lights date from the 1930 restoration project, and are of age have age and historical value. It is intended to replace to pavement lights in cast iron on a like-for-like basis.

**PHOTOGRAPH 4:** Typical pavement light externally.

The cast iron pavement lights are completely corroded and beyond repair. As stated above, the pavement lights were installed during the 1930 restoration and are considered to be of importance in terms of age and rarity. They will be replaced on a like-for-like basis.

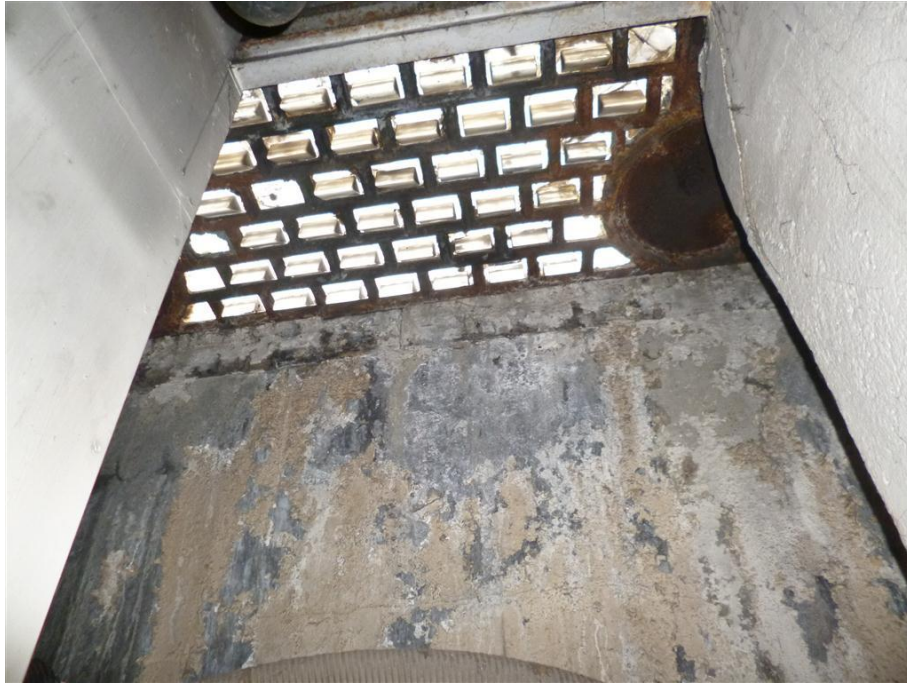
**PHOTOGRAPH 5:** Typical pavement light to Carey Street internally.

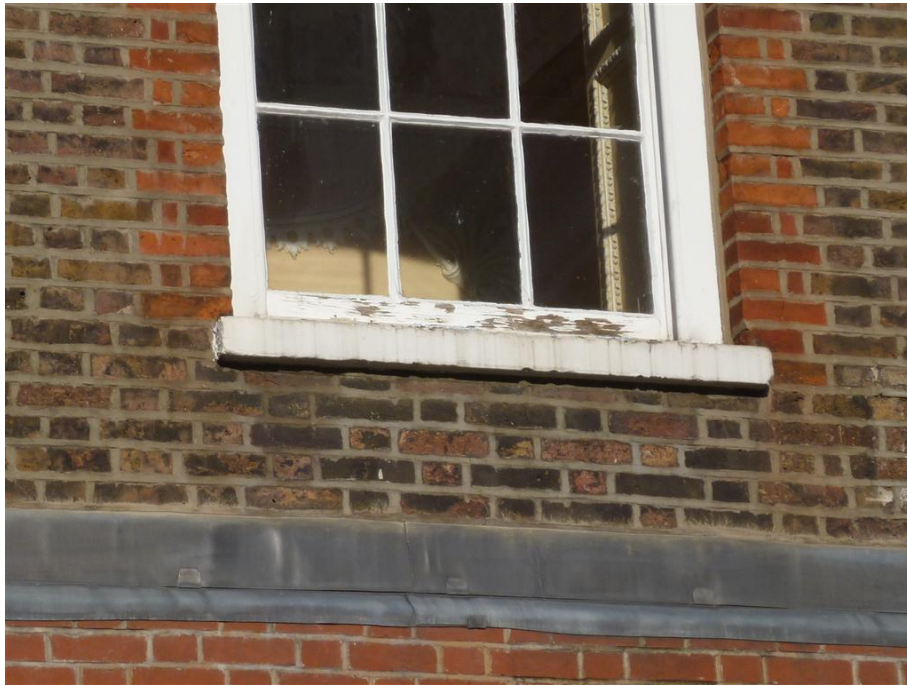
The sash windows are in poor condition and repairs and redecoration are required to protect the original timber ([photograph 7](#)). The works will be undertaken by experienced contractors, with high quality materials to suit the nature of the building. The visual appearance of the building will be improved as a result.

**PHOTOGRAPH 7:** Poor decorations to sash windows.

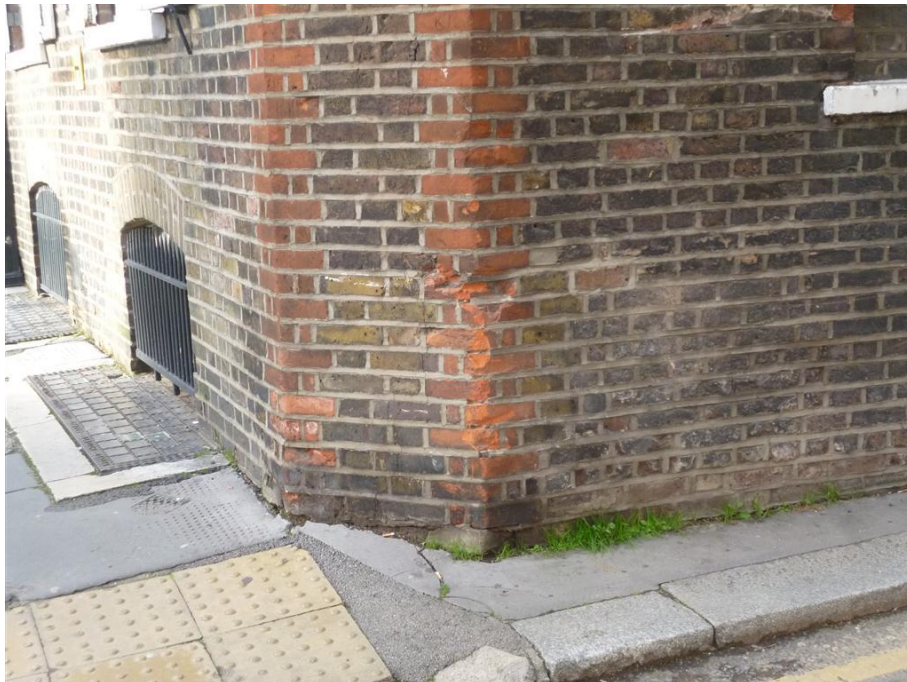
**PHOTOGRAPH 8:** Impact damaged brickwork.

Repairs to brickwork ([photograph 8](#)) will be undertaken with like-for-like materials, and specialist sampling of bricks and mortar will be undertaken to obtain an appropriate match. Reclaimed brown London stock bricks will be used if, as expected, these provide the best possible match.

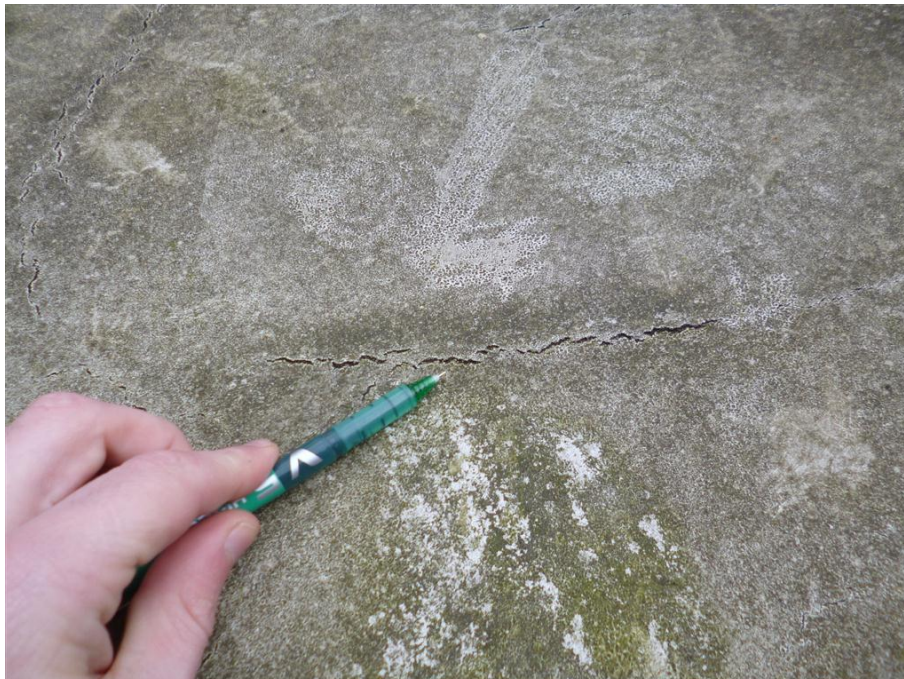
**PHOTOGRAPH 10:** Typical cracking to lantern light roofs – poultice repairs proposed.

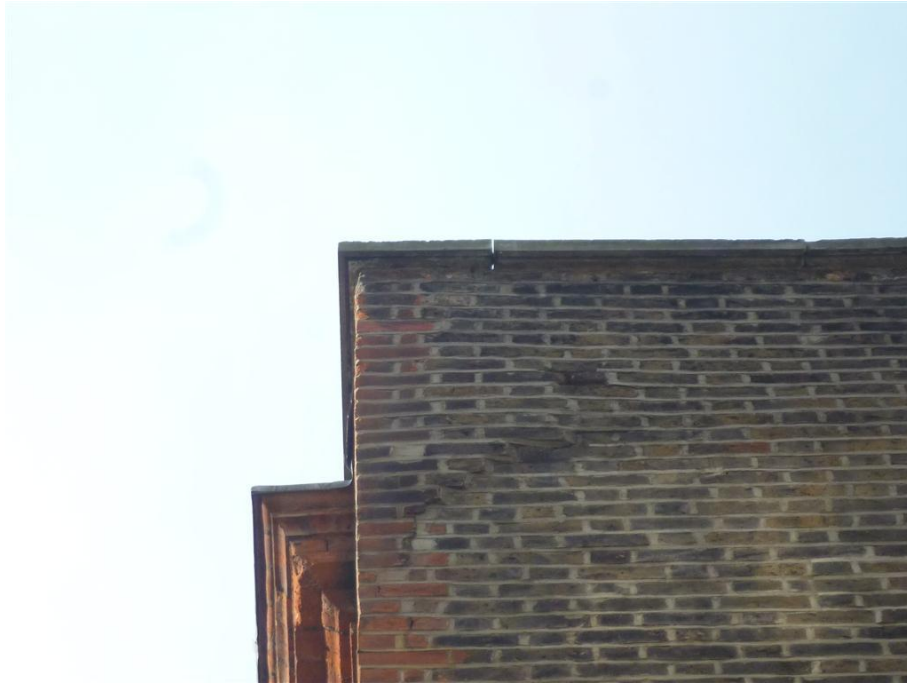
**PHOTOGRAPH 11:** Defective parapet brickwork to south east corner.

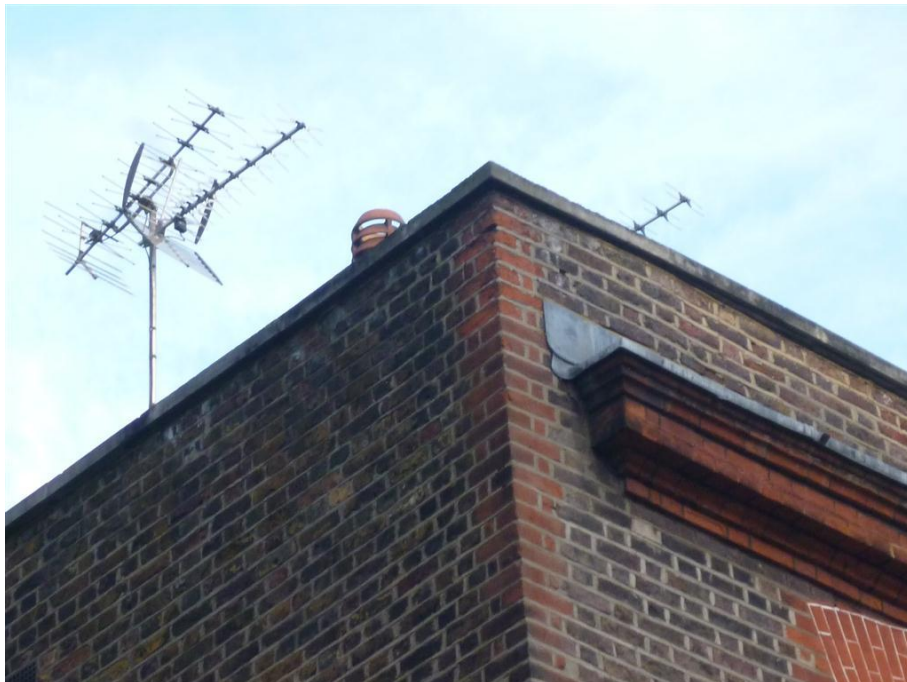
**PHOTOGRAPH 12:** Isolated spalled bricks to south west corner – to be replaced.

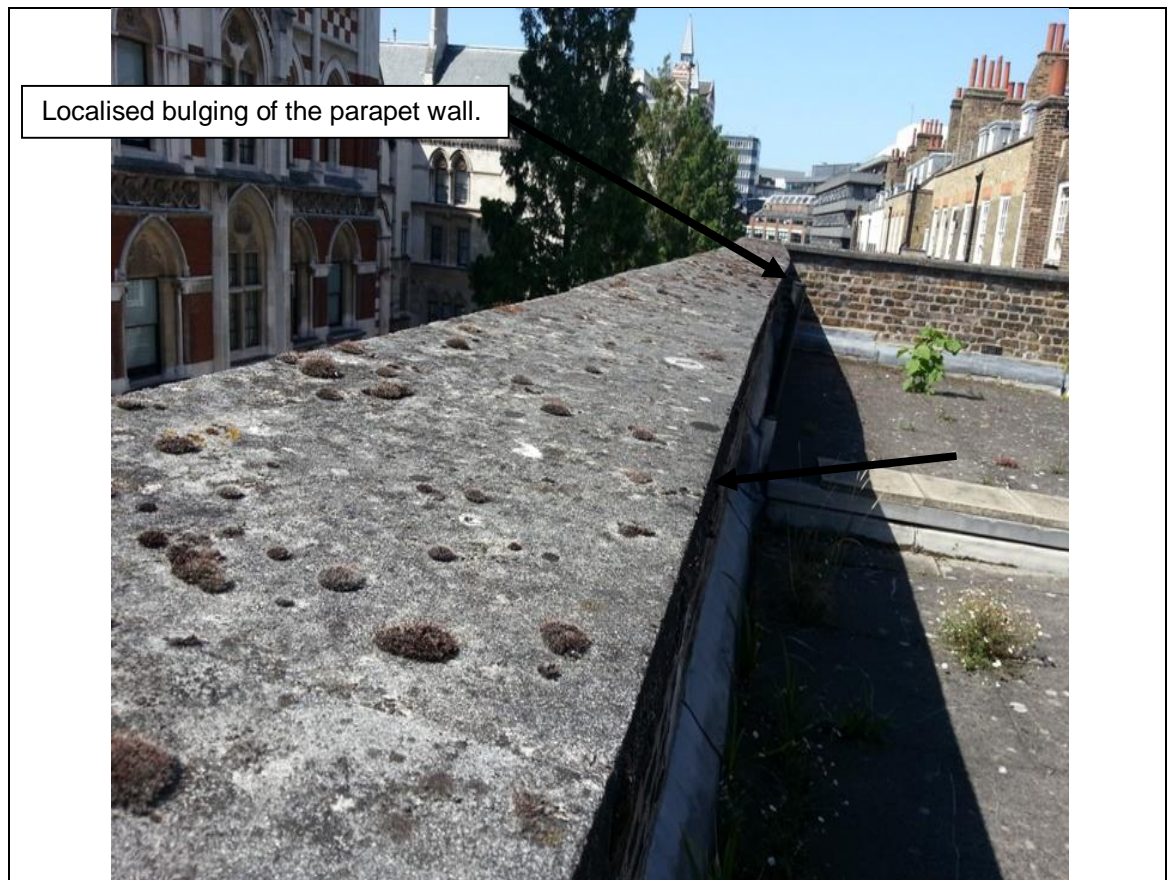
**PLATE 3**

- 3.3 A localised bulging of the parapet wall is also observed over one end of the front perimeter masonry roof parapet wall. (Plates 3 & 12)
- 3.4 There is localised repointing of the brickwork noted on the majority of the horizontal joint that is directly positioned below the underside of the concrete coping stone. (Plates 2 & 5) The Client representative highlighted that this repair/maintenance work is likely to have been undertaken at least more than ten years ago.

- 4.2 The above condition is also likely to be compounded by the differential rate of expansion over the section of the wall with the rotation of the parapet wall that has resulted on the out of plumb of approximately 10 degrees over the vertical section of this wall.

Rotation of the roof parapet/ out of plumb over the vertical section together with the localised bulging of the wall at the far end.

- 5.3 The bulging and the out of plumb defects observed on the roof parapet wall are considered to be caused by the historic movement of the brickwork. However, this will need to be checked via further inspection on the condition of the wall in terms of stability at the roof junction level beneath the lead flashing finishes. It might be necessary to consider some form of strengthening remedial works in order to enhance the overall stability of the roof parapet wall via vertical stainless steel dowels to be drilled and grouted centrally over the width of the section through the height of the parapet wall at regular centres to be agreed.

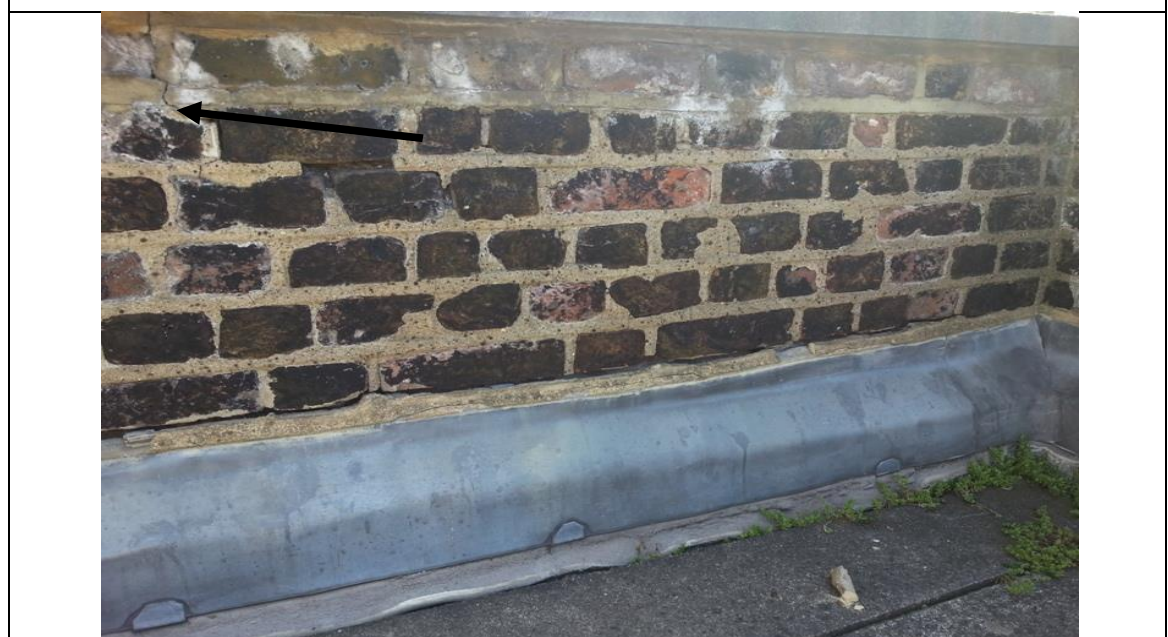
**PLATE 4**

- 3.5 There is sign of lateral thermal expansion movement over the length of the front masonry parapet wall with some vertical cracking exhibited on the internal face of the wall (Plate 4). At one end, there is also sign of local movement at the gable end of the parapet wall adjacent to the masonry chimney flue where there is a gap on the concrete coping stone noted on the corner return of the parapet wall. (Plate 10)

- 4.1 It is considered that the most likely cause of the damage to the masonry roof parapet wall is the insufficient capability of accommodating the thermal expansion of the lateral movement over the entire length of the wall without any provision of movement joints.

Vertical cracking on the internal face of the parapet wall that is located approx. 1.2m from the gable return.

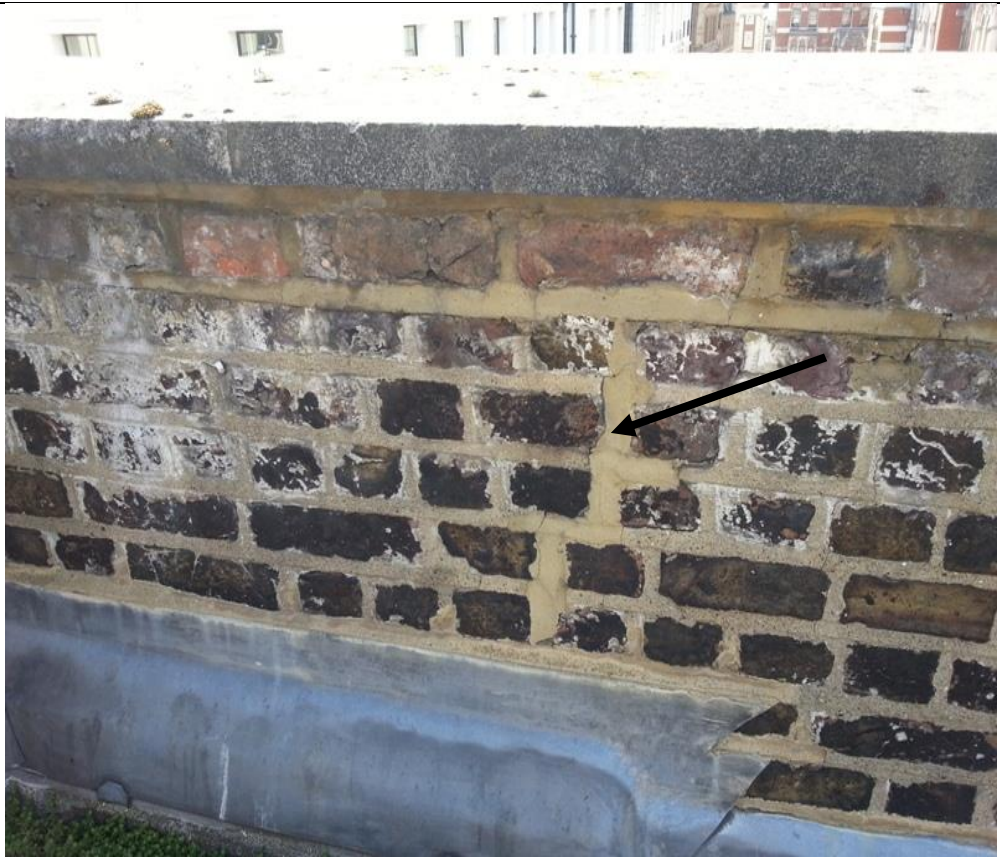
**PLATE 5**

Localised repointing of the perpendicular joints as well as the horizontal joint located directly below the coping stones.

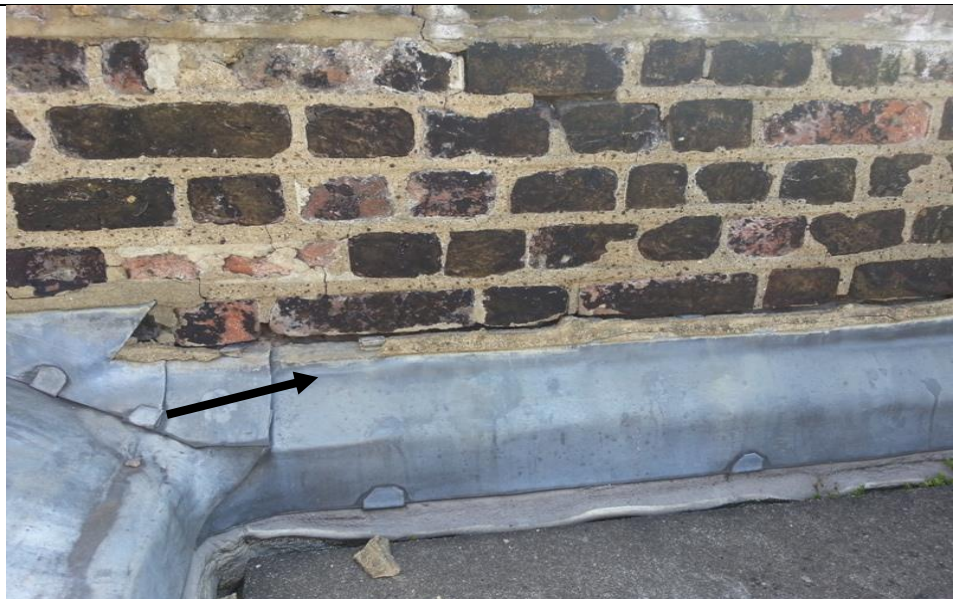
**PLATE 6**

- 3.8 Some loose mortar repointing over the horizontal joint above the lead flashing have lost its bonding onto the brickwork locally. (Plates 6 & 7)

- 4.5 The bonding on some of the repointing of the bed joint mortar on the horizontal joints just above the lead flashing level have been lost which is likely to be attributed to some minor on-going lateral thermal movement along the wall. This defect is potentially compounded by the quality of the type of mortar being used and the associated workmanship applied. Consequently, this nature of the defect could be effectively affected the watertightness of the parapet wall due to the likelihood of the potential ingress of water over this junction.

Loose mortar along the bed joint above the flashing line on gable wall adjacent to the chimney.

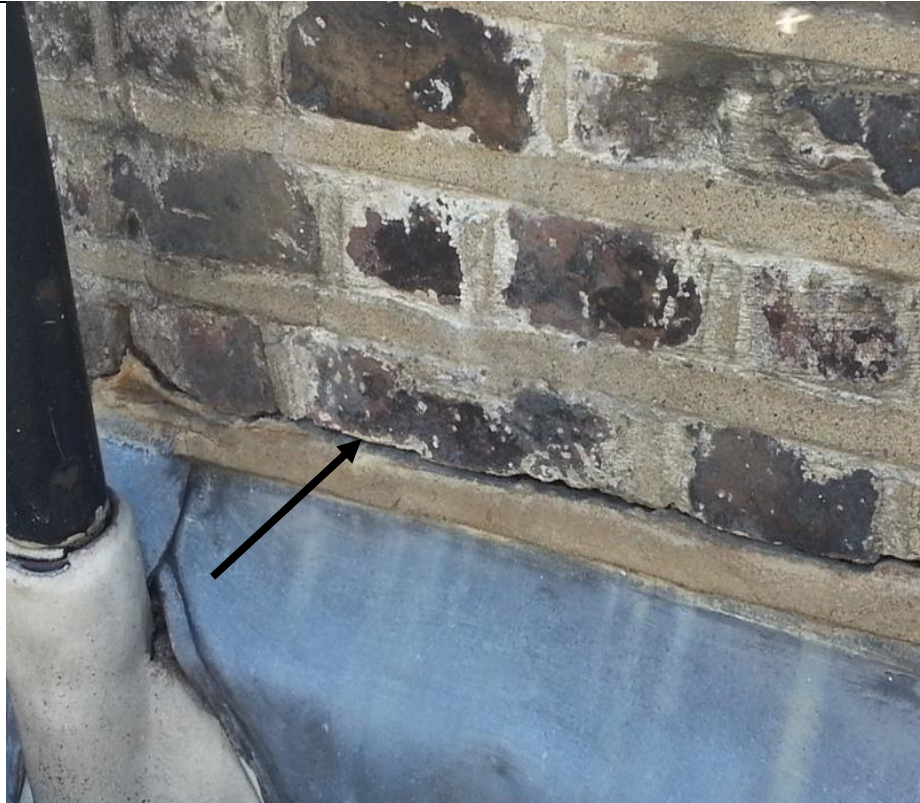
**PLATE 7**

Loose mortar joint along the horizontal joint above the lead flashing.

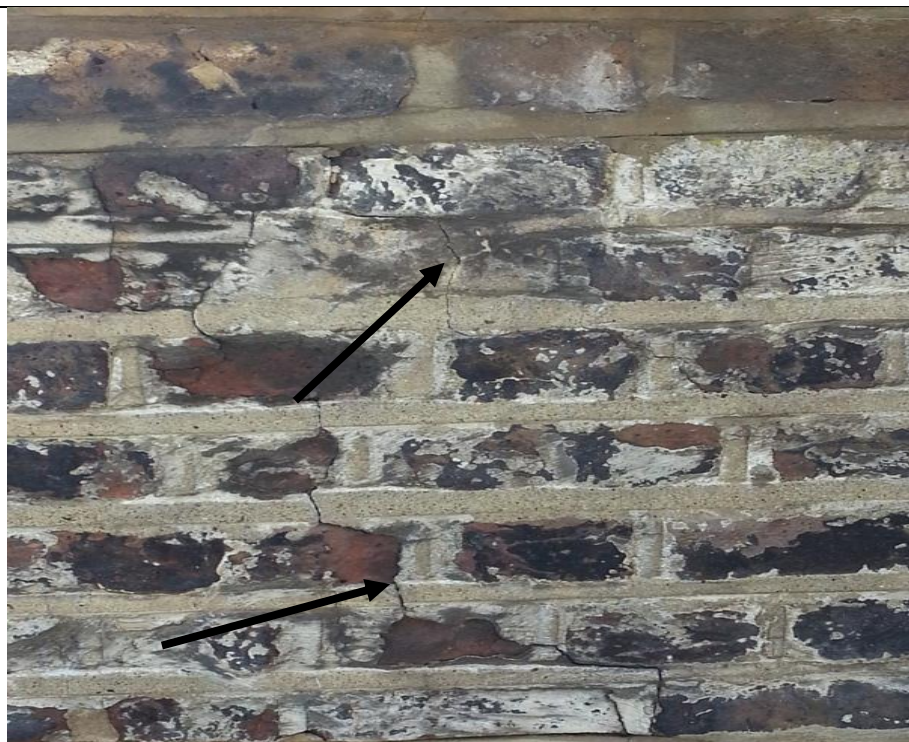
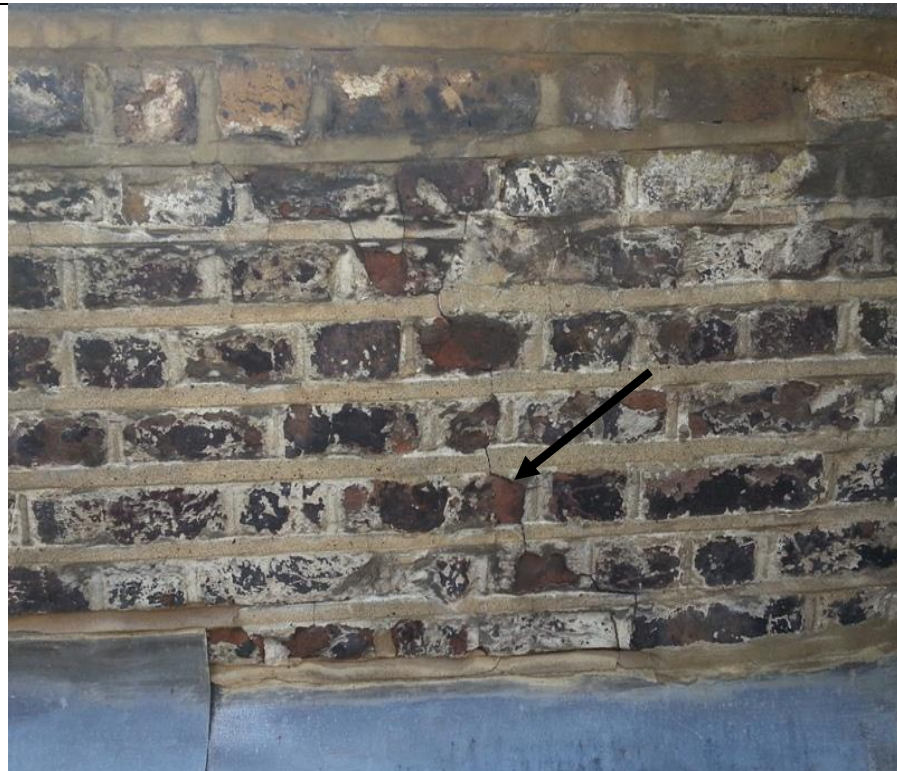
**PLATE 8**

- 3.6 Two lines of visible stepped cracking of the parapet wall are also observed on the internal face of this upstand. (Plates 8 & 9)
- 3.7 There is also a significant localised bulging of the parapet wall over on the South East corner return of the gable wall with upto approximately 20mm slippage of the brickwork that is observed on the external elevation of the building. The level of the bulging on the brickwork is located below the base of the perimeter of the parapet wall i.e. roof level and extended to at least eight courses of brickwork towards the corner of the building. (Plates 11 & 12)

Two lines of stepped cracking on the parapet wall.

Same cracks as noted on Plate 8 above.

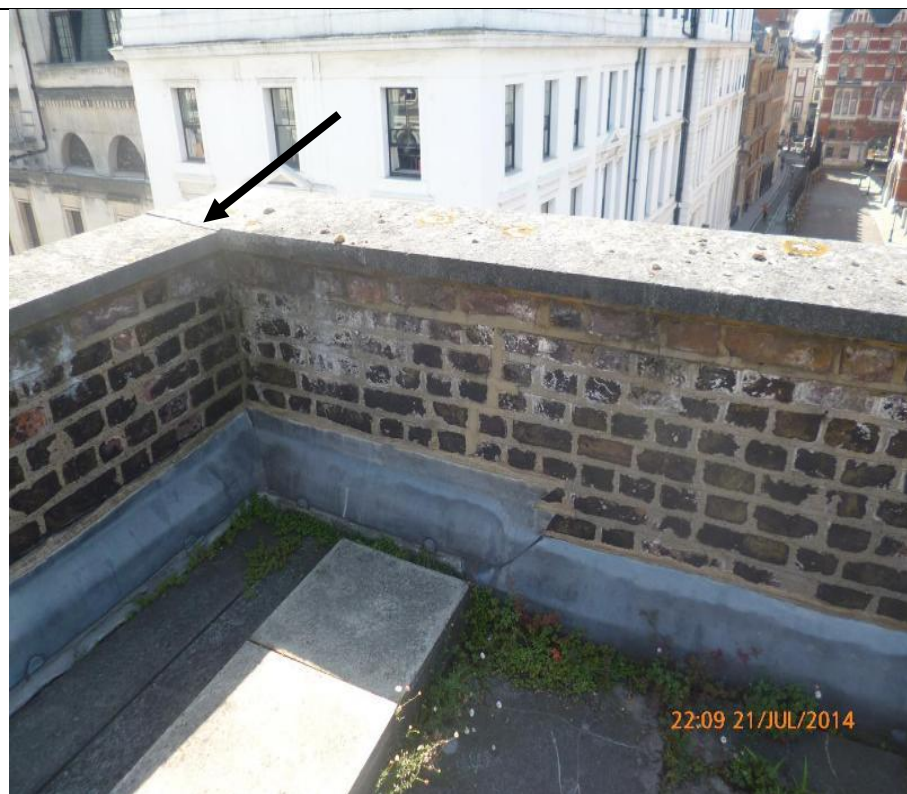
**PLATE 10**

Slight thermal movement noted on the coping stone at return with a nominal gap.

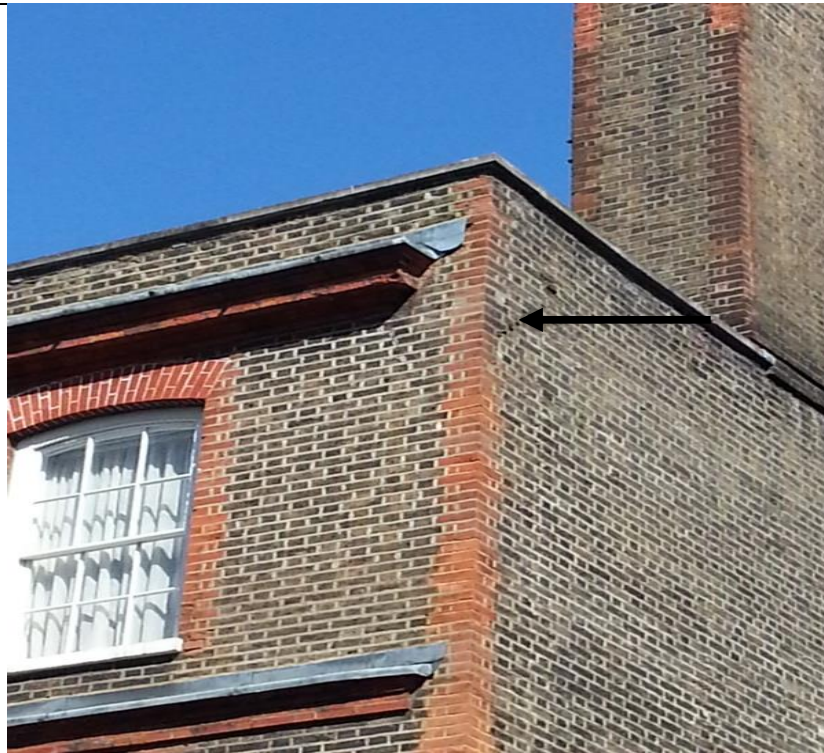
**PLATE 11**

- 4.6 A significant slippage of the gabled wall on the South West corner of the building elevation has been identified and it is considered that the likely cause of the damage is the primary issue of accommodating lateral movement on the wall due to the thermal expansion of the clay bricks. However, further internal inspection will be needed in order to ascertain the nature of this defect and also the full extent of the damage internally should also be established. Furthermore, the watertightness of the wall in this localised area is also likely to be compromised with the potential water ingress into the cracking of the brickwork.

Corner bulging and slippage of the gabled wall return.

- 5.2 Subject to the findings of the proposed internal investigation as detailed in Clause 5.7 below, it is likely that this localised gable section of this wall will need to be demolished and rebuilt in order to avoid any potential ingress of water over the cracked section of the brickwork in the long term.

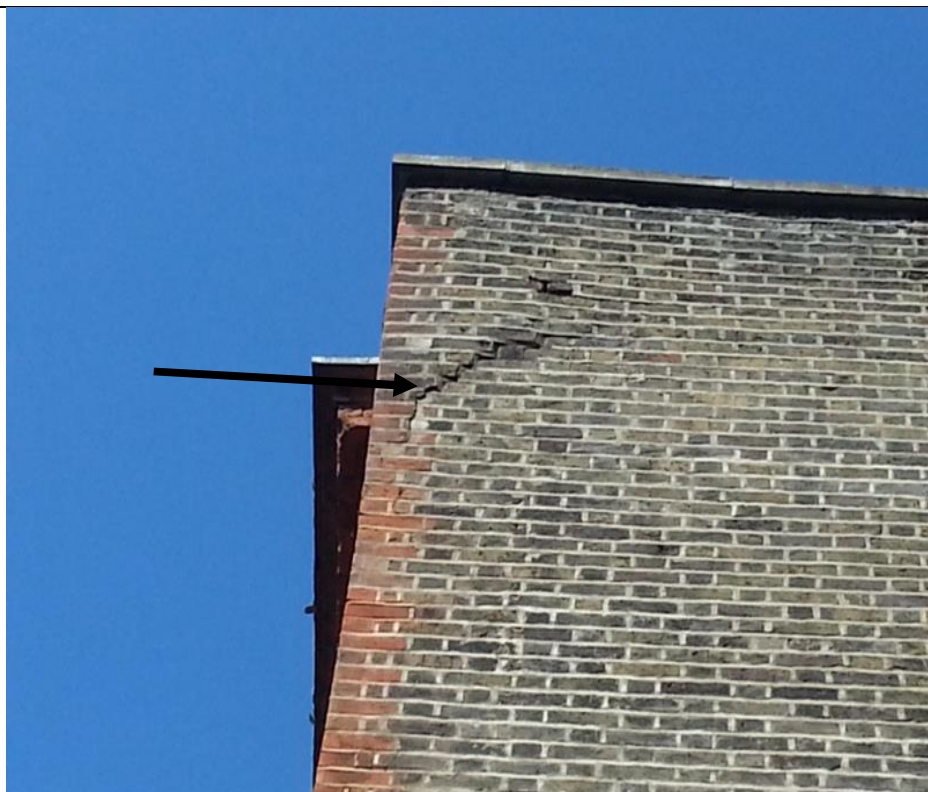
**PLATE 12 ( same defect location as Plate 11)**

Close up showing diagonal cracking and bulging of the return gable wall at the level just below the parapet wall.

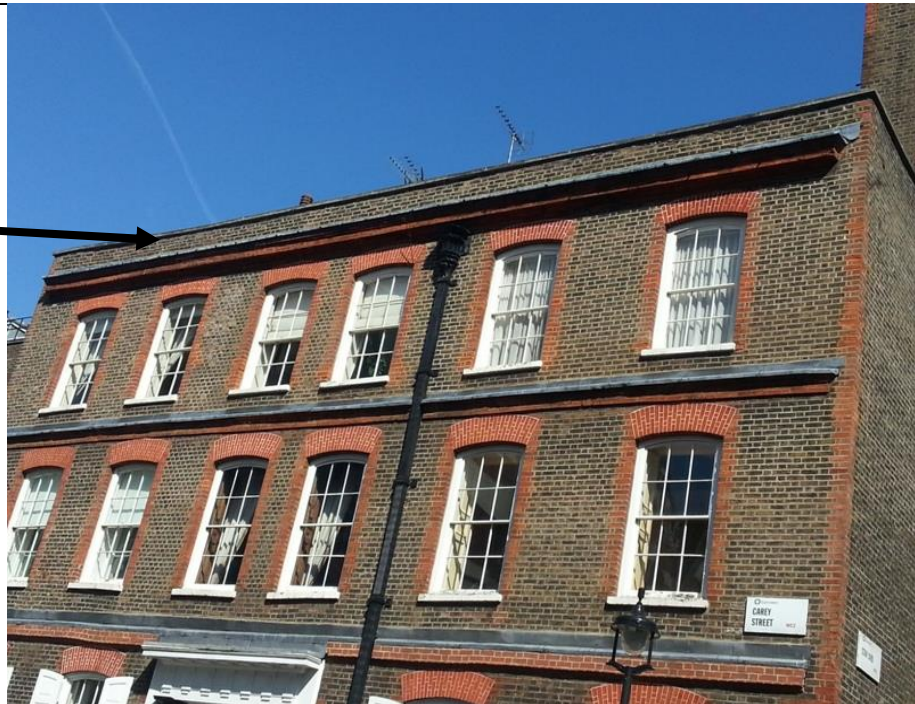
**PLATE 13**

Localised Bulging of the roof parapet wall.

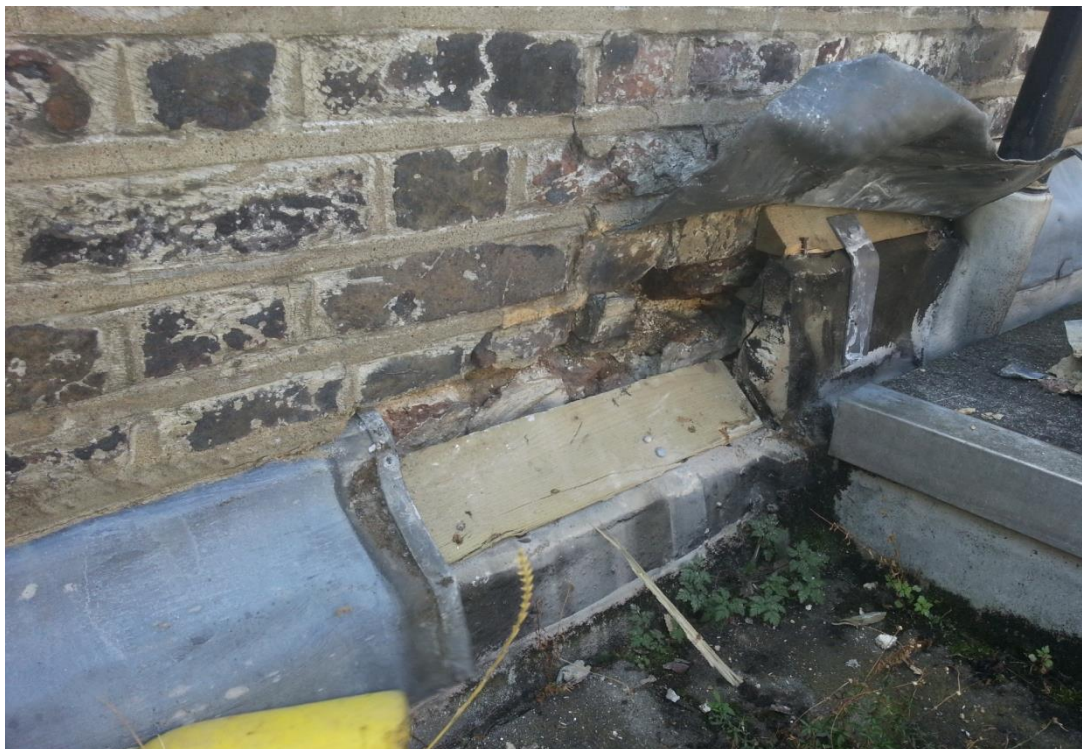
Plate 1: Base of roof parapet wall.

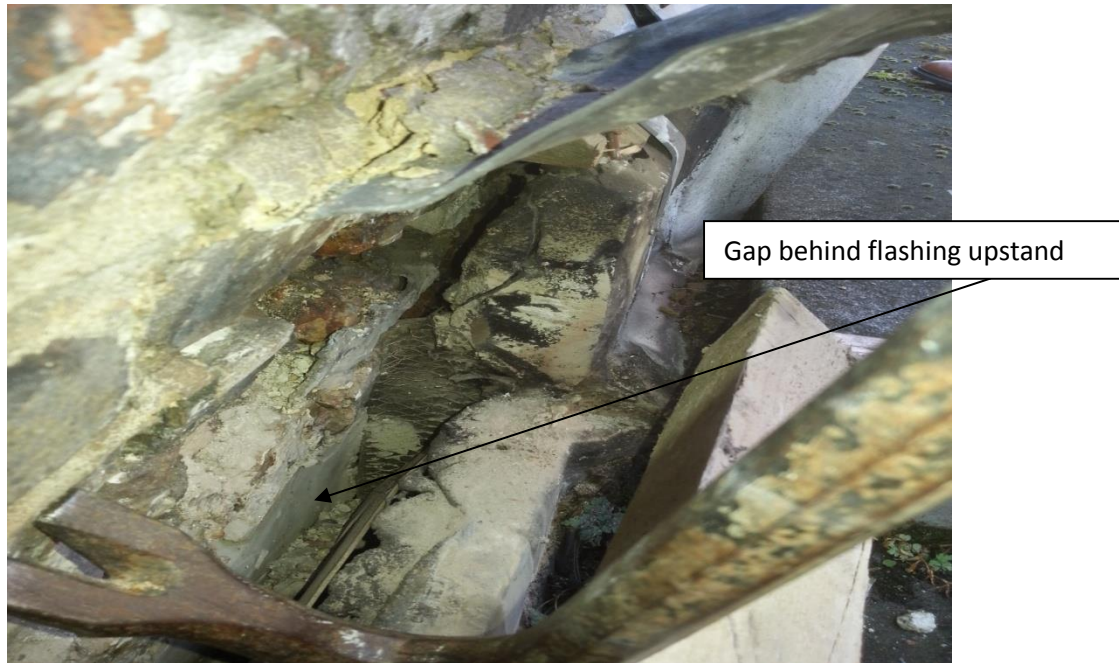
Plate 2: Section showing a horizontal gap at the base of wall behind timber wall plate and flashing upstand.

- A minimum of 20 to 40mm gaps varies along the back of the flashing upstand were identified.
- Some signs of visible localised deterioration of the weathering brickwork were noted.

- 1) An inspection on the condition of the wall at the roof junction beneath the lead flashing finishes has been carried out. It has revealed that the junction appears to be in a relatively poor condition in terms of the extent of the potential slippage on the horizontal axis of the parapet wall at the base this upstand at the lateral bulging area.

- a) It will necessary to consider some form of strengthening remedial works in order to enhance the overall stability of the roof parapet wall via vertical stainless steel dowels to be drilled and grouted centrally over the width of the section through the height of the parapet wall at regular centres to be agreed. Some of the weathered existing bricks will also need to be locally removed and replaced.

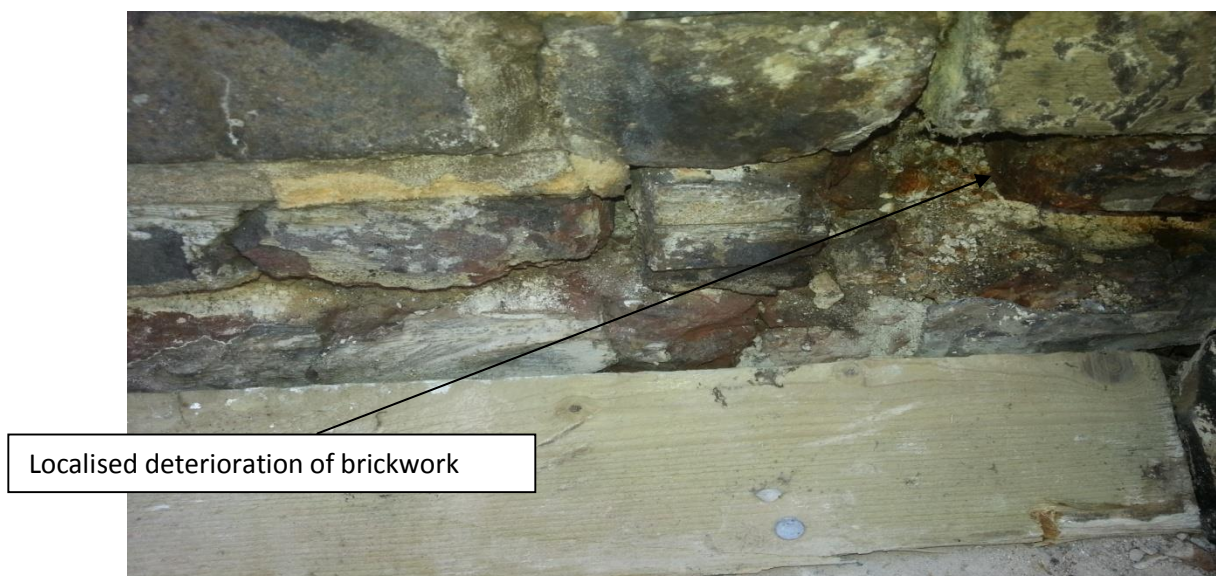
Plate 3: Weathered brickwork was identified below the flashing level.

- 3) Some localised deterioration of the weathered brickwork on the parapet wall upstand has also been identified during the opening works.
- 4) An internal inspection within the top floor President's bedroom has been undertaken in the corner cupboard behind the timber panelling which is in close proximity of the area exhibited an external cracking of the gable wall. There is no sign of any significant visible cracking of the brickwork internally on the inside face of the masonry parapet wall.

- c) The composition of the existing lime mortar and also the brickwork will need to be tested for the purpose of future repointing works on the mortar and replacement of weathered bricks.

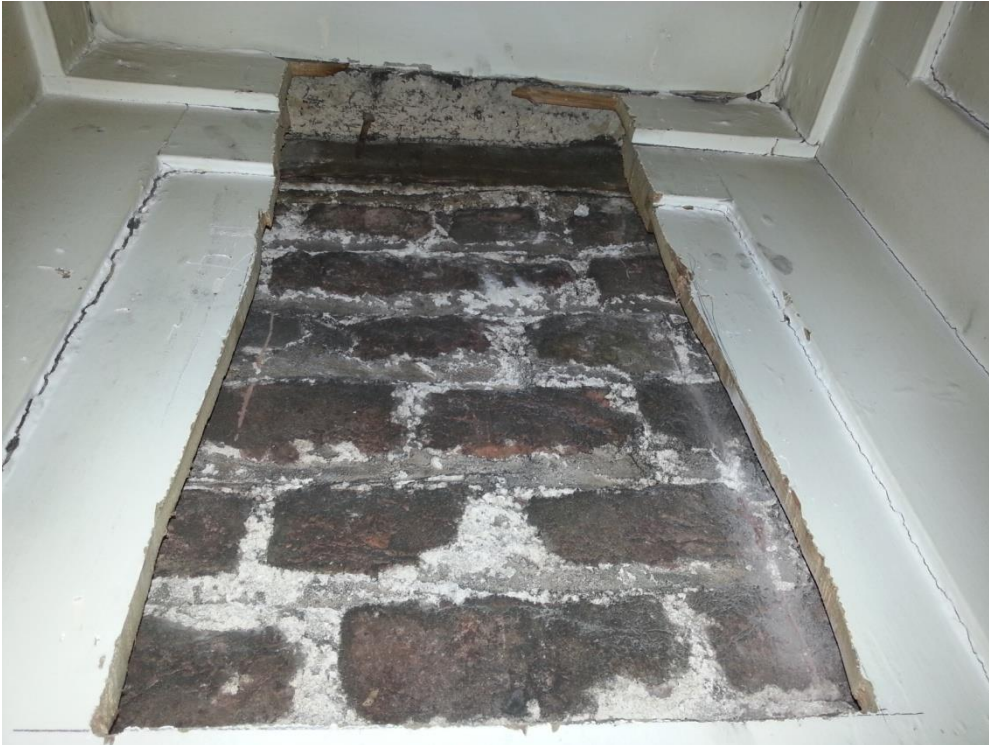
Plate 4: Reveal of the brickwork details behind the timber panelling in the approx location of the external cracking of the gable wall.

- No sign of any visible cracking of the brickwork on the internal face of the masonry wall.
