**REPORT ON ARBORICULTURAL IMPLICATIONS OF SUBSIDENCE**

**13 TORRIANO AVENUE,  
LONDON  
NW5 2SN.**

**REF: B1239944**

**19<sup>TH</sup> APRIL 2013**

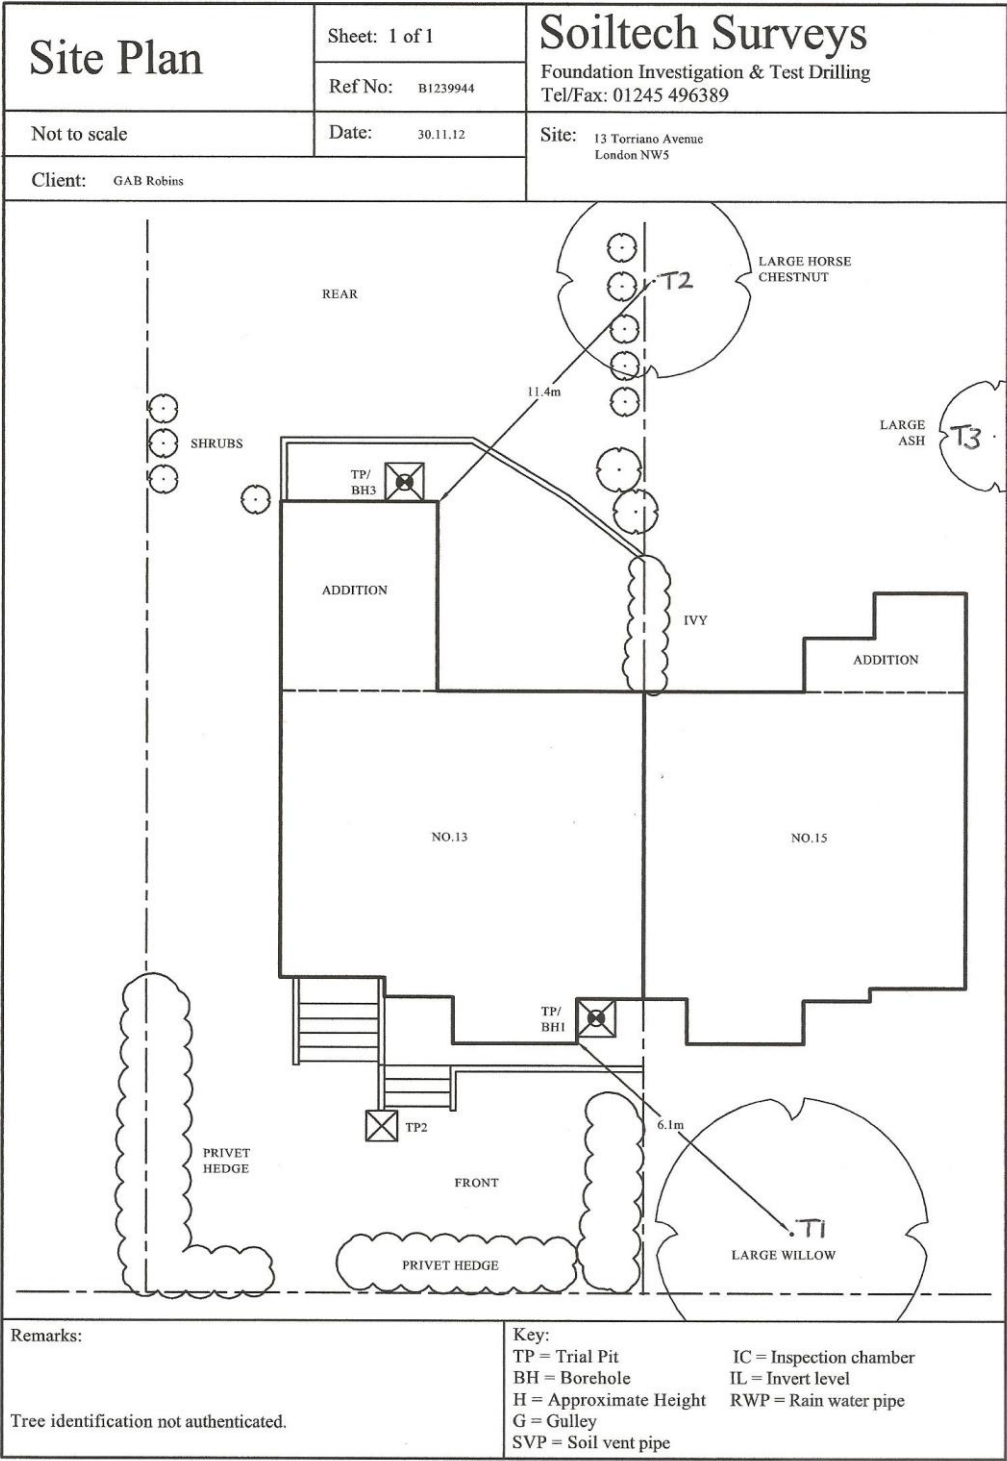
3.3.1. Three trees were recorded in the gardens of the adjacent property 15 Torriano Avenue. See amended Soiltech Site Plan for location of trees surveyed. Data on these trees is included in Appendix 1.
