#### **FURTHER INVESTIGATION REPORT:**

6 Nutley Terrace,

Ref: SHF/NTL/PCS/02

Date: 1ST December 2014

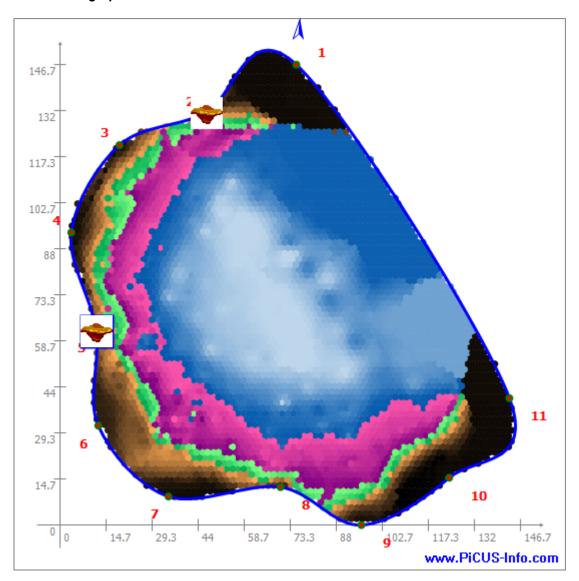
Test at 30cm agl

The Tomograph shows the cavity to the over most of the section coloured blue. There is a small amount of decay coloured purple and some incipient, early decay coloured green. The straight line from point 11 to point 1 is where the tree was close to the perimeter wall.

The Tomograph shows that the cavity and decay is extensive and could affect the structural integrity of the tree.

Fell as soon as practically possible. This work to be carried out by a full qualified and insured tree surgeon to British standard BS3998 (2010), Tree work.
