79 Fitzjohns Avenue, London NW3

**FITZJOHN'S AVENUE,  
HAMPSTEAD, NW3 6PA**

**REPORT ON PHASE 2 GROUND INVESTIGATION**

**Contract: 52247A**

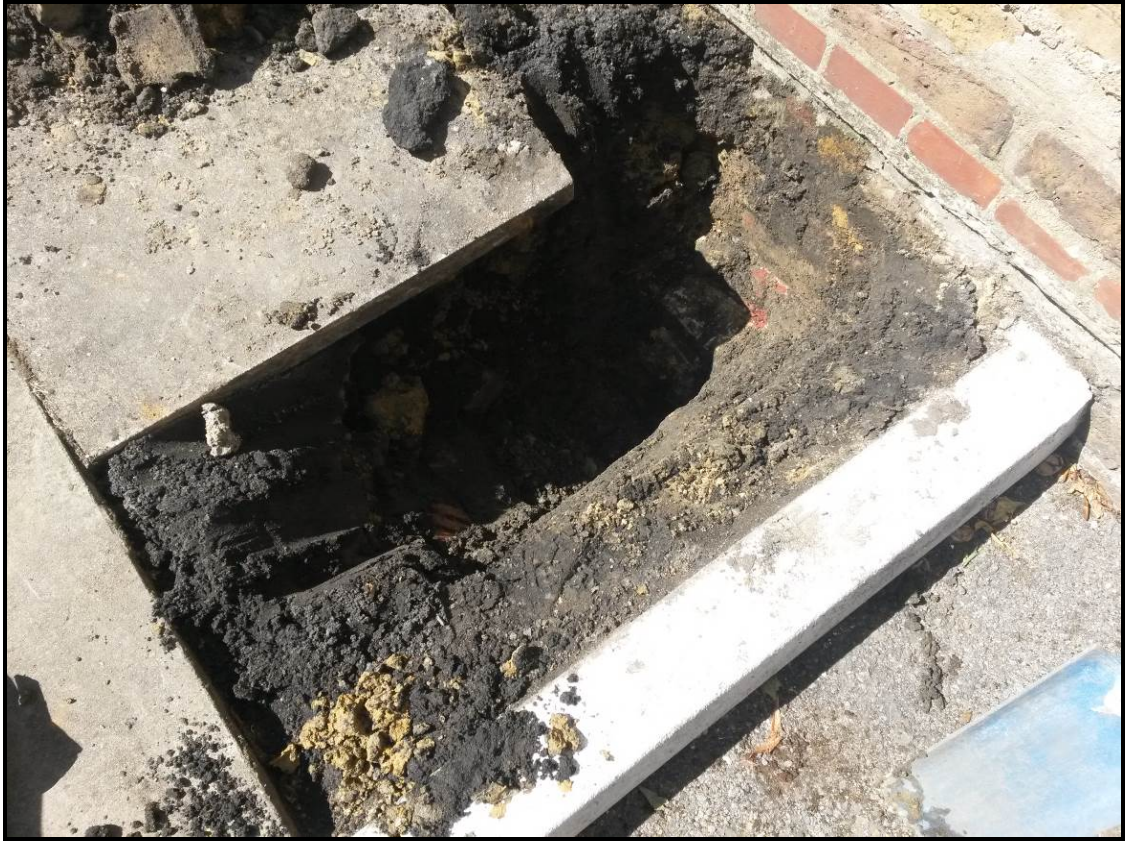
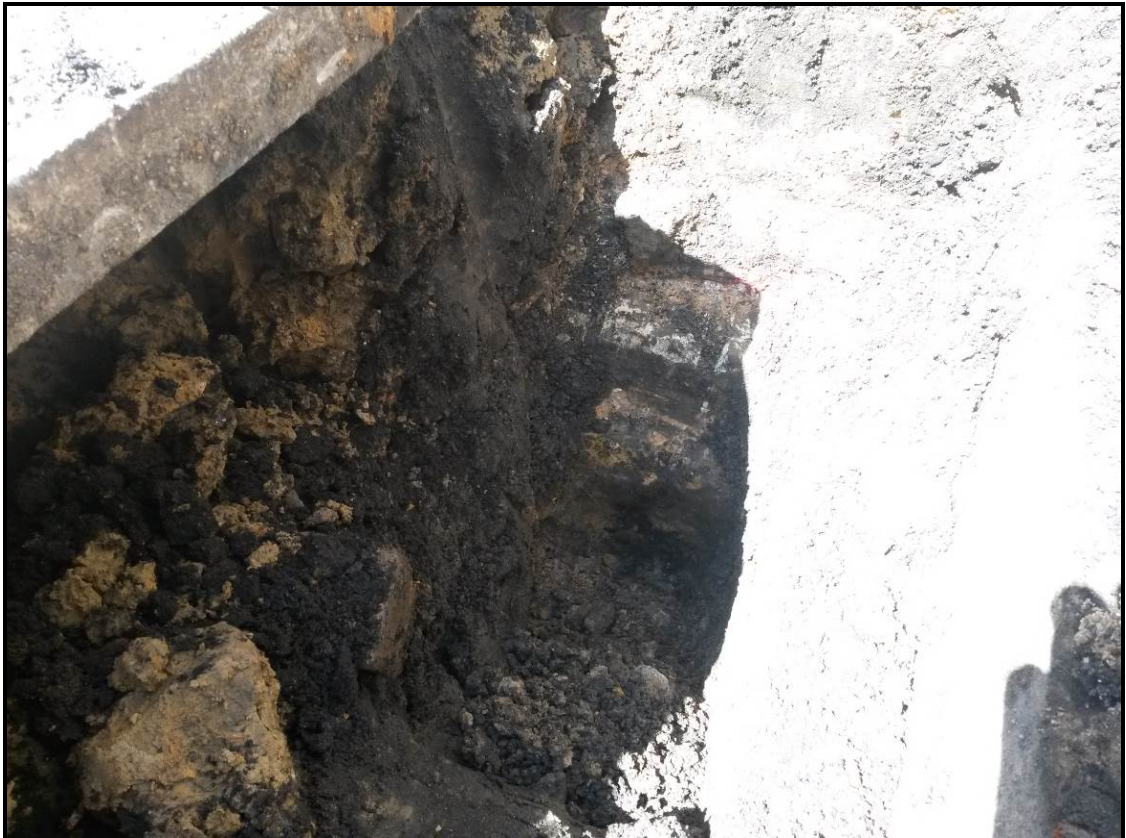
Trial pit 1

7.1.3 Details of the foundations to the adjacent boundary wall to the site are provided in the trial pit logs given in Appendix 2, Figures A2.6 to A2.8 and trial pit photographs Figures A2.9 to A2.11.
