Simon Pryce Arboriculture

Site: Grounds behind Weech Hall, Fortune Green Road, London, NW6 1DJ

Subject: Test drilling of ash tree to assess decay

Reference: 14/129

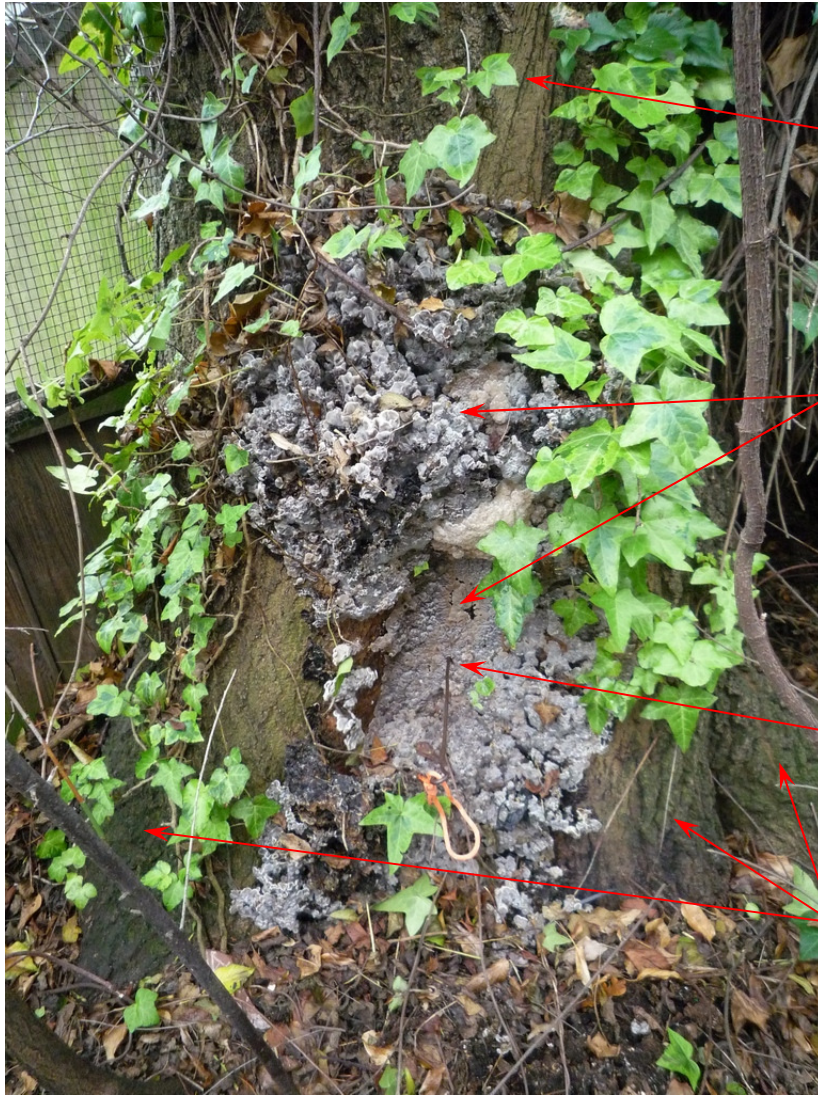
Photograph - N side of the trunk

- 3.2 It is carrying a dense growth of ivy up to just above half height, although near the base this has a few well spaced stems which allow reasonably clear inspection of the trunk. On the north side is an old wound starting between two root buttresses. This extends up to about 1.3m, becoming narrower with height, and is occluded by callus growth from round the edges.

- 3.3 The fungus is growing from the lower part of the wound and has partly spread over the healthy bark each side, although it is attached to it rather than growing from it and the buttresses each side of the wound are sound and healthy looking. It is *Auricularia mesenterica*, which is a grey, jelly like membrane, matching its common name of tripe fungus (see photo).

- 3.4 A blunt steel probe could be pushed into the centre of the old wound with little resistance, with a sudden stop at a clearly defined harder zone at about 250mm.

Top of old wound

Fungus

Probe

Well developed root buttresses

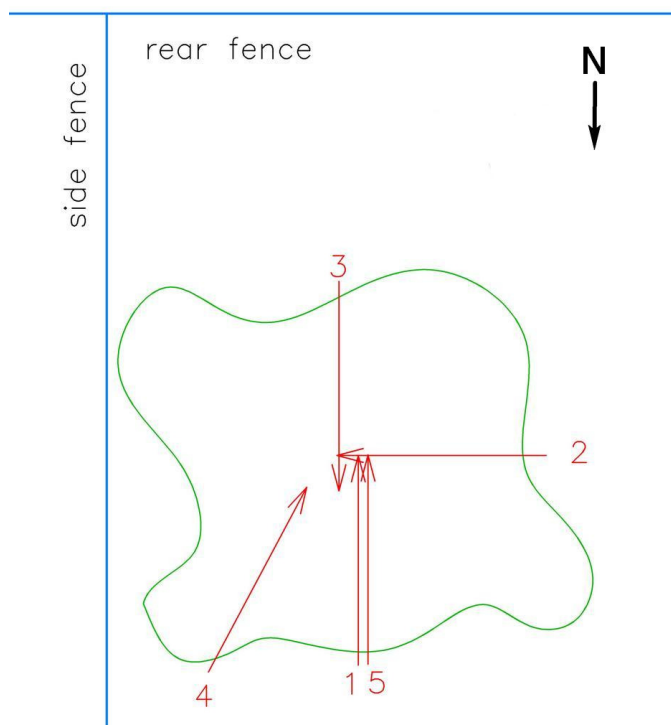
Test drill locations. Nos. 1 - 4 were at about 200mm above ground, no.5 at 1.3m

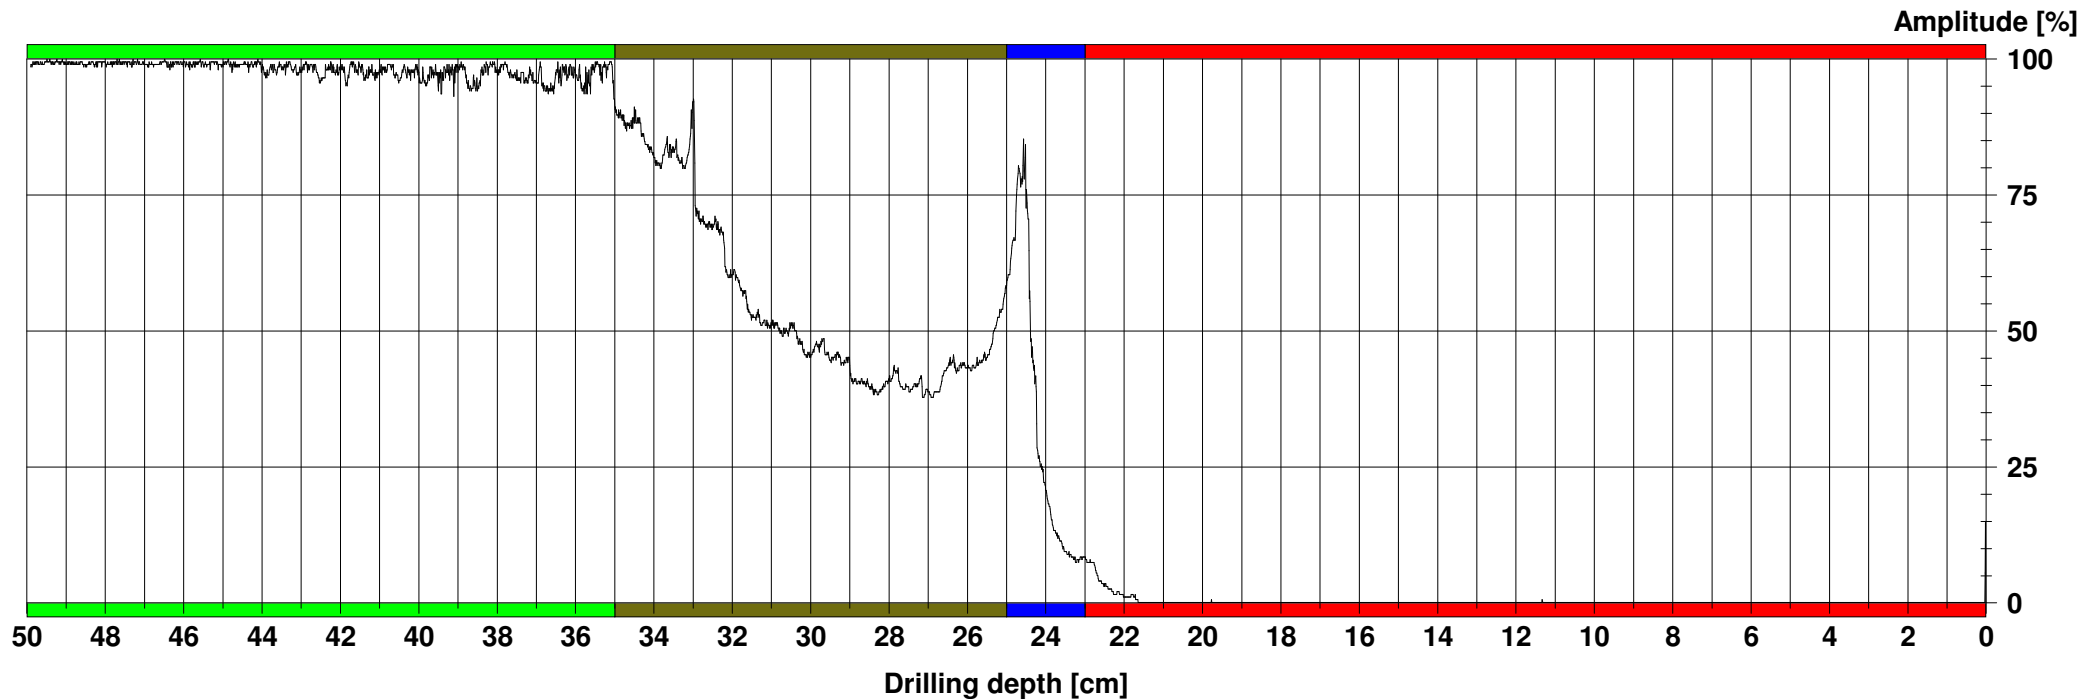
Measurement no. : 1	Tilt : ---	Name : Bowood Commercial
Drilling depth : 49,91 cm	Avg. curve : off	
Wood species : Soft (1)	Diameter : 80,0 cm	
ID number : 14_129_1	Level : 15,0 cm	
Date : 22.12.2014	Direction : from N	
Time : 11:54:18	Object species : Ash	
Advance : 54 cm/min	Location : Weech Hall

- 3.5 The tree was test drilled in five locations with the Resistograph to a depth of 500mm, i.e. to about the centre of the trunk or just beyond. The side fence restricted access, but in this case that did not create problems. The charts are attached and the first, low in the wound, found advanced decay to about 250mm where there was an abrupt zone of resistance. Resistance also increases markedly at 350mm, but from 250mm to there the timber shows higher resistance and grain texture. At worst that might be very early decay, but the timber in that zone is currently sound. The fifth test drill, higher up from the same direction, shows that the decayed zone tapers down with height, more or less matching the wound.
- 3.6 The other three test drills all show sound wood for the full 500mm depth.

■	From 0,0 cm to 23,0 cm : Advanced decay
■	From 23,0 cm to 25,0 cm : Reaction zone
■	From 25,0 cm to 35,0 cm : Suspected decay
■	From 35,0 cm to 50,0 cm : Sound wood
■	From 0,0 cm to 0,0 cm :
■	From 0,0 cm to 0,0 cm :

Drilled into wound more or less level. Significant decay to about 25cm, with reaction zone as evidence of the tree resisting it. Possible early decay from there to about 35cm but serrated pattern and increasing resistance are also consistent with sound wood.

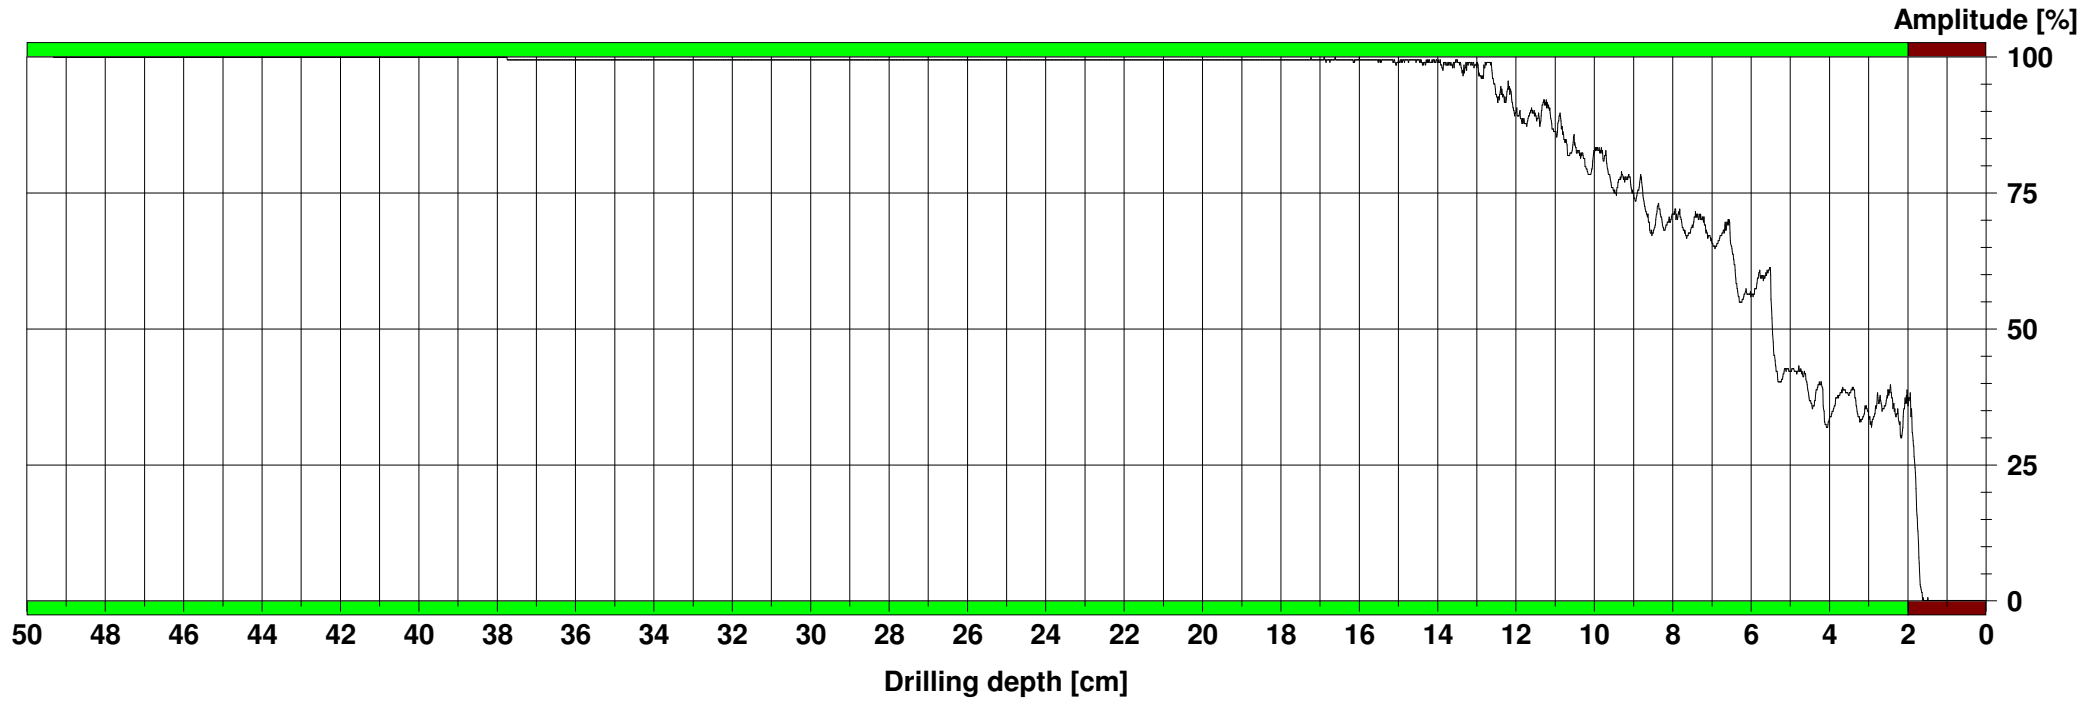
Measurement no. : 2	Tilt : ---	Name : Bowood Commercial
Drilling depth : 49,33 cm	Avg. curve : off	
Wood species : Soft (1)	Diameter : 80,0 cm	
ID number : 14_129_2	Level : 20,0 cm	
Date : 22.12.2014	Direction : from W	
Time : 11:58:26	Object species : Ash	
Advance : 54 cm/min	Location : Weech Hall

From 0,0 cm to 2,0 cm : Bark
	From 2,0 cm to 50,0 cm : Sound wood
	From 0,0 cm to 0,0 cm :
	From 0,0 cm to 0,0 cm :
	From 0,0 cm to 0,0 cm :
	From 0,0 cm to 0,0 cm :

On soft setting, so instrument goes off the scale from about 13cm - next ones are on hard setting. Serrated pattern is due to natural grain texture of sound wood, steady increase in resistance is due partly to drag on the drill with increasing depth.

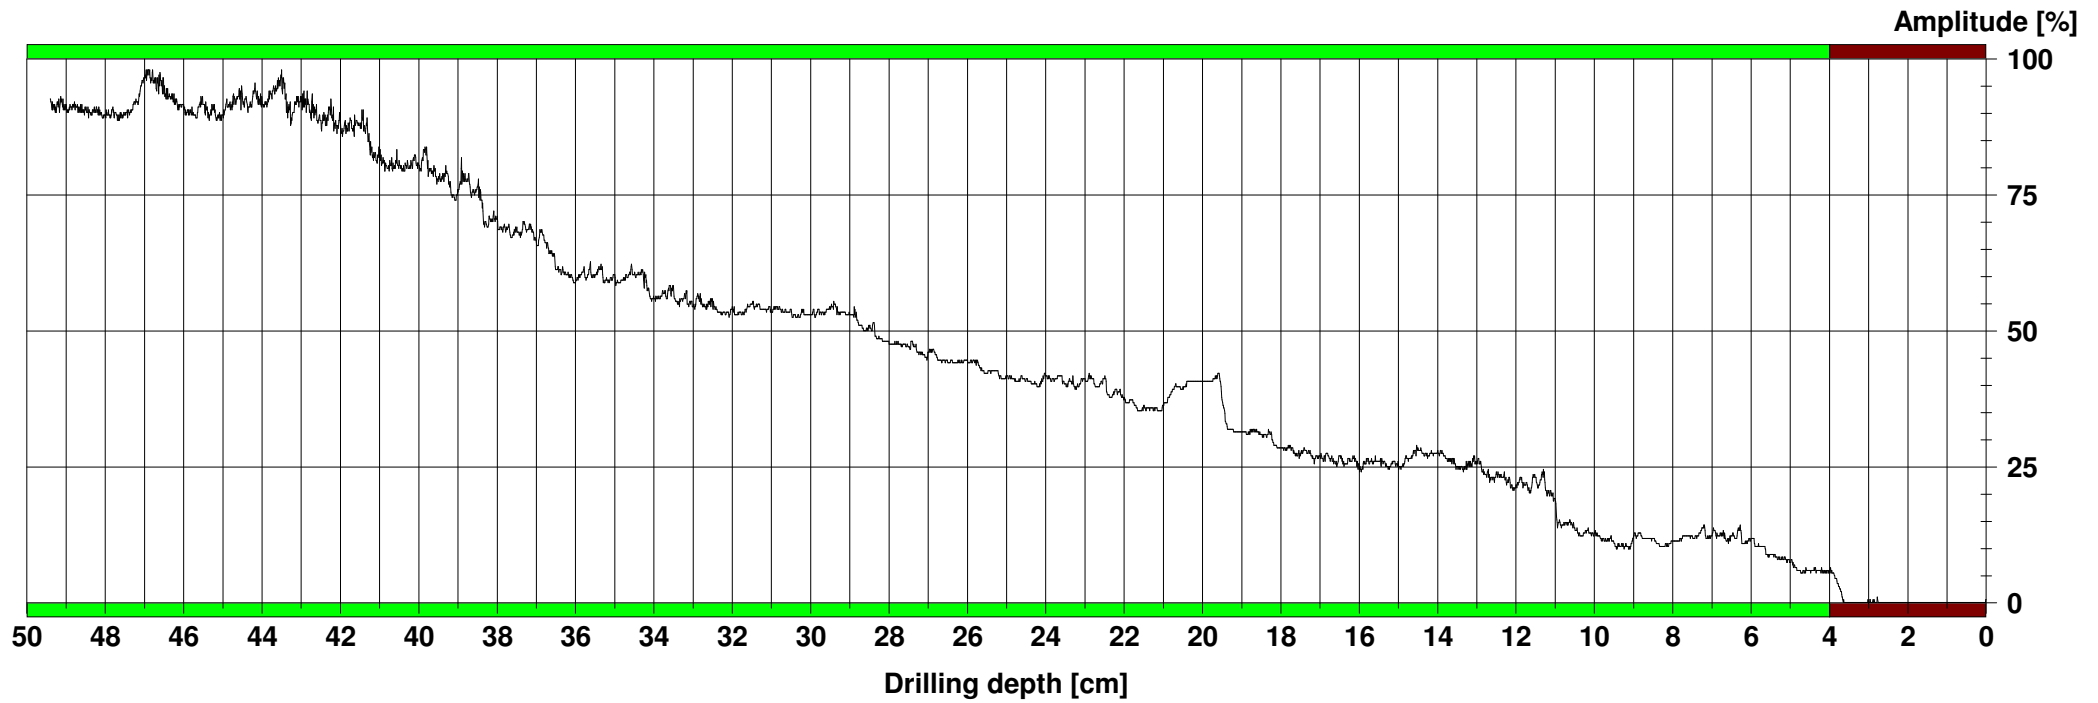
Measurement no. : 3	Tilt : ---	Name : Bowood Commercial
Drilling depth : 49,41 cm	Avg. curve : off	
Wood species : Hard (2)	Diameter : 80,0 cm	
ID number : 14_129_3	Level : 20,0 cm	
Date : 22.12.2014	Direction : from S	
Time : 12:02:44	Object species : Ash	
Advance : 53 cm/min	Location : Weech Hall

From 0,0 cm to 4,0 cm : Bark
 From 4,0 cm to 50,0 cm : Sound wood
 From 50,0 cm to 0,0 cm :
 From 0,0 cm to 0,0 cm :
 From 0,0 cm to 0,0 cm :
 From 0,0 cm to 0,0 cm :

On hard setting, so resistance looks lower than in chart 2, but serrated grain pattern and steady increase in resistance indicate sound wood

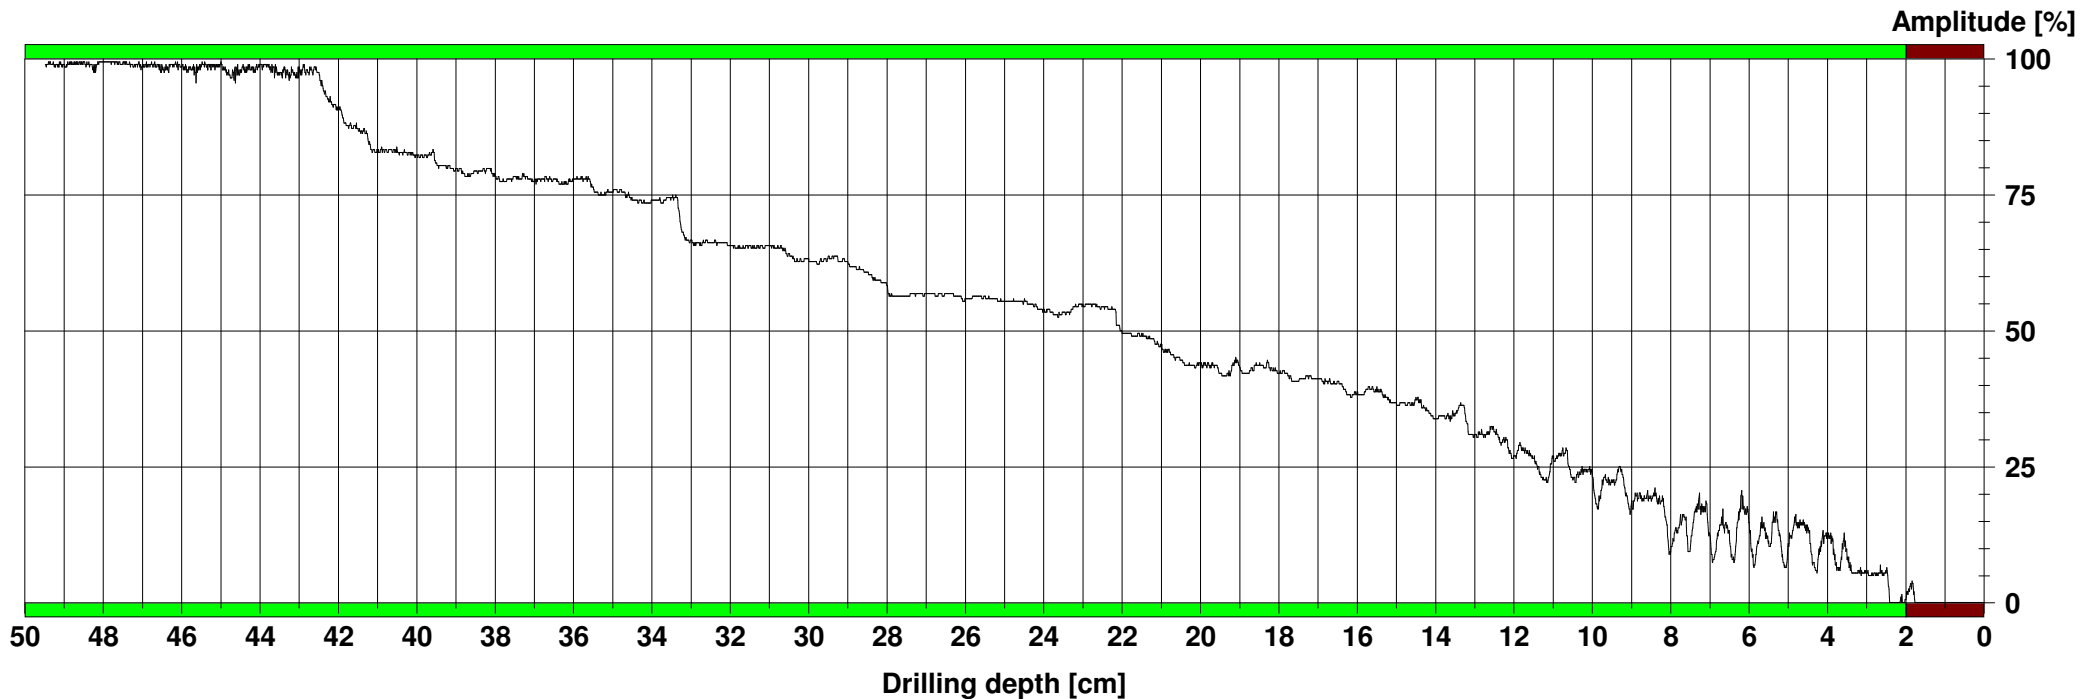
Measurement no. : 4	Tilt : ---	Name : Bowood Commercial
Drilling depth : 49,48 cm	Avg. curve : off	
Wood species : Hard (2)	Diameter : 80,0 cm	
ID number : 14_129_4	Level : 20,0 cm	
Date : 22.12.2014	Direction : from NE	
Time : 12:06:41	Object species : Ash	
Advance : 51 cm/min	Location : Weech Hall

From 0,0 cm to 2,0 cm : Bark
 From 2,0 cm to 50,0 cm : Sound wood
 From 0,0 cm to 0,0 cm :
 From 0,0 cm to 0,0 cm :
 From 0,0 cm to 0,0 cm :
 From 0,0 cm to 0,0 cm :

Drilled into buttress to the L of the fungus.
Serrated pattern less apparent from about 14 cm, possibly due to drill being near the edge of the decay zone, but steady increase in resistance indicates sound wood.

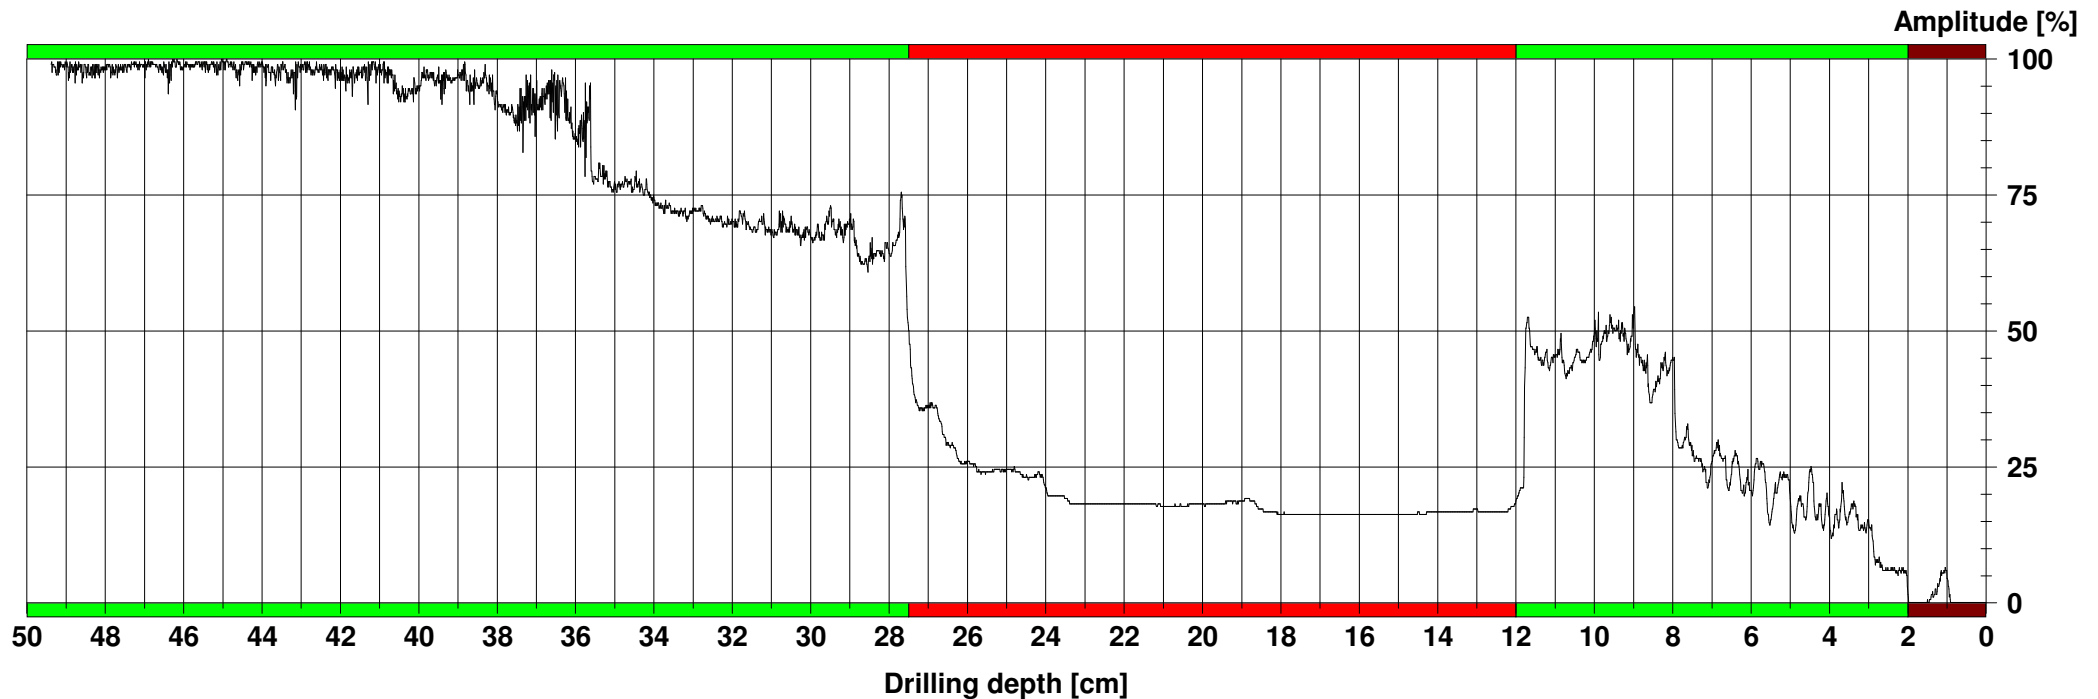
From 0,0 cm to 2,0 cm : Bark
 From 2,0 cm to 12,0 cm : Sound wood
 From 12,0 cm to 27,5 cm : Advanced decay
 From 27,5 cm to 50,0 cm : Sound wood
 From 0,0 cm to 0,0 cm :
 From 0,0 cm to 0,0 cm :

Drilled from the same direction as 1 but near the top of the old wound. Timber is sound with a small pocket of decay indicating that the column of decay is tapering down with height. Well defined boundaries indicate that the tree is preventing the decay from spreading.
