1. Case Details

Insured	Mr & Mrs Coveney	Address	11 Sherlock Road, London, NW3 2HR		
Client	GAB Robins	Contact	Roger Lowe	Claim No.	B1426953
MT Ref	NL/0212141509/TP	Consultant	Thomas Peppiatt	Contact No.	0330 380 1036
Report Date	24/12/2014

5. Technical Synopsis

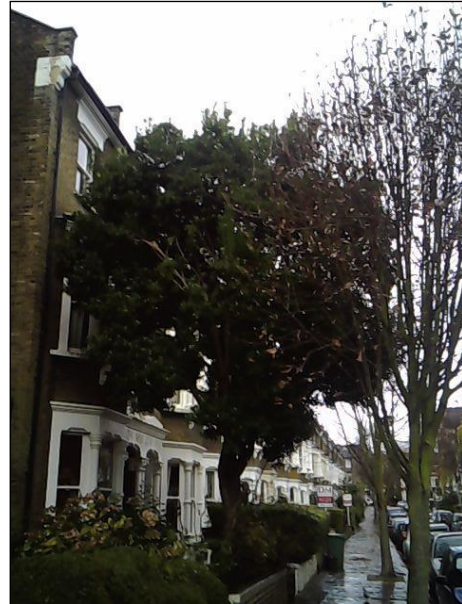
T4 - Strawberry Tree

There is currently no positive root identification to implicate T4 (Strawberry Tree), however based on our assessment on site we consider that the footings of the subject property fall within the anticipated rooting zone of this vegetation.

In assessing the potential drying influence of the vegetation on site, T3 (Sorbus) is considered the dominant feature and accordingly we have identified them as the principal cause of subsidence. T4 (Strawberry Tree) is also considered to retain a contributory influence.

Tree No.	Species	Age Cat	Approx. Height (m)	Distance to Building (m)	Ownership	Action	Requirement
T3	Sorbus	1	7.5	6.1	B - Local Authority	Remove	Remove.
T4	Strawberry Tree	1	8	5	A - Third Party No 13 Shirlock Road. London. NW32HR.	Remove	Remove and treat stump to inhibit regrowth.

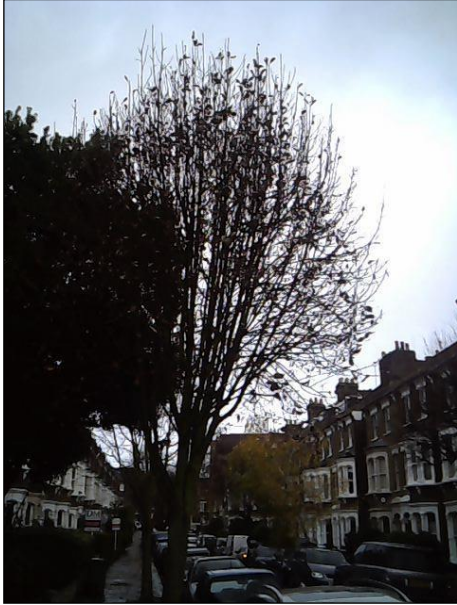
T3 - Sorbus

Roots recovered from TP/BH1 have been formally identified as Pomoideae gp. The most likely origin of the roots is T3 (Sorbus). Such circumstances confirms the potential for T3 (Sorbus) to influence soil volumes and to contribute to the damage observed.
