Geotechnical Survey Report

FSI Ref: 8994
Issue Date: October 2014

Client Name: Mr & Mrs Coveney
Risk Address: 11 Shirlock Road
London
NW3 2HR

Company: GAB Robins
Claim Ref: B1426953

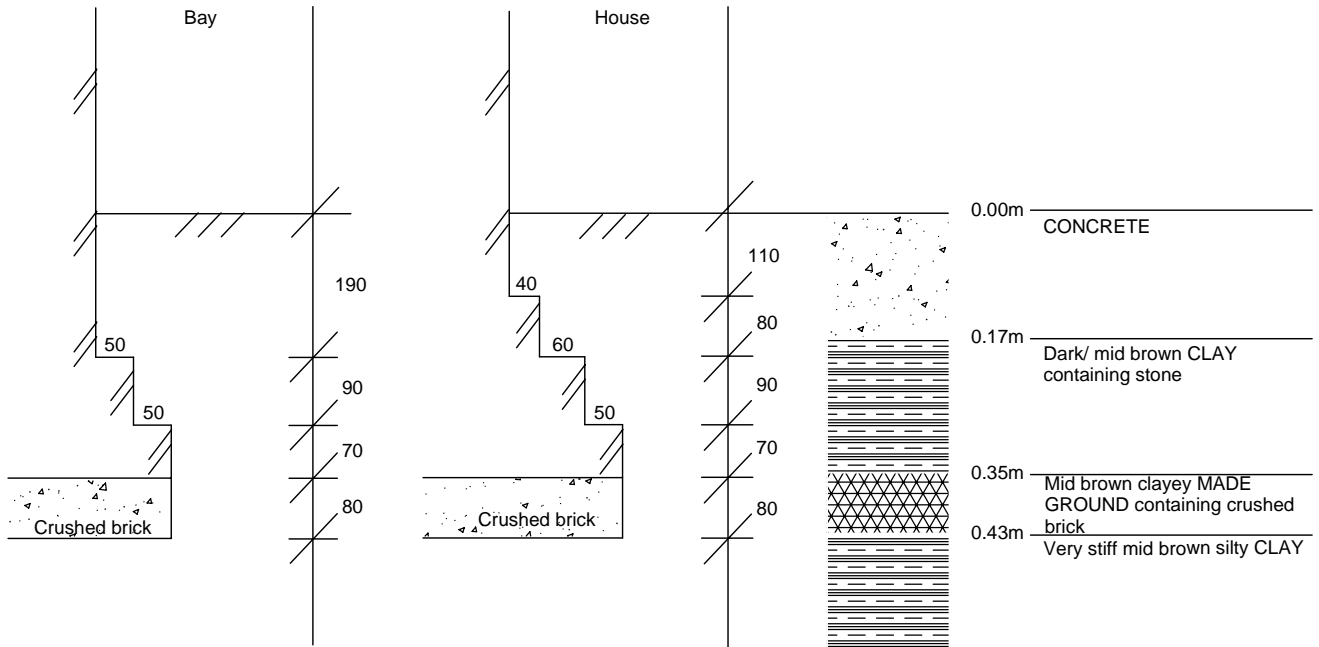
TRIAL PIT 1

D1 @ F.L. (0.43m)

V = 140+kPa

Founding strata:

Very stiff mid brown silty CLAY

Water Strikes	Samples		Insitu Tests		Depth (m)	Legend	Stratum Description and Observations
	Type	Depth (m)	Type	Results			
	D1	0.43	V	140.00	0.17	CONCRETE	FOUNDATION TOP - 0.110m (House) (Brick & crushed brick construct, 3 brick step outs projecting 40mm, 60mm & 50mm with thickness' of 80mm, 60mm & 70mm respectively onto a crushed brick footing with 80mm thickness & no projection) Dark/ mid brown CLAY containing stone FOUNDATION TOP - 0.19m (Bay) (Brick & crushed brick construct, 2 brick step outs both projecting 50mm with thickness' of 90mm & 70mm respectively onto a crushed brick footing with 80mm thickness & no projection)
					0.35	Mid brown clayey MADE GROUND containing crushed brick	
					0.43	Very stiff mid brown silty CLAY FOUNDATION LEVEL - 0.43m (Bay & House)	
	D2	1.00	V	140.00			
							Noted to contain gravel at 1.20m
					1.40		End of Borehole at 1.40 m

Remarks: Borehole closed at 1.40m due to gravel
Borehole was noted to be dry on completion
N.b. Unless otherwise stated small vane paddle used
