JOB TITLE		
Christ Church		
Hampstead		
DRAWING TITLE		
South Elevation		
Existing Condition		
JOB No	DWG No	REV
537A	SU03	-
DRAWN BY	SCALE (AT A1)	DATE
JMc	1:100 (1:200@A3)	Dec14

RICHARD GRIFFITHS ARCHITECTS

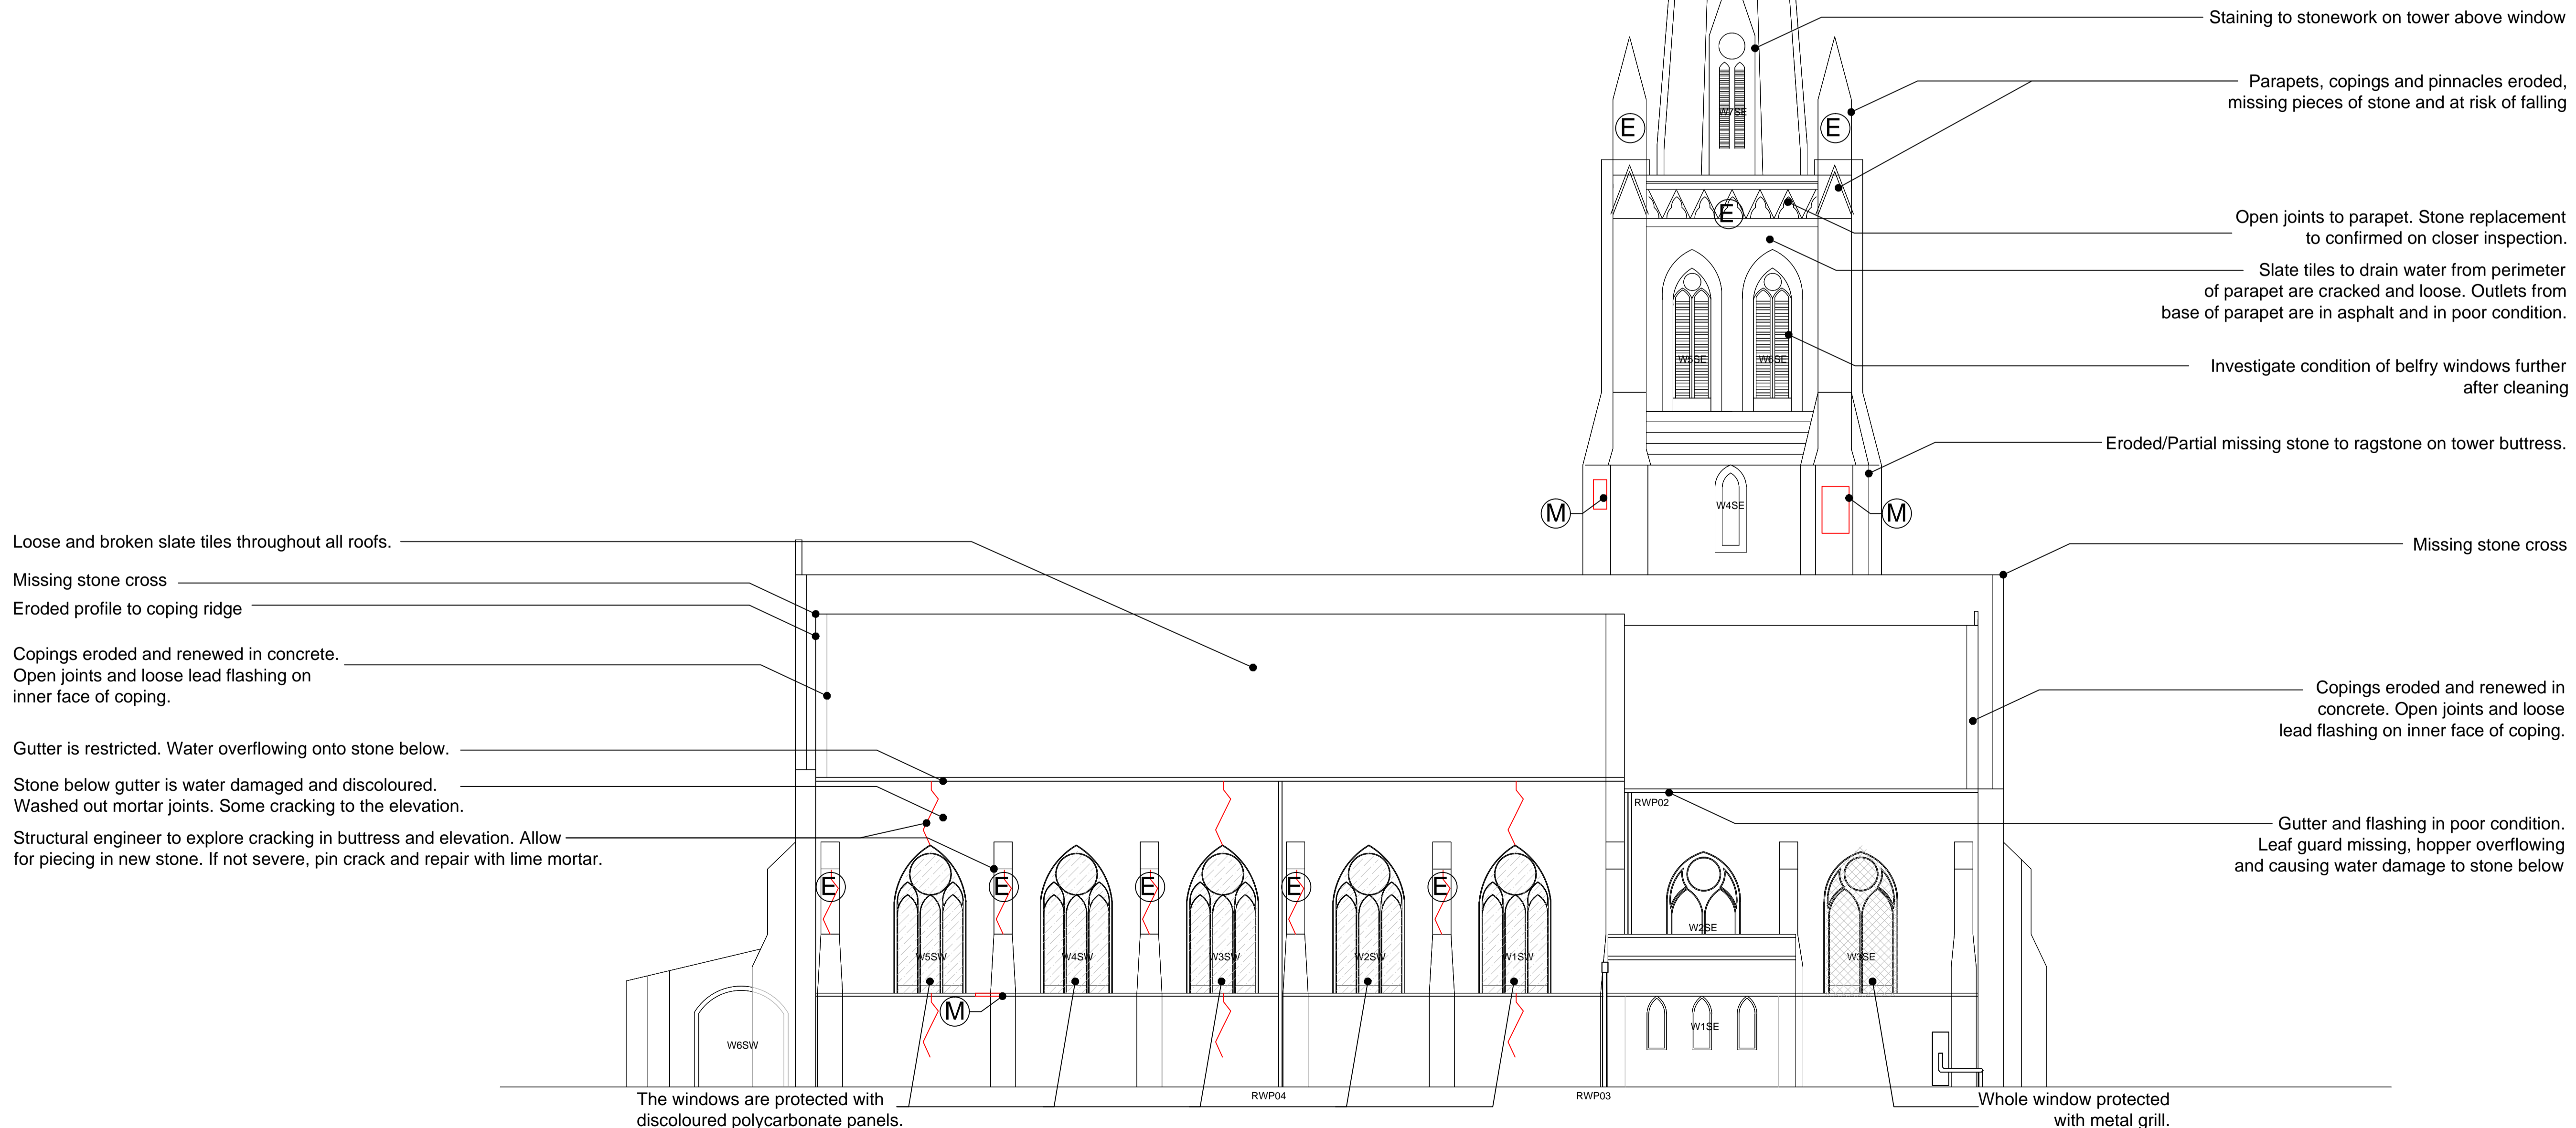
- Existing grey metal mesh
- Existing polycarbonate panel

- Vegetation - Algae/Moss build up
- Missing Stone - Partial or whole stone missing
- Eroded Stone - Due to weathering/water damage

Due to limited roof access, inspection undertaken from ground level and tower parapet. Carry out a closer roof inspection, by scaffolding, to ascertain any repairs required to slates, battens, underlay, gutters and flashings. Replace slates and lead flashing to all areas of roof as RGA condition survey and specification and LSA recommendations.

Cleaning
All areas to be DOFF cleaned early in contract. Conservation Architect to explore stonework and re survey after cleaning and identify any further cracking and repairs.

Repointing
From initial condition survey allow for 75% of ashlar to be repointed and approx 60% repointing to ragstone in lime mortar in accordance with RGA specification.

Repointing to include all elevations, all sky facing surfaces, all buttresses, open joints around downpipes, all main cornices along gutters, all copings, parapets and pinnacles. Rake out loose and cement mortar, re point 100% with lime mortar in accordance with RGA specification.

Stone Replacement
Re survey previous stone indents after cleaning to confirm if structurally sound. If acceptable aesthetically leave in situ.

Stone details; pinnacles, molded copings and crosses to be cleaned and repaired by approved conservator not the contractor. All repairs shown are provisional and subject to inspection and recommendations by conservator on site.

Windows
Remove existing discoloured polycarbonate panels or mesh panel and replace with black stainless steel grilles set out in each individual light.

Clean all plain glass windows in situ.

For leaded glass and stain glass, where possible clean and repair insitu, otherwise remove and repair in workshop. If remove, install a temporary board in light. If replacement lead required, retain as much as possible of existing lead. Replace broken quarries and refix to ferramenta with copper wire.
