JOB TITLE		
Christ Church		
Hampstead		
DRAWING TITLE		
East Elevation		
Existing Condition		
JOB No.	DWG No.	REV
537A	SU04	-
DRAWN BY	SCALE (AT A1)	DATE
JMc	1:100 (1:200@A3)	Dec14

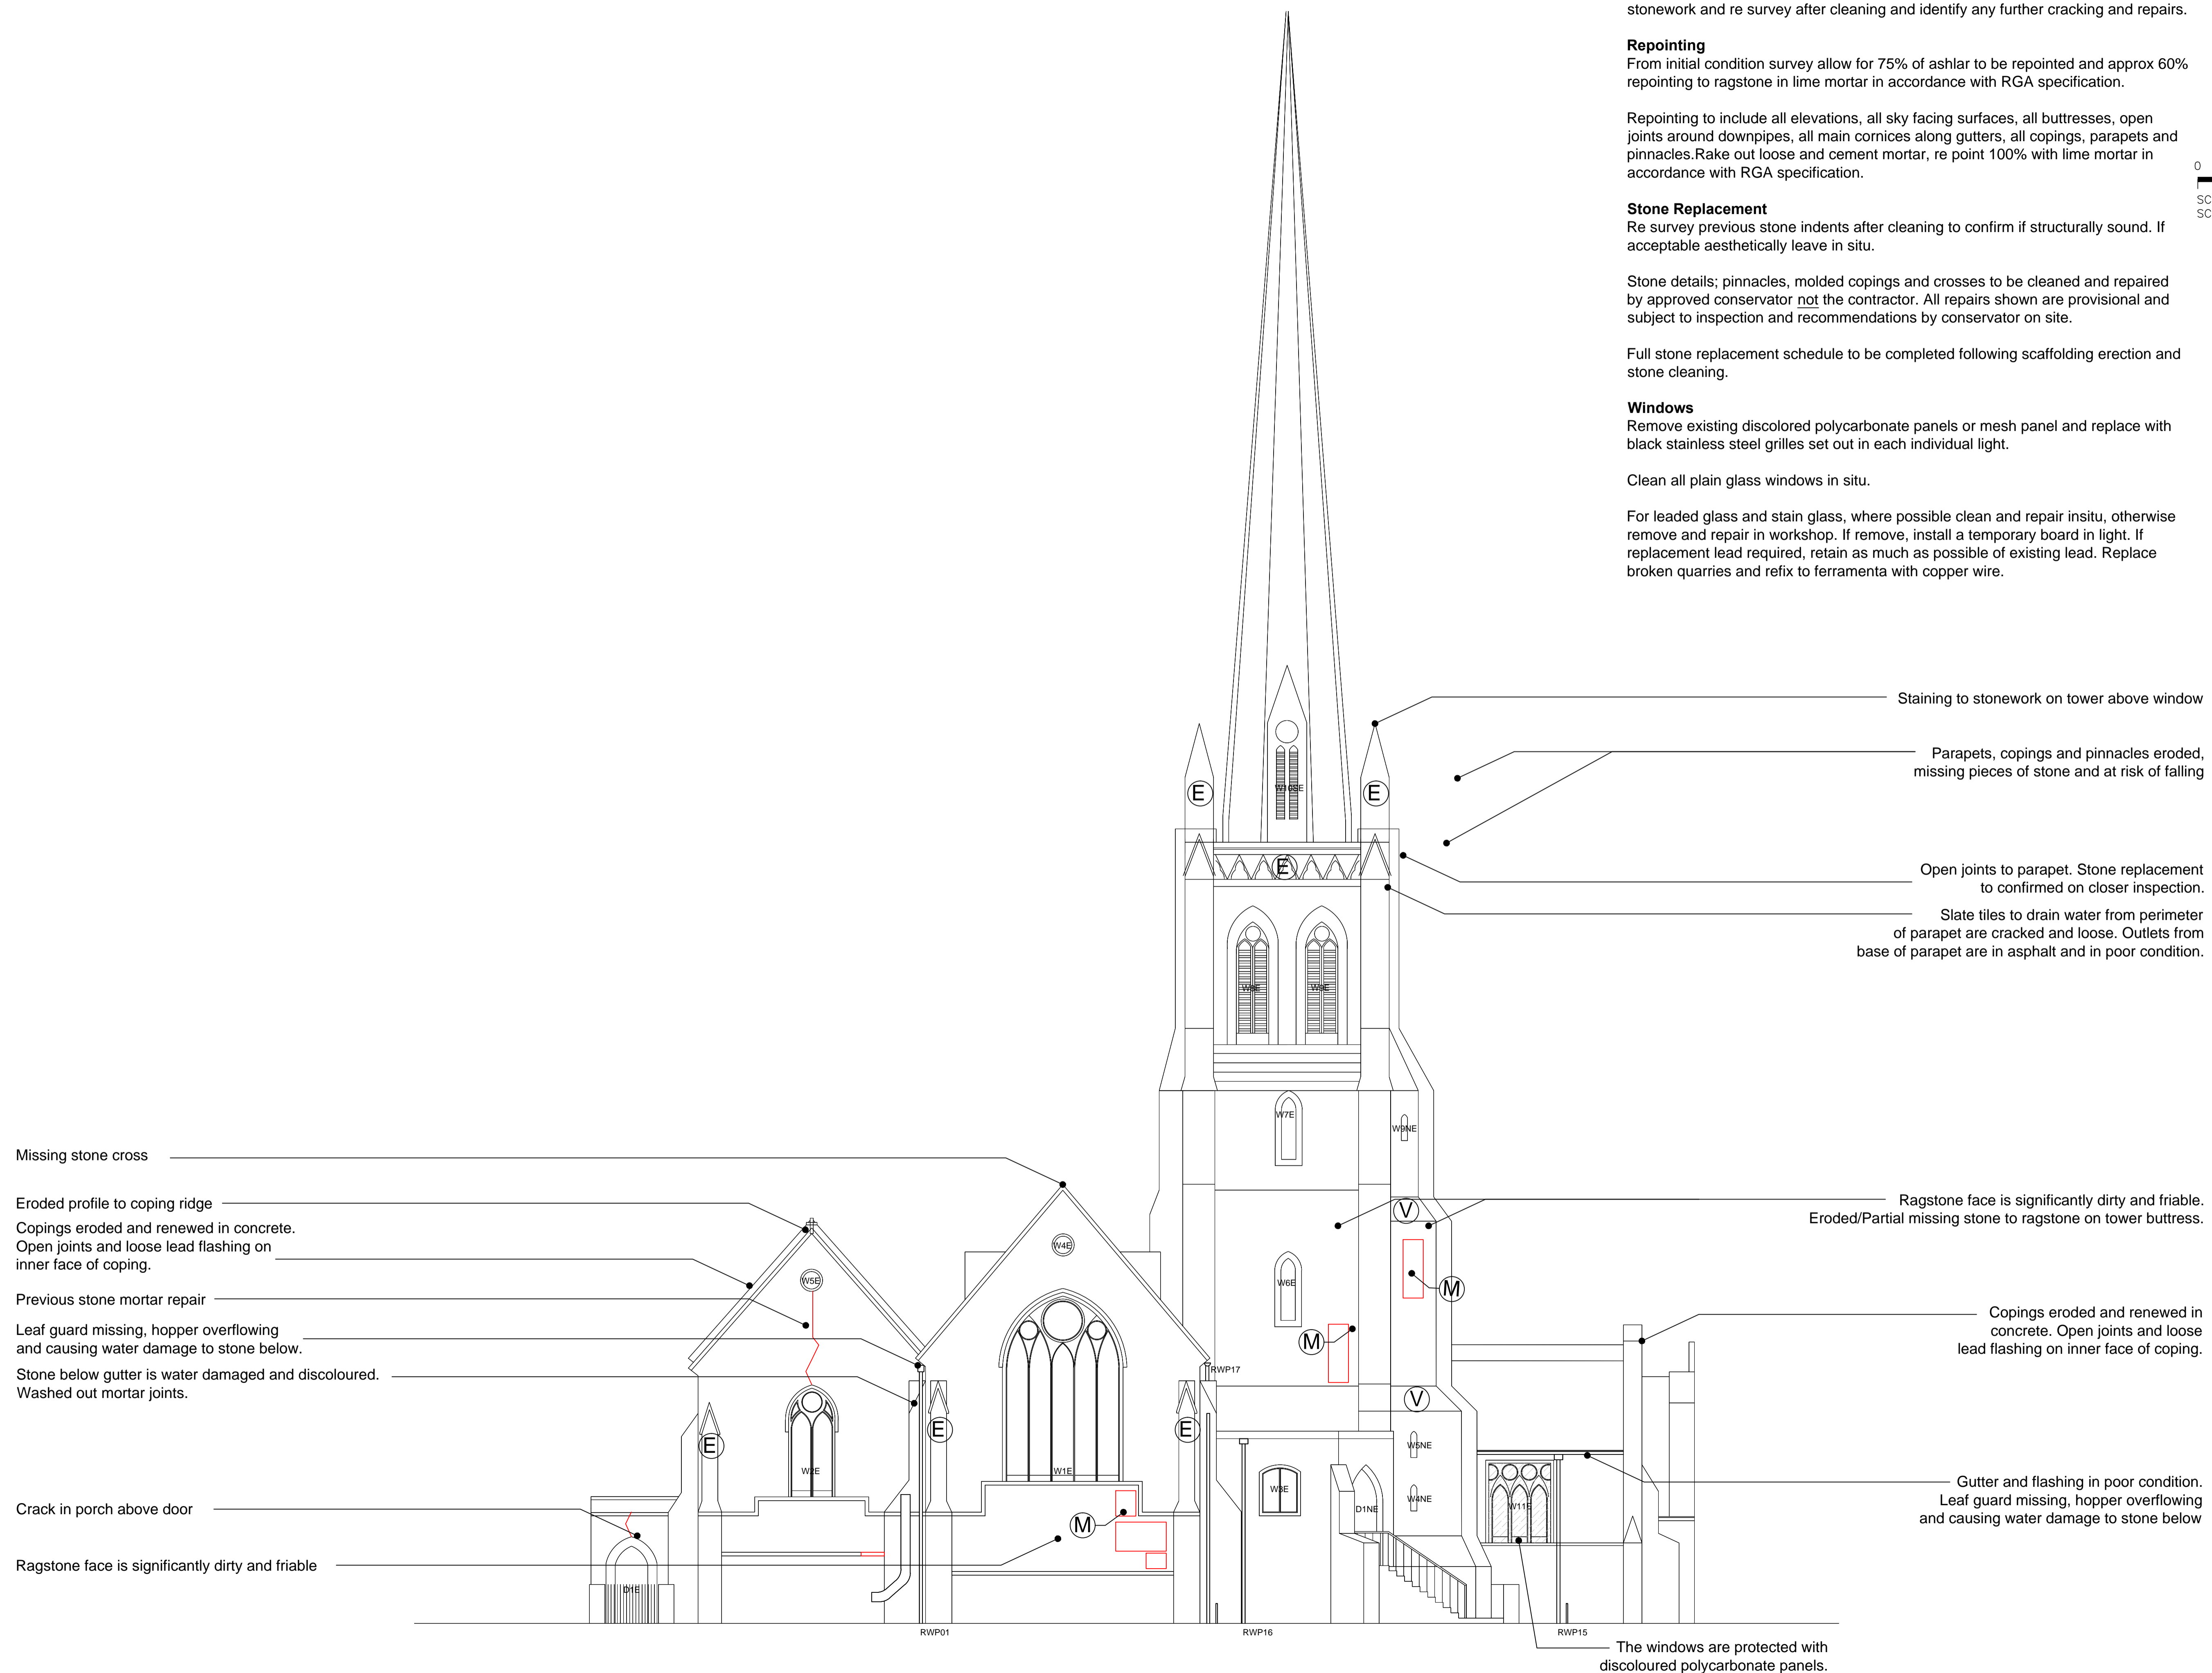
Staining to stonework on tower above window

Parapets, copings and pinnacles eroded, missing pieces of stone and at risk of falling

Open joints to parapet. Stone replacement to confirmed on closer inspection.

Slate tiles to drain water from perimeter of parapet are cracked and loose. Outlets from base of parapet are in asphalt and in poor condition.

Missing stone cross

Eroded profile to coping ridge
Copings eroded and renewed in concrete.
Open joints and loose lead flashing on inner face of coping.

Previous stone mortar repair

Leaf guard missing, hopper overflowing and causing water damage to stone below.

Stone below gutter is water damaged and discoloured. Washed out mortar joints.

Crack in porch above door

Ragstone face is significantly dirty and friable

Ragstone face is significantly dirty and friable. Eroded/Partial missing stone to ragstone on tower buttress.

Copings eroded and renewed in concrete. Open joints and loose lead flashing on inner face of coping.

Gutter and flashing in poor condition. Leaf guard missing, hopper overflowing and causing water damage to stone below

The windows are protected with discoloured polycarbonate panels.

Due to limited roof access, inspection undertaken from ground level and tower parapet. Carry out a closer roof inspection, by scaffolding, to ascertain any repairs required to slates, battens, underlay, gutters and flashings. Replace slates and lead flashing to all areas of roof as RGA condition survey and specification and LDA recommendations.

All areas to be DOFF cleaned early in contract. Conservation Architect to explore stonework and re survey after cleaning and identify any further cracking and repairs.

From initial condition survey allow for 75% of ashlar to be repointed and approx 60% repointing to ragstone in lime mortar in accordance with RGA specification.

Repointing to include all elevations, all sky facing surfaces, all buttresses, open joints around downpipes, all main cornices along gutters, all copings, parapets and pinnacles. Rake out loose and cement mortar, re point 100% with lime mortar in accordance with RGA specification.

Re survey previous stone indents after cleaning to confirm if structurally sound. If acceptable aesthetically leave in situ.

Stone details; pinnacles, molded copings and crosses to be cleaned and repaired by approved conservator not the contractor. All repairs shown are provisional and subject to inspection and recommendations by conservator on site.

Remove existing discoloured polycarbonate panels or mesh panel and replace with black stainless steel grilles set out in each individual light.
