JOB TITLE		
Christ Church Hampstead		
DRAWING TITLE		
West Elevation Existing Condition		
JOB No.	DWG No.	REV
537A	SU06	-
DRAWN BY	SCALE (AT A1)	DATE
JMc	1:100 (1:200@A3)	Dec14

RICHARD GRIFFITHS ARCHITECTS

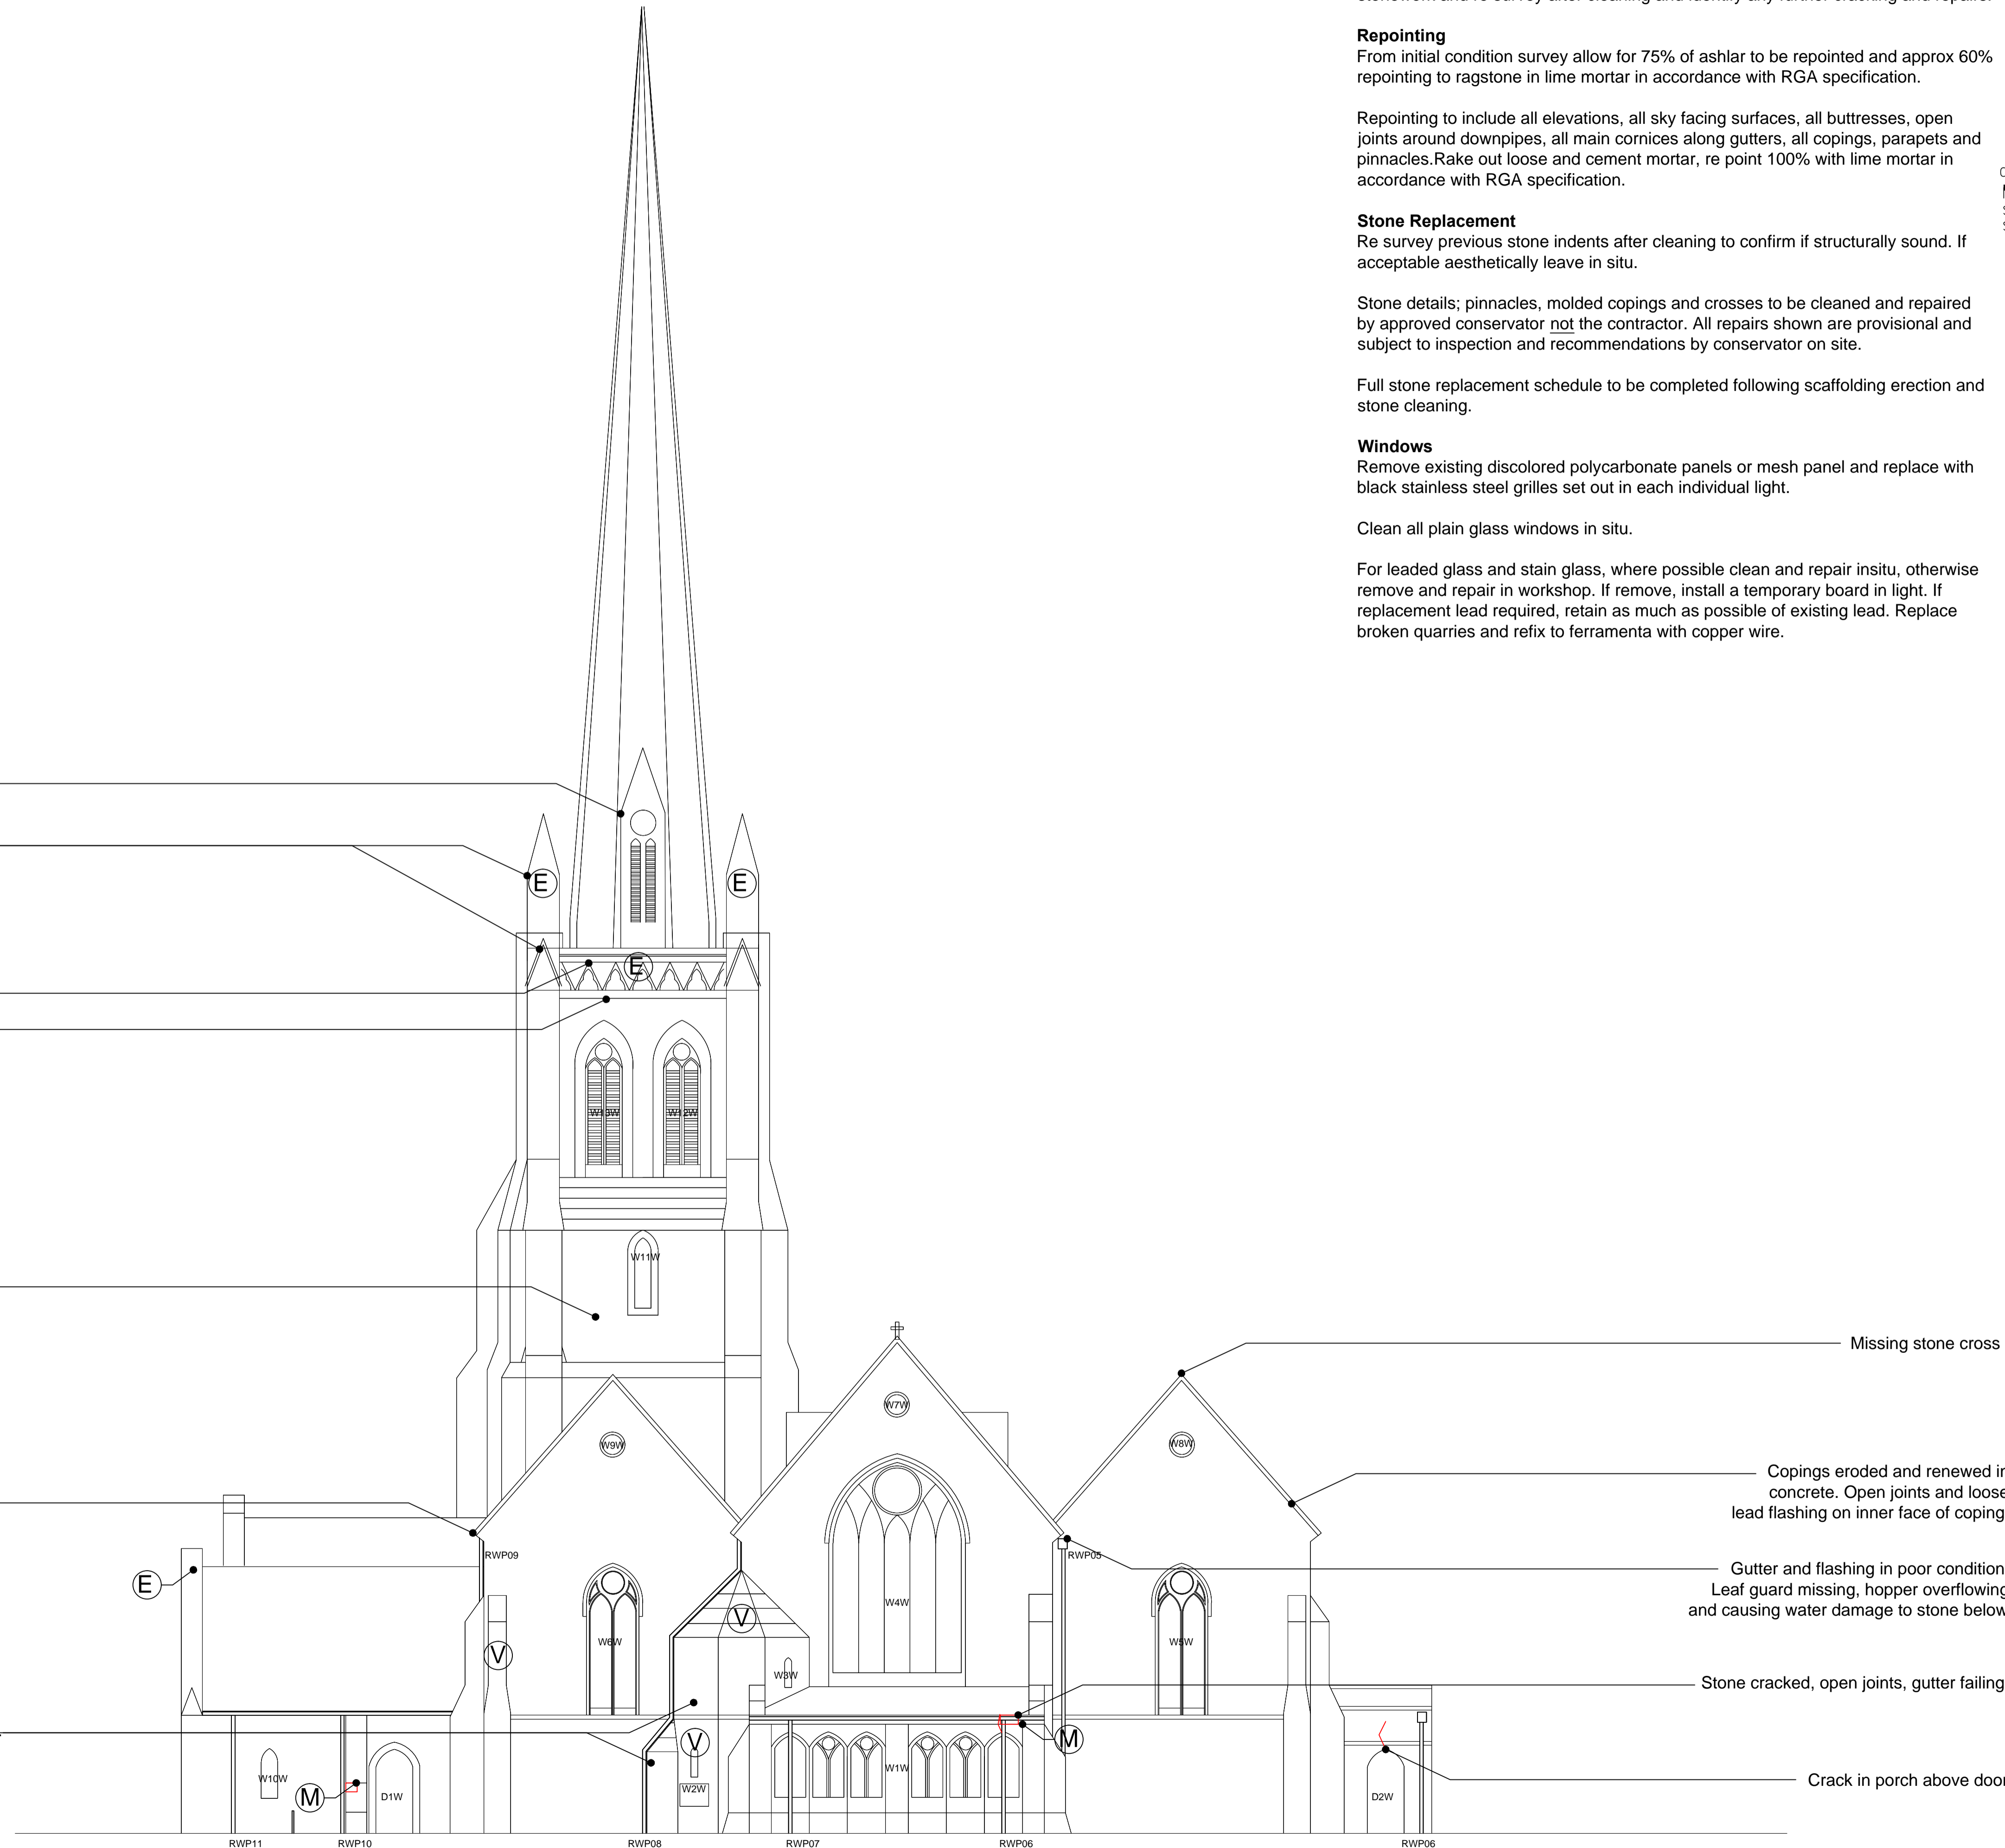
Staining to stonework on tower above window

Parapets, copings and pinnacles eroded, missing pieces of stone and at risk of falling

Open joints to parapet. Stone replacement to confirmed on closer inspection.

Slate tiles to drain water from perimeter of parapet are cracked and loose. Outlets from base of parapet are in asphalt and in poor condition.

Eroded/Partial missing stone to ragstone on tower buttress.

Leaf guard missing, hopper overflowing and causing water damage to stone below.

Stone below on stair tower is water damaged and discoloured. Washed out mortar joints and mos/algae build up.

Missing stone cross

Copings eroded and renewed in concrete. Open joints and loose lead flashing on inner face of coping.

Gutter and flashing in poor condition. Leaf guard missing, hopper overflowing and causing water damage to stone below

Stone cracked, open joints, gutter failing.

Crack in porch above door

Due to limited roof access, inspection undertaken from ground level and tower parapet. Carry out a closer roof inspection, by scaffolding, to ascertain any repairs required to slates, battens, underlay, gutters and flashings. Replace slates and lead flashing to all areas of roof as RGA condition survey and specification and LSA recommendations.

All areas to be DOFF cleaned early in contract. Conservation Architect to explore stonework and re survey after cleaning and identify any further cracking and repairs.

From initial condition survey allow for 75% of ashlar to be repointed and approx 60% repointing to ragstone in lime mortar in accordance with RGA specification.

Repointing to include all elevations, all sky facing surfaces, all buttresses, open joints around downpipes, all main cornices along gutters, all copings, parapets and pinnacles. Rake out loose and cement mortar, re point 100% with lime mortar in accordance with RGA specification.

Re survey previous stone indents after cleaning to confirm if structurally sound. If acceptable aesthetically leave in situ.

Stone details; pinnacles, molded copings and crosses to be cleaned and repaired by approved conservator not the contractor. All repairs shown are provisional and subject to inspection and recommendations by conservator on site.

Full stone replacement schedule to be completed following scaffolding erection and stone cleaning.

Remove existing discoloured polycarbonate panels or mesh panel and replace with black stainless steel grilles set out in each individual light.

Clean all plain glass windows in situ.

For leaded glass and stain glass, where possible clean and repair insitu, otherwise remove and repair in workshop. If remove, install a temporary board in light. If replacement lead required, retain as much as possible of existing lead. Replace broken quarries and refix to ferramenta with copper wire.
