Internal Reordering & External Repairs Christ Church Hampstead

Proposed Alterations

Draft 1 | December 2014 | Ref: 537B&C

Existing Photographs

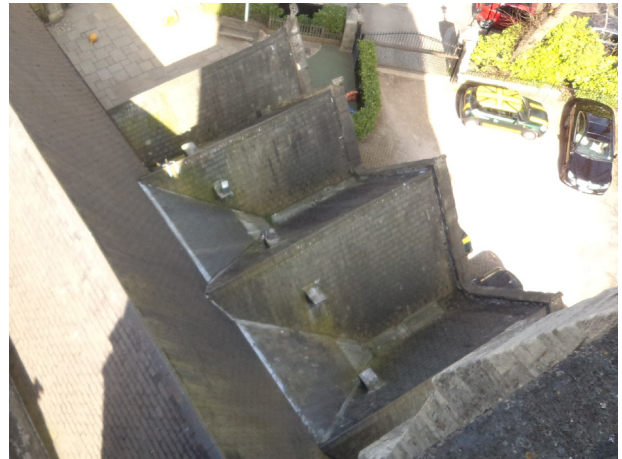
Outer north aisle and north porch roof: The roof is of slate with blue tile ridges and lead cover flashings. The valleys between the gabled roofs of the outer north aisle are of lead laid in excessively long lengths and there is evidence of a build-up of sediment vegetation at the top of the gutters and at the outlets behind the gables.

Action: Carry out a closer inspection to ascertain whether a full re-roofing is necessary with new valley gutters laid to improved falls.

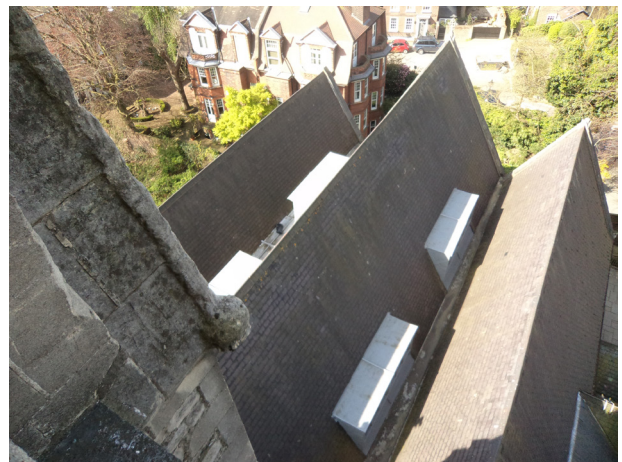
Nave, north and south aisle roof: The roof is of slate with blue tile ridges and lead cover flashings. The gutter between the south aisle and the nave is of lead in excessively long lengths, between nave and north aisle in asphalt in one run, apparently not in very good condition. The clerestory windows are also clad in lead.

Action: Replacement of the missing finial cross to the west apex of the south aisle. A closer inspection will be undertaken to identify loose slates/battens/underlay/flashings and ascertain whether a full re-roofing is necessary.

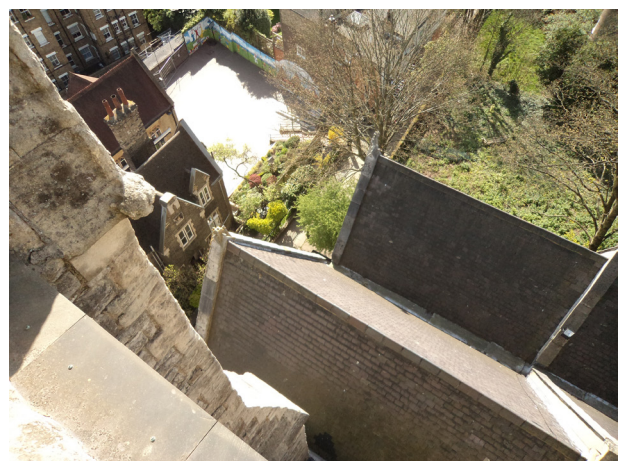
Chancel and vestry roof: The roof is of slate with blue tile ridges and lead cover flashings. The valley gutter is of lead with a stepped base. A closer inspection would be desirable to identify loose or damaged slates in need of repair.

Action: Replacement of the missing finial cross to the east apex of the chancel gable. A closer inspection will be undertaken to identify loose slates/battens/underlay/flashings and ascertain whether a full re-roofing is necessary.

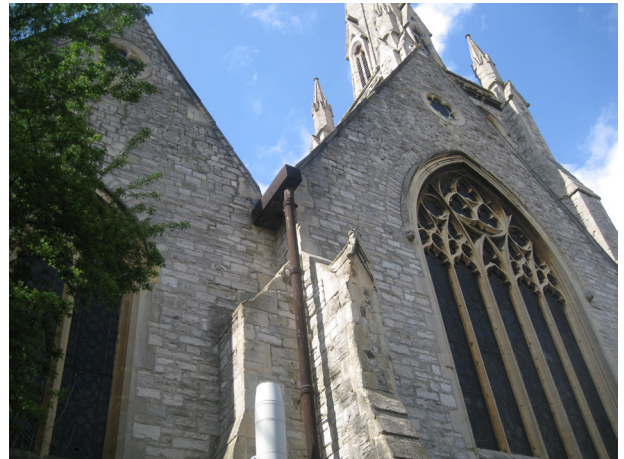
Elevations General: The walls are coursed Kentish ragstone with ashlar dressings. Cleaning is required of the superficial dirt and of the friable stone surface. High level projecting details are eroding and at risk of falling.

Action: Clean moss and algae from the ragstone walls and remove the friable surface. Re-evaluate constrained drainage once roof inspected. Repair/replace missing stones and remove/repoint were required.

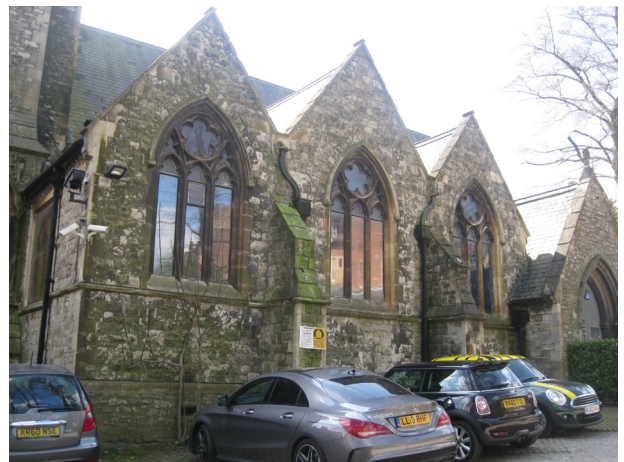
Elevations of outer north aisle porch and gables: The walls are coursed Kentish ragstone with ashlar dressings. Washed out joints and algae present on elevation due to restricted rainwater goods. Stone deterioration and loss along elevation. Buttress to west elevation of west gable has stone missing.

Action: Clean moss and algae from the ragstone walls and remove the friable surface. Re-evaluate constrained drainage once roof inspected. Repair/replace missing stones and remove/repoint were required.

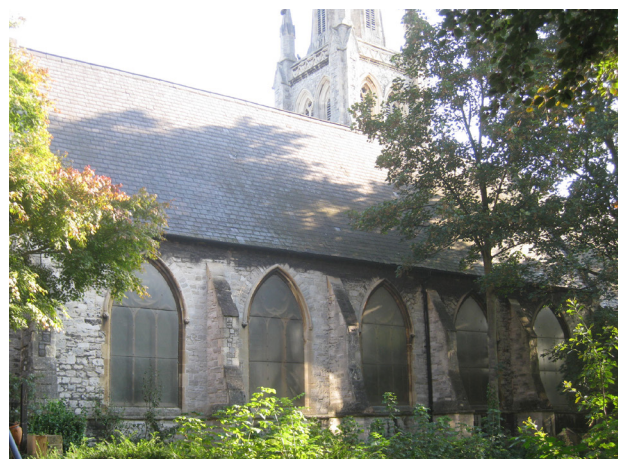
South Elevation: The walls are coursed Kentish ragstone with ashlar dressings. The pointing is in poor condition, the face is friable and dirty. Large crack to south east porch wall and lintel. Cracks in the buttresses.

Engineer to investigate evidence of subsidence on the south elevation

Action: Clean moss and algae from the ragstone walls and remove the friable surface. Repair/replace missing stones and remove/repoint were required. Investigate and repair crack to south east porch and to buttresses.

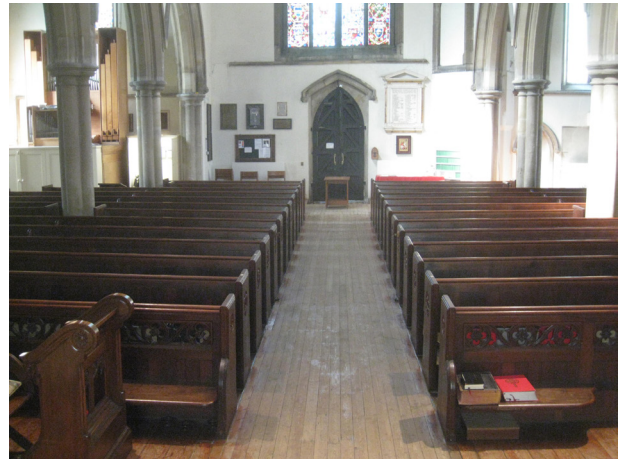
Nave floor: Plain pine boarding. Some damaged and badly cut. It has not been sanded or sealed for some time.

Pews: Pews in good condition, will incorporate ways to maximize use.

Action: Replace timber flooring throughout to suit realigned entrance ramp and chancel steps. Retain historic pew edging and lay new flooring to accommodate.

Action: Some pews will be relocated and adapted as part of the reordering.

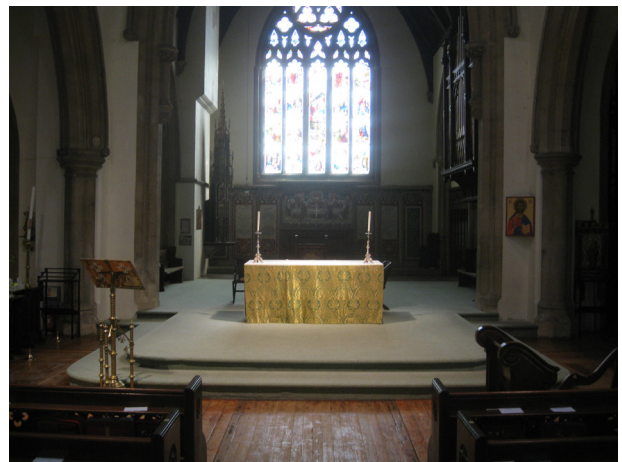
Chancel floor: Carpet to chancel steps and chancel floor. Mosaic flooring to sanctuary, some damaged.

Action: Remove carpet. Re align chancel steps to allow for a greater useable space. Re make with stone steps and pammet tiles. Repair any existing damaged mosaic tiles in sanctuary.

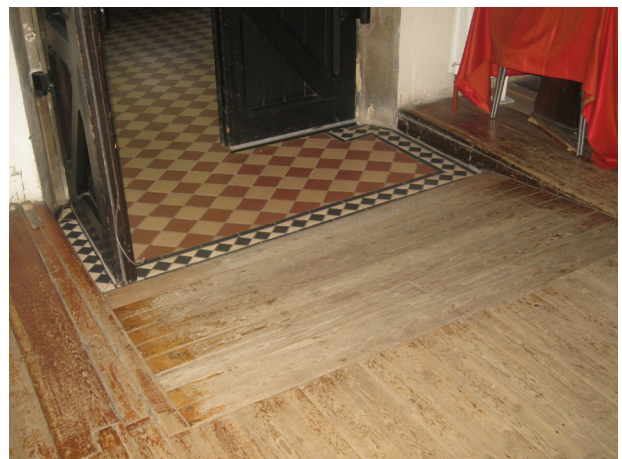
Entrance ramp from West Porch: Red, buff and black patterned tiles, in good condition. Tiles also laid in doorway to nave, at bottom of boarded ramp. Boarded ramp does not suit DDA requirements of 1:12.

Action: Remove nave tiles and stop under door. Remake ramp to 1:12 angle, in new timber flooring by extending it to doorway. Rehang door to suit.
