| Christ Church | | |
| Hampstead | | |
| Ground Floor Plan | | |
| External Repairs - Drainage | | |

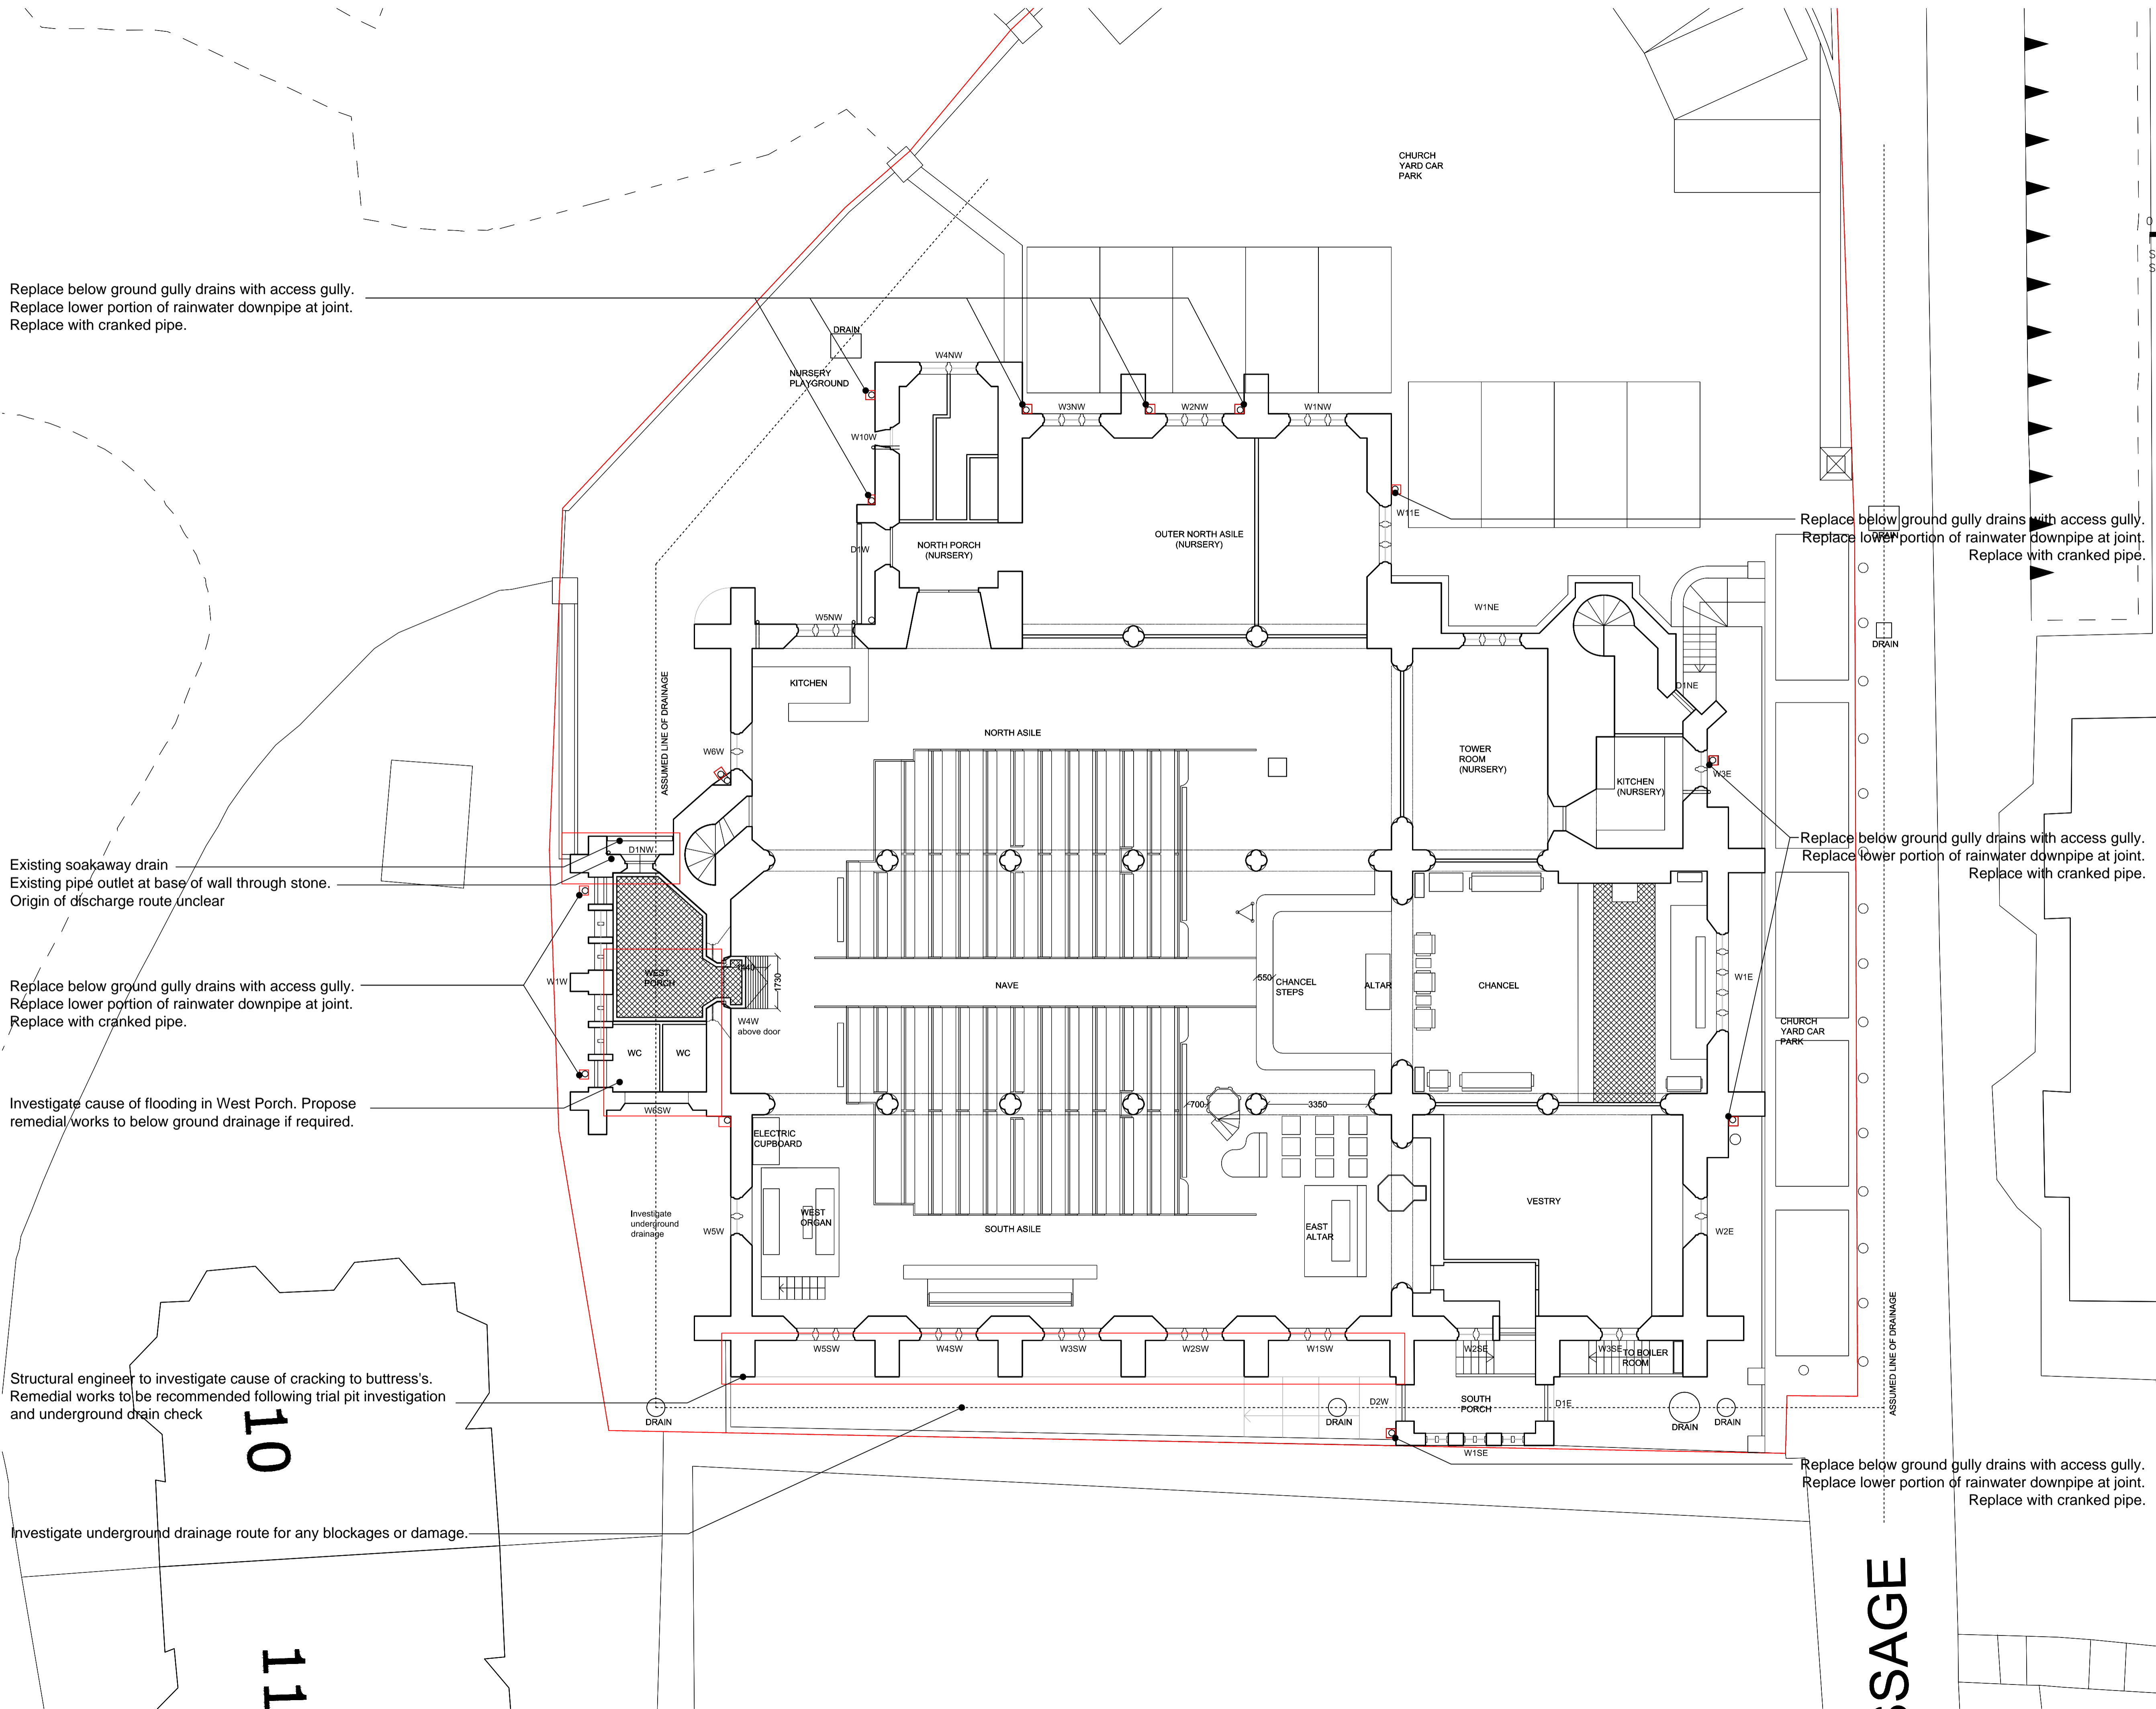
Due to limited roof access, inspection  
 undertaken from ground level and  
 tower parapet. Carry out a closer roof  
 inspection, by scaffolding, to ascertain  
 any repairs required to slates, battens,  
 underlay, gutters and flashing's.  
 Replace slates and lead flashing to all  
 areas of roof as RGA condition survey  
 and specification and LSA  
 recommendations.

Existing soakaway drain  
 Existing pipe outlet at base of wall through stone.  
 Origin of discharge route unclear

Structural engineer to investigate cause of cracking to buttress's.  
 Remedial works to be recommended following trial pit investigation  
 and underground drain check

Replace below ground gully drains with access gully.  
 Replace lower portion of rainwater downpipe at joint.  
 Replace with cranked pipe.

Investigate cause of flooding in West Porch. Propose  
 remedial works to below ground drainage if required.

Investigate underground drainage route for any blockages or damage.
