FOR DAC			
JOB TITLE Christ Church Hampstead			
DRAWING TITLE South Elevation Proposed Repairs			
JOB No	DWG No	REV	
537A	D03	-	
DRAWN BY	SCALE (AT A1)	DATE	
JMc	1:100 (1:200@A3)	Dec14

RICHARD GRIFFITHS ARCHITECTS
5 Maidstone Mews, 72-76 Borough High Street, London SE1 1GN
T +44(0)20 7357 8788 | F +44(0)20 7403 7887
E admin@rgarchitects.com | www.rgarchitects.com

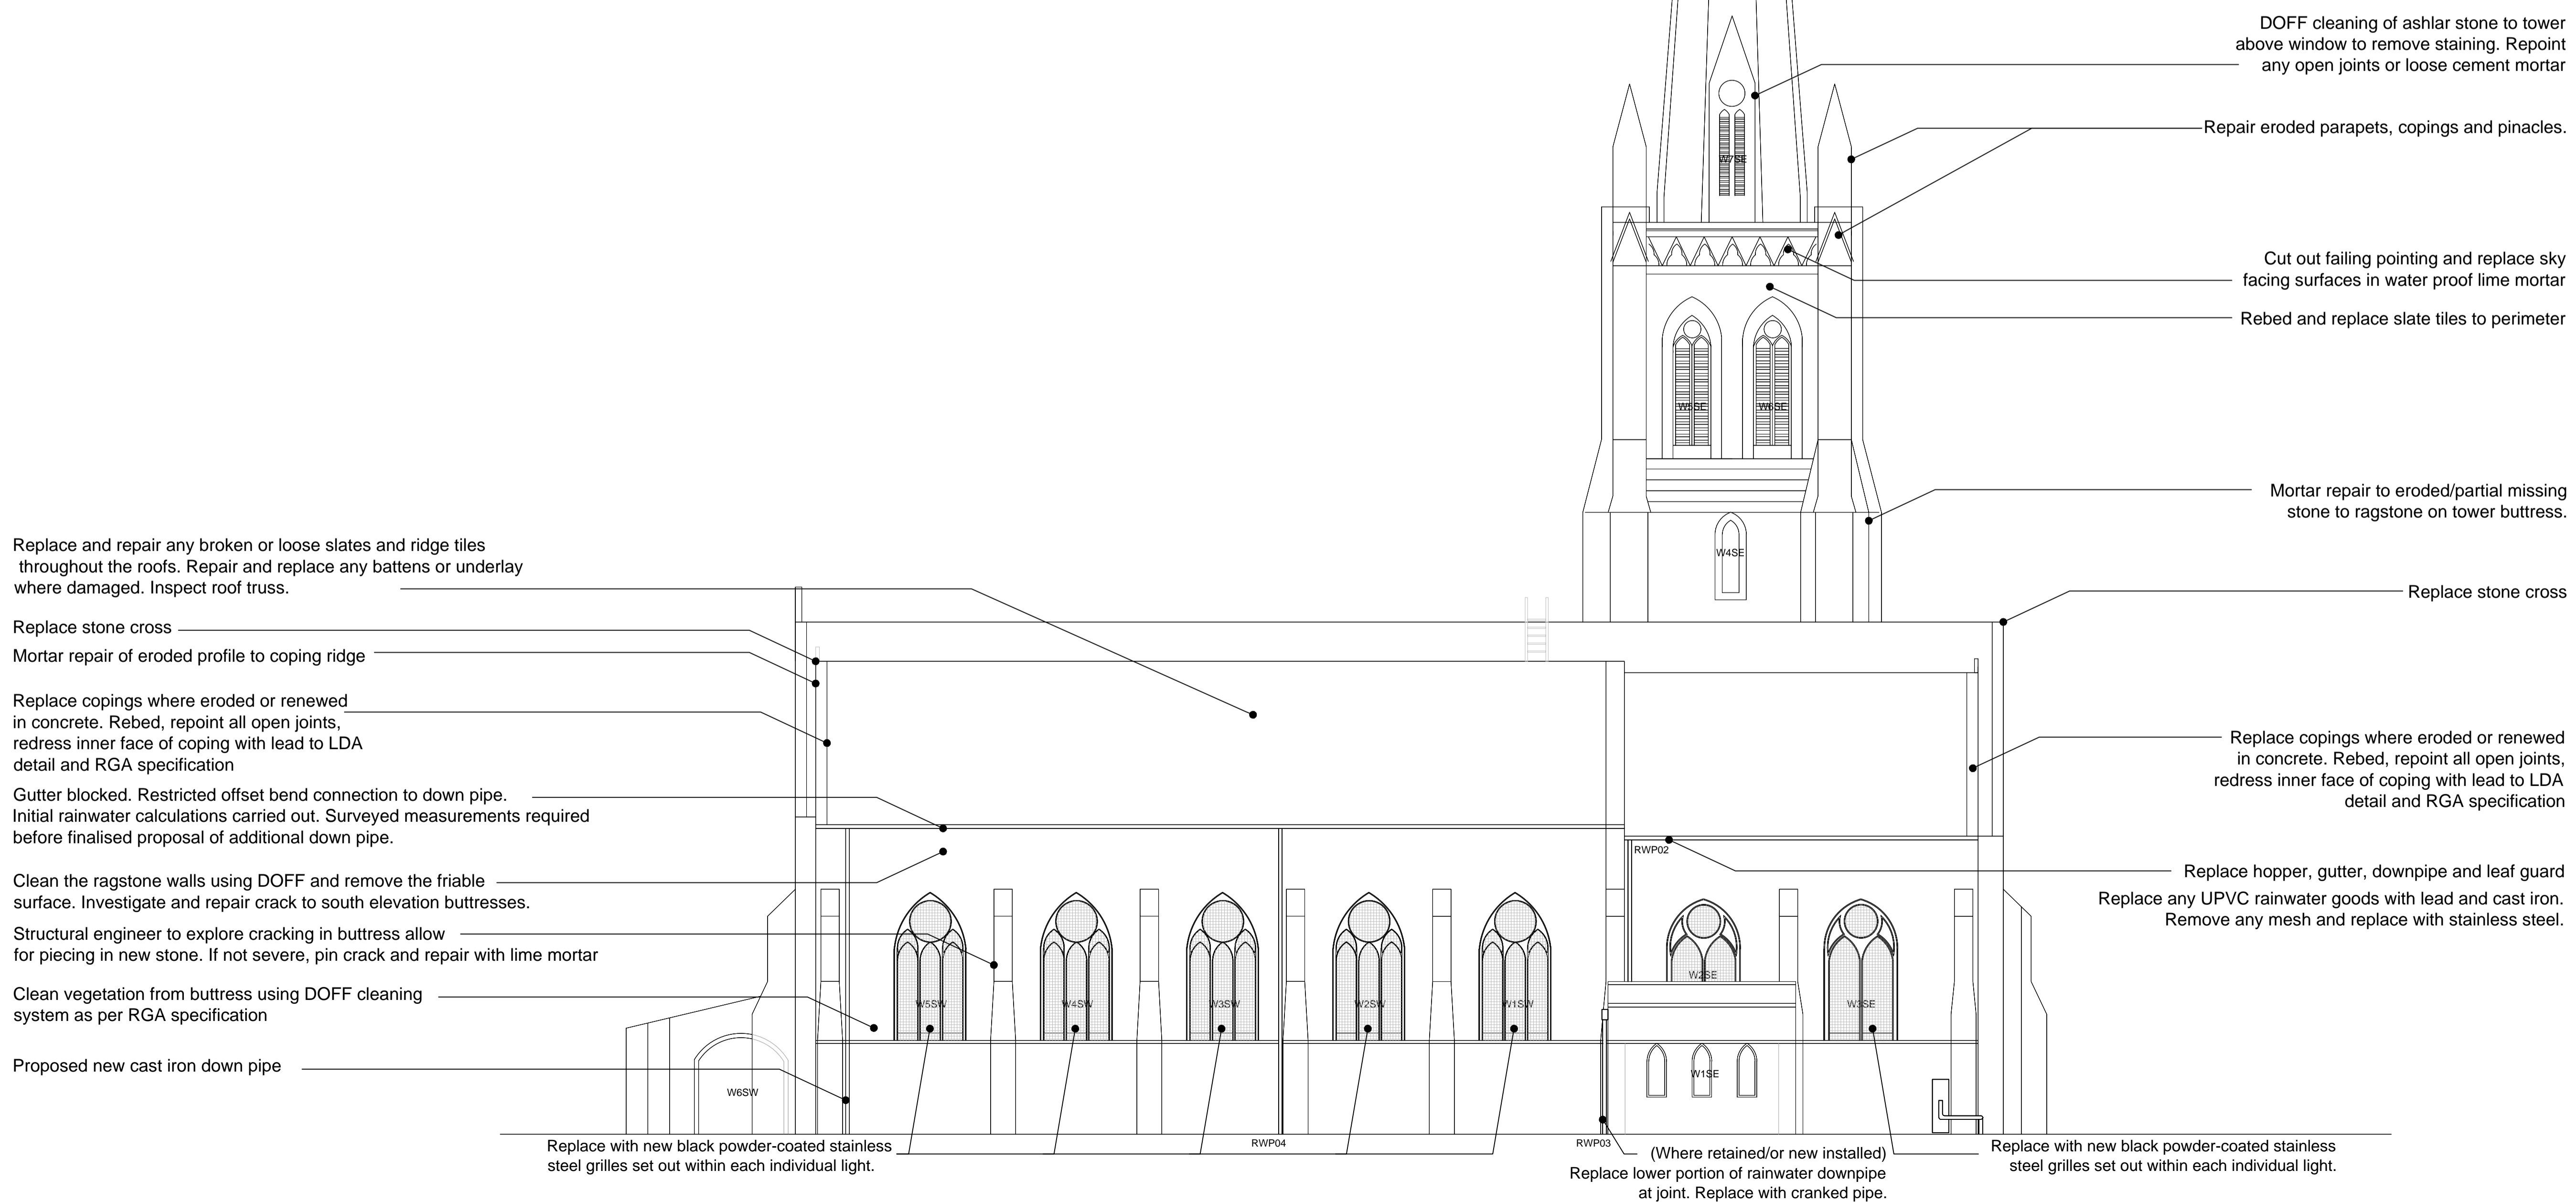
All drawings are based on a scaled PDF not a survey. All dimensions to be checked on site and confirmed with Conservation Architect.

Due to limited roof access, inspection undertaken from ground level and tower parapet. Carry out a closer roof inspection, by scaffolding, to ascertain any repairs required to slates, battens, underlay, gutters and flashing's. Replace slates and lead flashing to all areas of roof as RGA condition survey and specification and LSA recommendations.

All areas to be DOFF cleaned early in contract. Conservation Architect to explore stonework and re survey after cleaning and identify any further cracking and repairs.

From initial condition survey allow for 75% of ashlar to be repointed and approx 60% repointing to ragstone in lime mortar in accordance with RGA specification.

Repointing to include all elevations, all sky facing surfaces, all buttresses, open joints around downpipes, all main cornices along gutters, all copings, parapets and pinnacles. Rake out loose and cement mortar, re point 100% with lime mortar in accordance with RGA specification.

Re survey previous stone indents after cleaning to confirm if structurally sound. If acceptable aesthetically leave in situ.

Stone details; pinnacles, molded copings and crosses to be cleaned and repaired by approved conservator not the contractor. All repairs shown are provisional and subject to inspection and recommendations by conservator on site.

Full stone replacement schedule to be completed following scaffolding erection and stone cleaning.

Remove existing discolored polycarbonate panels or mesh panel and replace with black stainless steel grilles set out in each individual light.

Clean all plain glass windows in situ.

For leaded glass and stain glass, where possible clean and repair insitu, otherwise remove and repair in workshop. If remove, install a temporary board in light. If replacement lead required, retain as much as possible of existing lead. Replace broken quarries and refix to ferramenta with copper wire.
