Due to limited roof access, inspection undertaken from ground level and tower parapet. Carry out a closer roof inspection, by scaffolding, to ascertain any repairs required to slates, battens, underlay, gutters and flashing's. Replace slates and lead flashing to all areas of roof as RGA condition survey and specification and LSA recommendations.

RICHARD GRIFFITHS ARCHITECTS

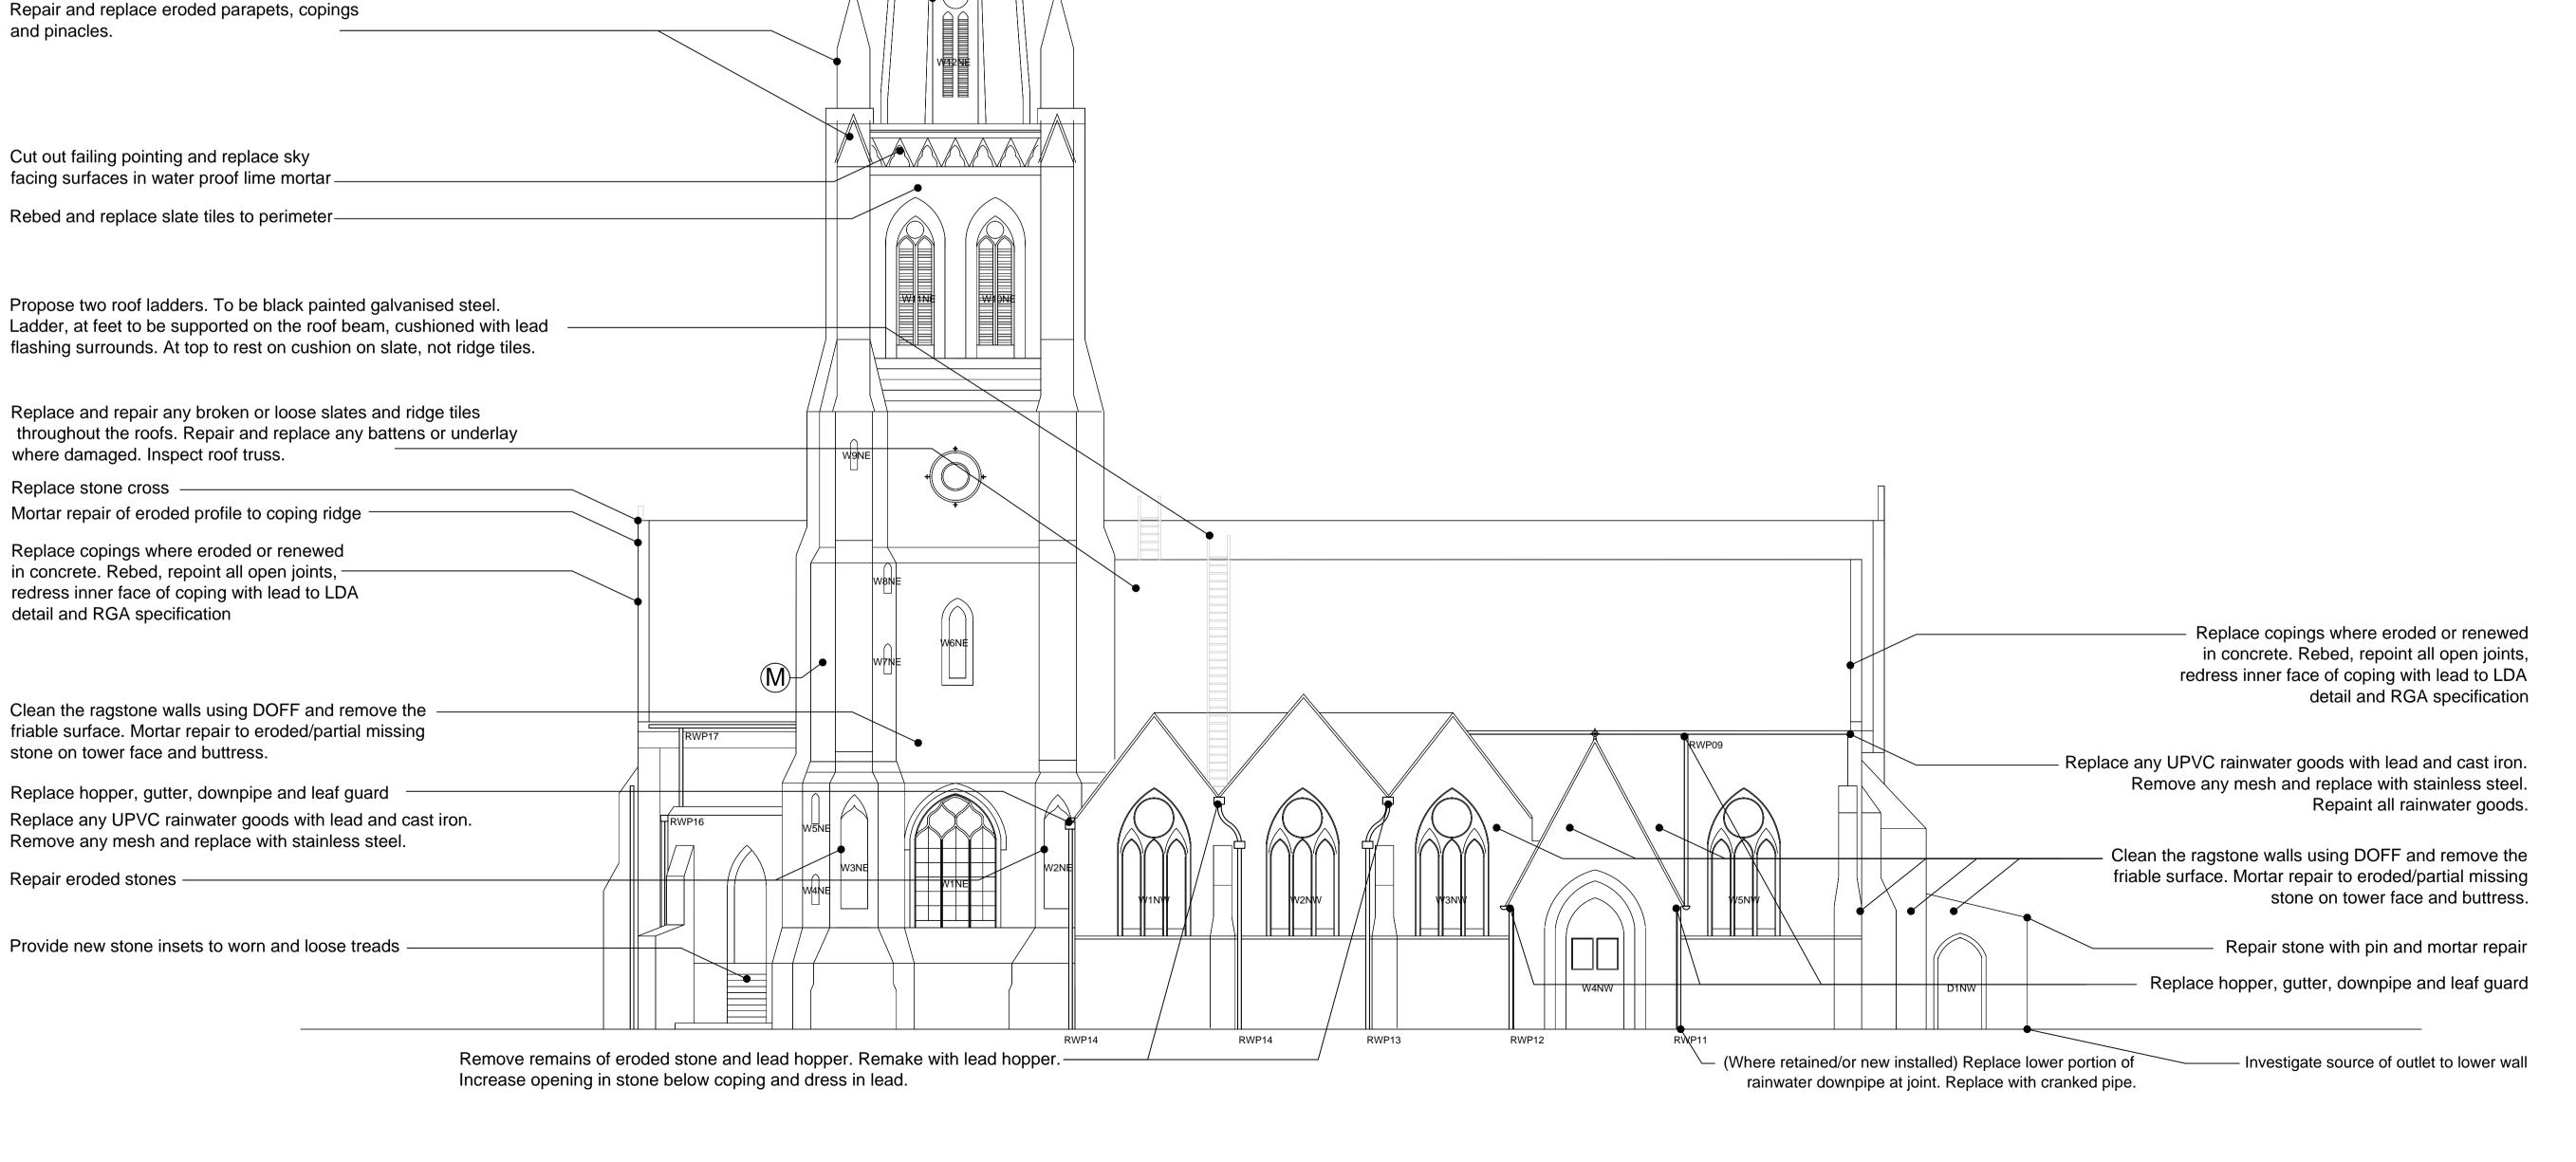
DOFF cleaning of ashlar stone to tower above window to remove staining. Repoint

any open joints or loose cement mortar

and pinacles.

Replace stone cross —

Repair eroded stones -
