FOR DAC

JOB TITLE		
Christ Church Hampstead		
DRAWING TITLE		
West Elevation Proposed Repairs		
JOB No.	DWG No.	REV
537A	D06	-
DRAWN BY	SCALE (AT A1)	DATE
JMc	1:100 (1:200@A3)	Dec14

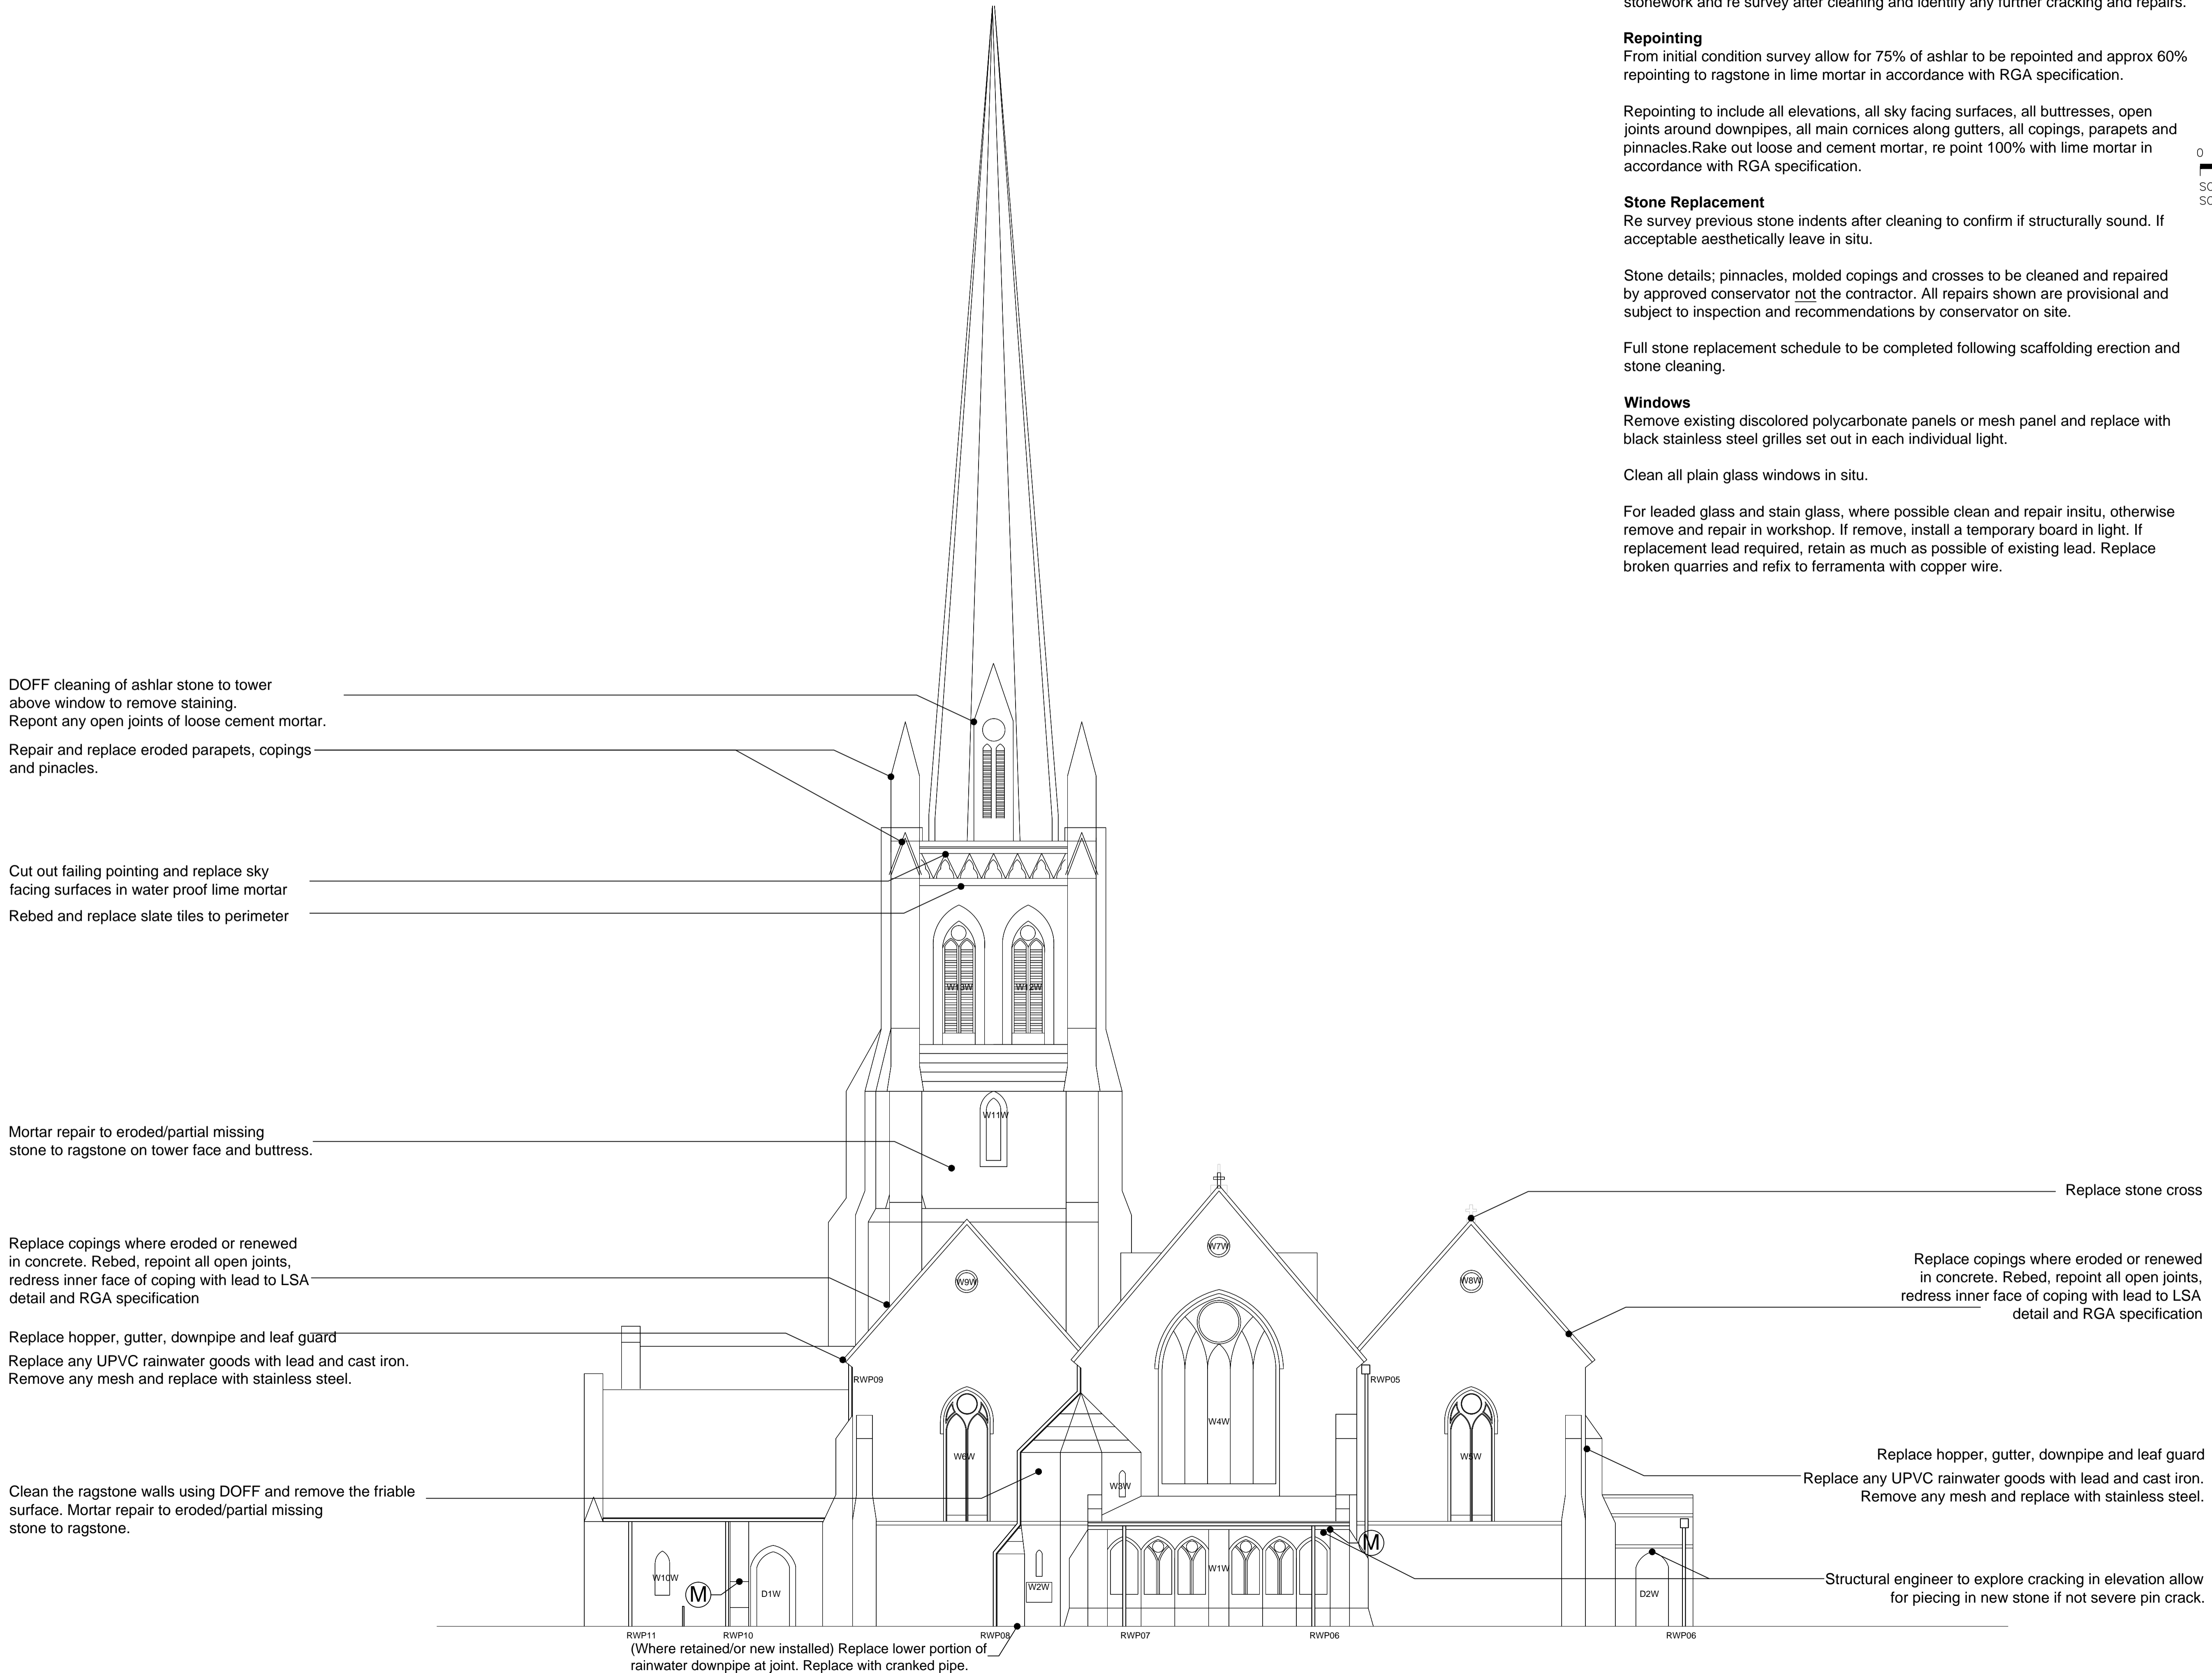
DOFF cleaning of ashlar stone to tower above window to remove staining. Repoint any open joints of loose cement mortar.

Repair and replace eroded parapets, copings and pinnacles.

Cut out failing pointing and replace sky facing surfaces in water proof lime mortar. Rebed and replace slate tiles to perimeter

Mortar repair to eroded/partial missing stone to ragstone on tower face and buttress.

Clean the ragstone walls using DOFF and remove the friable surface. Mortar repair to eroded/partial missing stone to ragstone.

Structural engineer to explore cracking in elevation allow for piecing in new stone if not severe pin crack.

Replace copings where eroded or renewed in concrete. Rebed, repoint all open joints, redress inner face of coping with lead to LSA detail and RGA specification

Replace hopper, gutter, downpipe and leaf guard. Replace any UPVC rainwater goods with lead and cast iron. Remove any mesh and replace with stainless steel.

Replace stone cross

(Where retained/or new installed) Replace lower portion of rainwater downpipe at joint. Replace with cranked pipe.
