Simon Pryce Arboriculture

Date: 07 December 2014

My ref 14/119

Trees at Belsize Court, Wedderburn Road, NW3

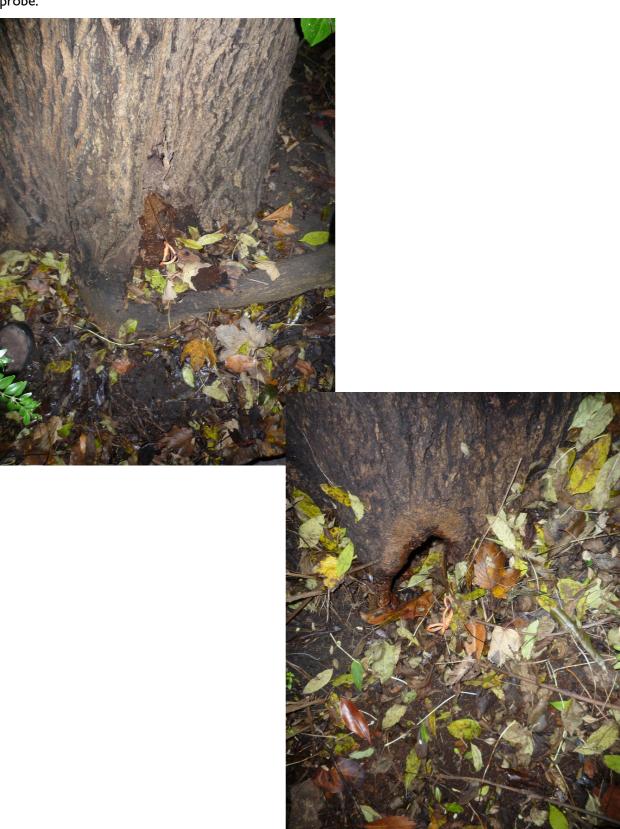
- 8. This was reduced by about 30% some time ago, the operation has been repeated at least once and it is growing on. The Conservation Area notice covering the other trees allows it to be reduced back to the pruning points again and the application states that there are indications of decay at the base. I probed two points at the base with a steel probe about 400mm long. In one point this penetrated dead bark and decayed timber for almost its full length and when put into a small opening it revealed an extensive cavity that seems to extend under most of the tree's base. This was not evident when I inspected the tree in March 2008, but decay was developing by the time I next inspected it in 2011, so I recommended felling the tree then, my ref 11/004. Since then the decay has spread even more.

Probe 400mm long in decay in two points at the base of tree 35, orange cord indicates the end of the probe.

- 9. The permitted reduction would lessen the uprooting risk slightly, but the decay is too extensive for that to be effective or reliable and, as the tree is near the school playground it should be felled for safety without delay. This can be done under Regulation 14 of the 2012 TPO Regulations which states that consent is not needed for "the cutting down, uprooting, topping or lopping of a tree, to the extent that such works are urgently necessary to remove an immediate risk of serious harm, or to such other extent as agreed in writing by the authority prior to the works being undertaken."
