Basement Impact Assessment

Site	11 Cannon Lane London NW3 1EL
Client	Greenway Architects
Date	December 2014
Our Ref	BIA/4938

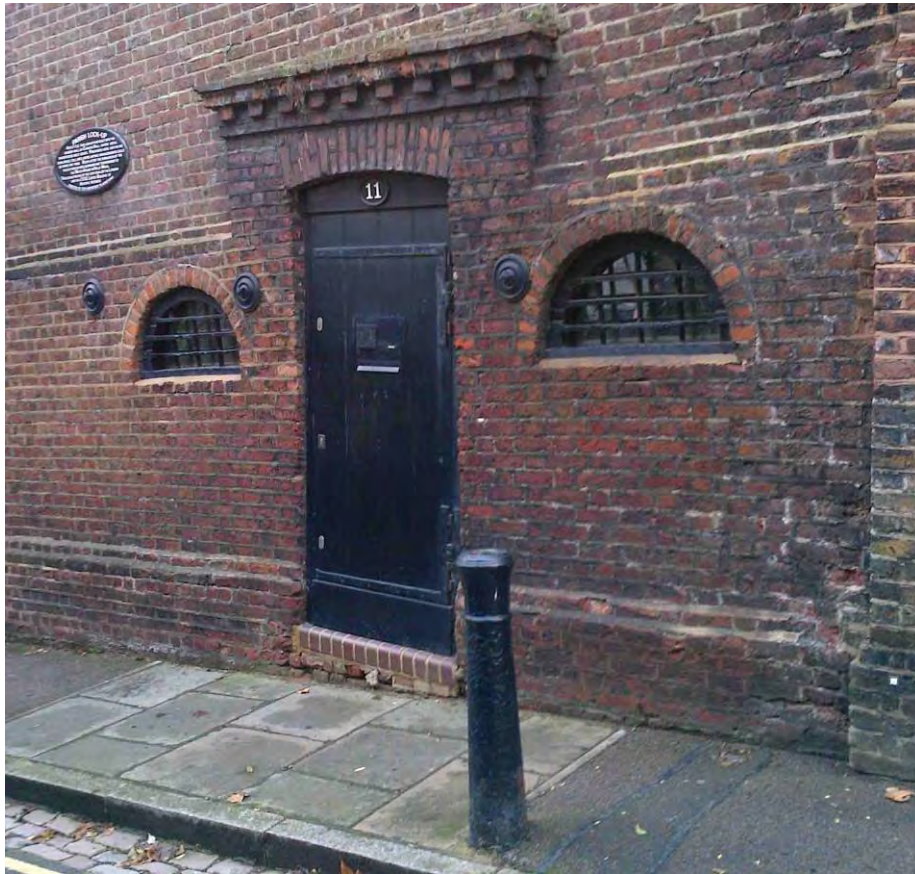
Photo 1: Front elevation (street scene). Within the boundary wall of the site, in the north-east corner of the site, is a 'Parish Lock-Up' thought to date back to 1730. Note southwards fall of Cannon Lane.

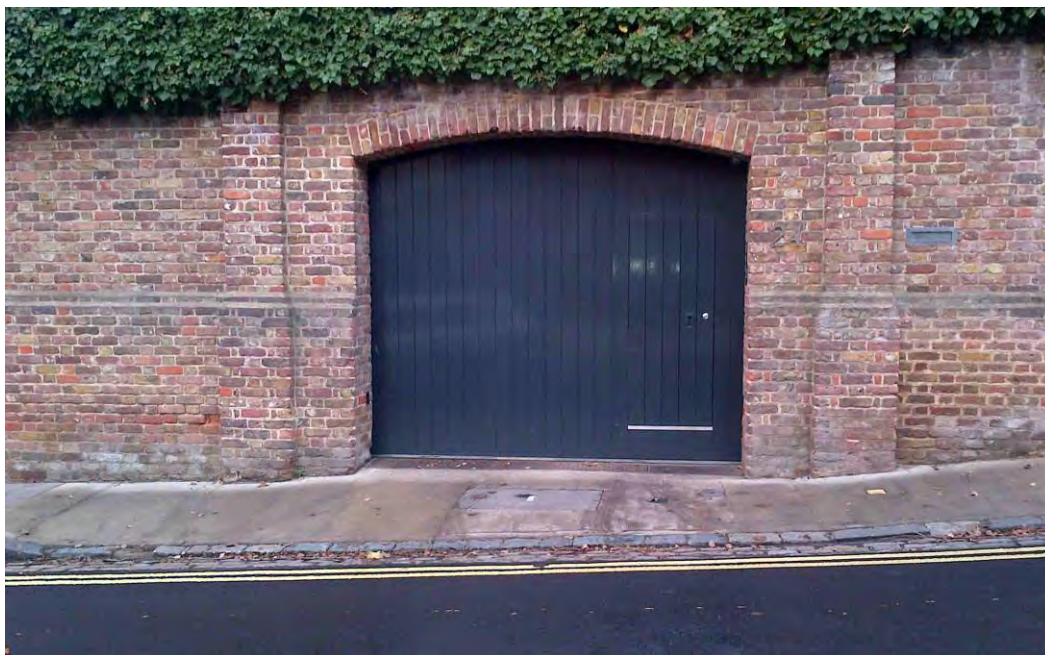
Photo 2: Driveway entrance shared with the adjoining No.24 Well Road. Note the south-westwards fall of Well Road, despite the general south-easterly facing orientation of the slope.

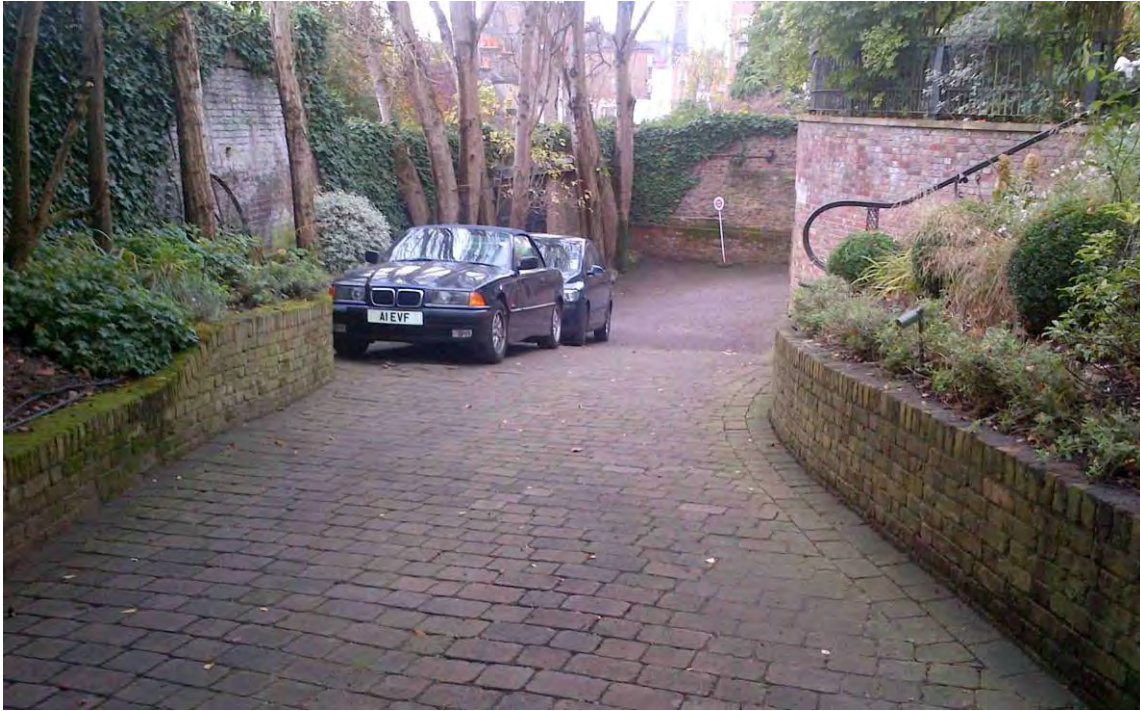
Photo 3: Shared driveway, leading up from the entrance arch (Photo 2) to the SW corner of the site.

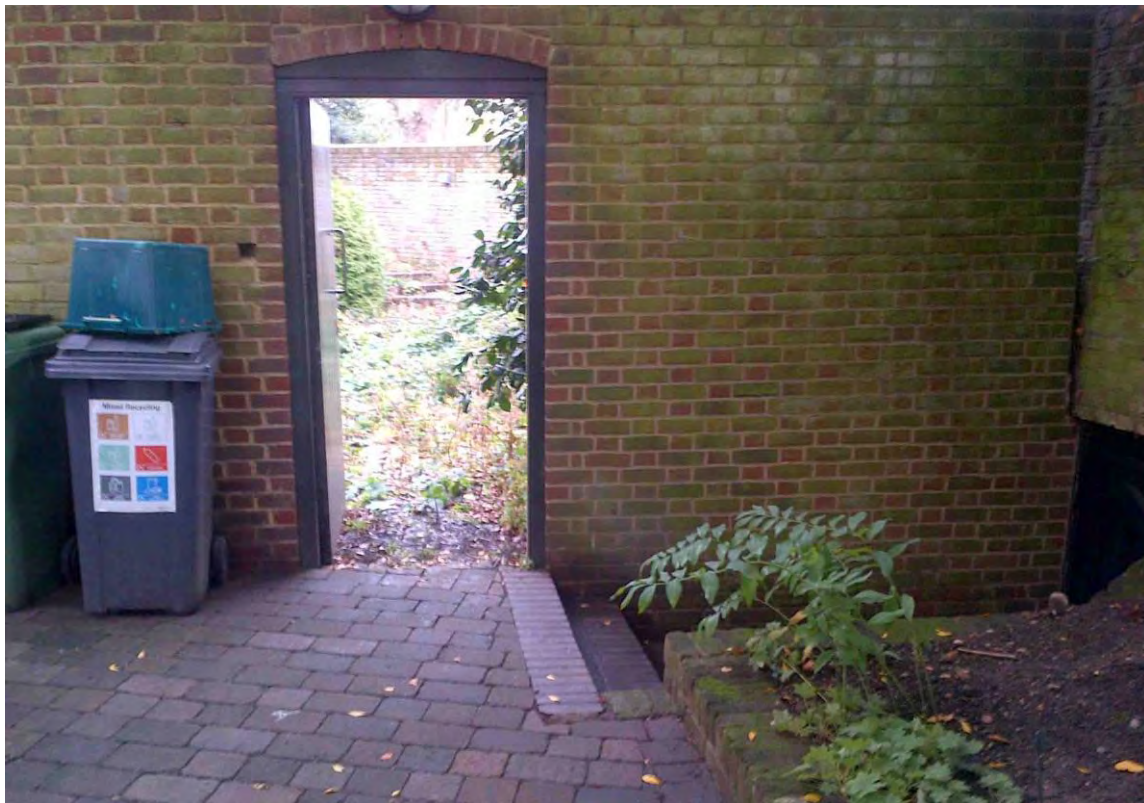
Photo 4: Entrance doorway in the southern part of the western boundary wall. Note the adjacent flight of steps which lead up from the Well Road footway, and the more modern brickwork of the western boundary wall compared with the southern and eastern boundaries.

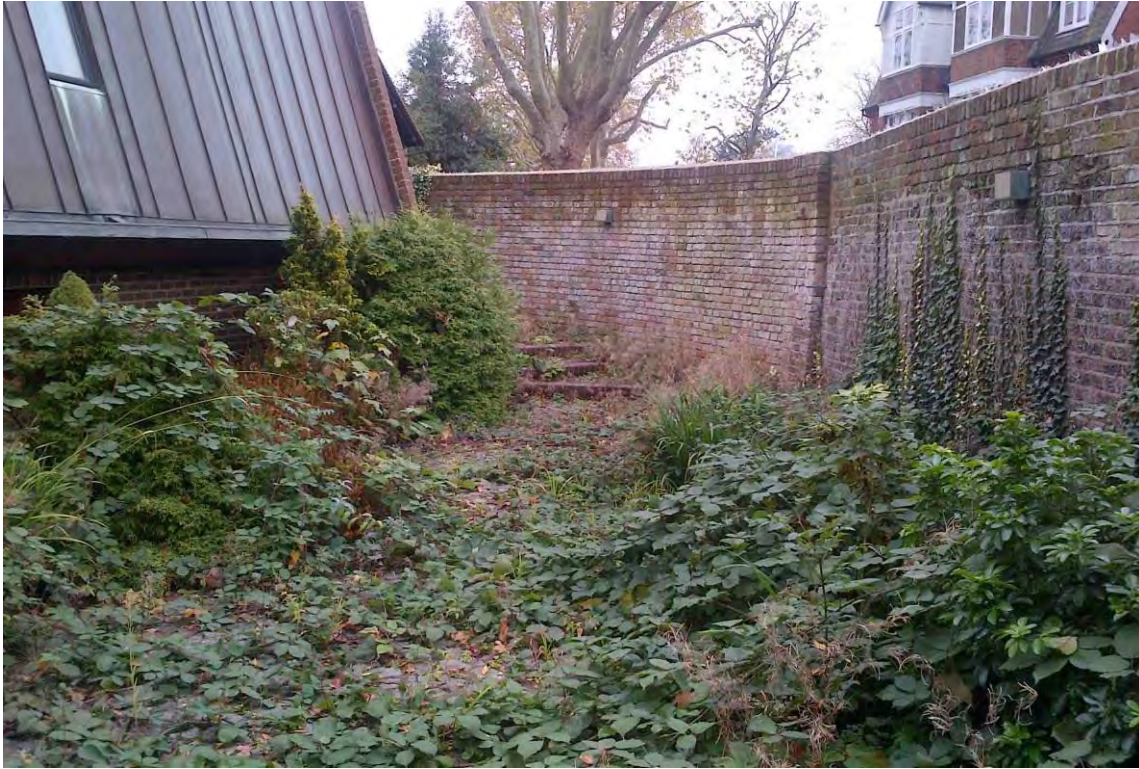
Photo 5: Front garden of No.11. Beneath the vegetation, the majority of the front garden is paved with granite setts, with the exception of a flower bed adjacent to the southern boundary wall.

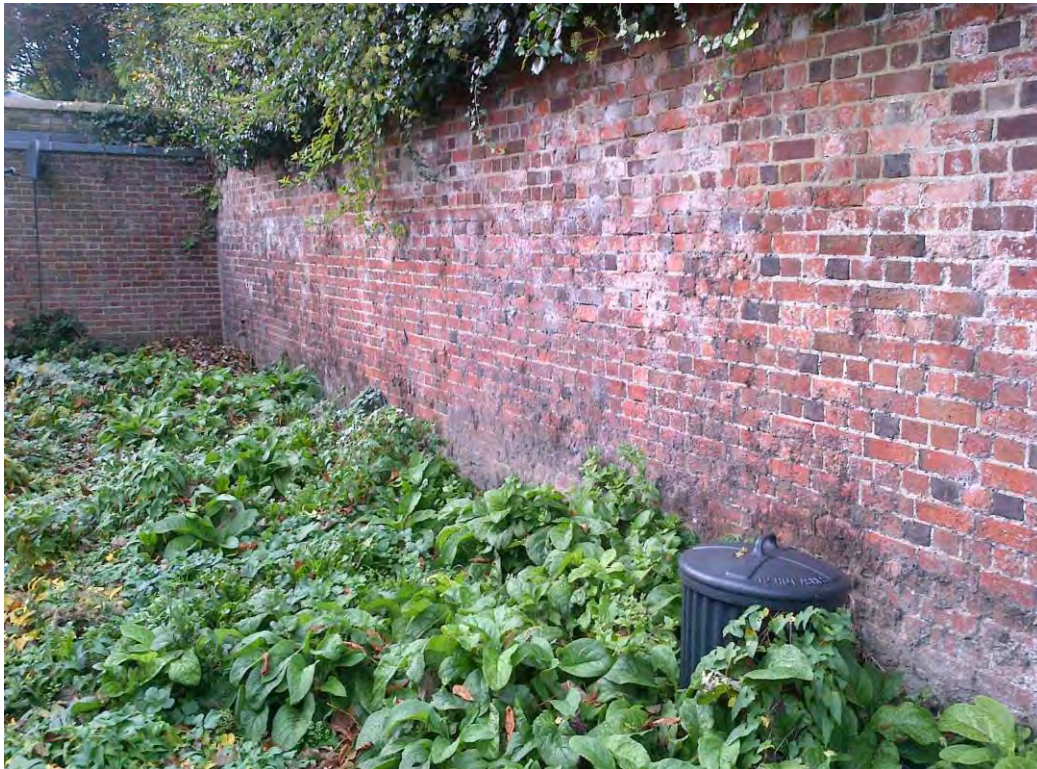
- 5.4 The rear garden to No.11 is also bounded by high brick boundary walls, therefore the surface water catchment for the rear garden is also restricted to direct rainfall, and there will be no run-off from or to neighbouring gardens. Part of the rear garden to No.11 was surfaced with tiles so infiltration will be limited or nil in that area, whereas infiltration is likely to occur in the adjacent soft landscaped part of the rear garden (Photo 6).

Photo 6: Rear garden to No.11, the majority of which consists of a planting area. Note the brick retaining wall which forms the northern boundary to the site.

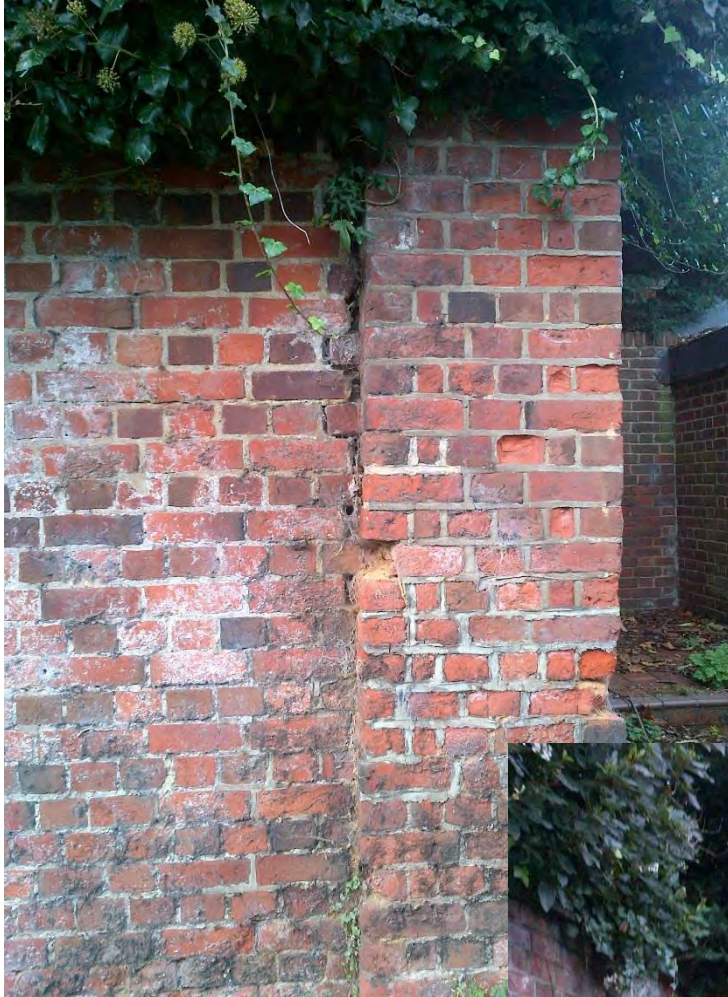
Photo 7: Rear retaining wall showing signs of damage (forward rotation, to right).

- tension piles will be required to resist the hydraulic uplift forces (10.2.7);
- the retaining walls on the upslope boundary were already showing evidence of forward rotation, so measures will be required to strengthen and stabilize these before the proposed basement is excavated (10.4.1).
- condition surveys should be undertaken of neighbouring properties before the works start (10.6.1);
- if further testing shows that use of soakaways would not be viable, then use of appropriate SuDS system(s) for management of surface water (10.7.4 & 10.7.5).
- Provision of upstands or ramped paving around the recessed areas alongside the new house and raised thresholds or floor levels to protect all entrances to the house (10.7.6).
- Provision of non-return valves or above ground loop systems and temporary interception storage (10.7.7 & 10.7.8).

- 11.6 There are no concerns regarding the overall stability of the slope, although the damaged retaining walls on the upslope side of the excavation must be repaired before the excavations start (10.4.1). Ground anchors, with appropriate wayleaves, will be required for the retaining wall on the up-slope side of the excavation (10.4.2).

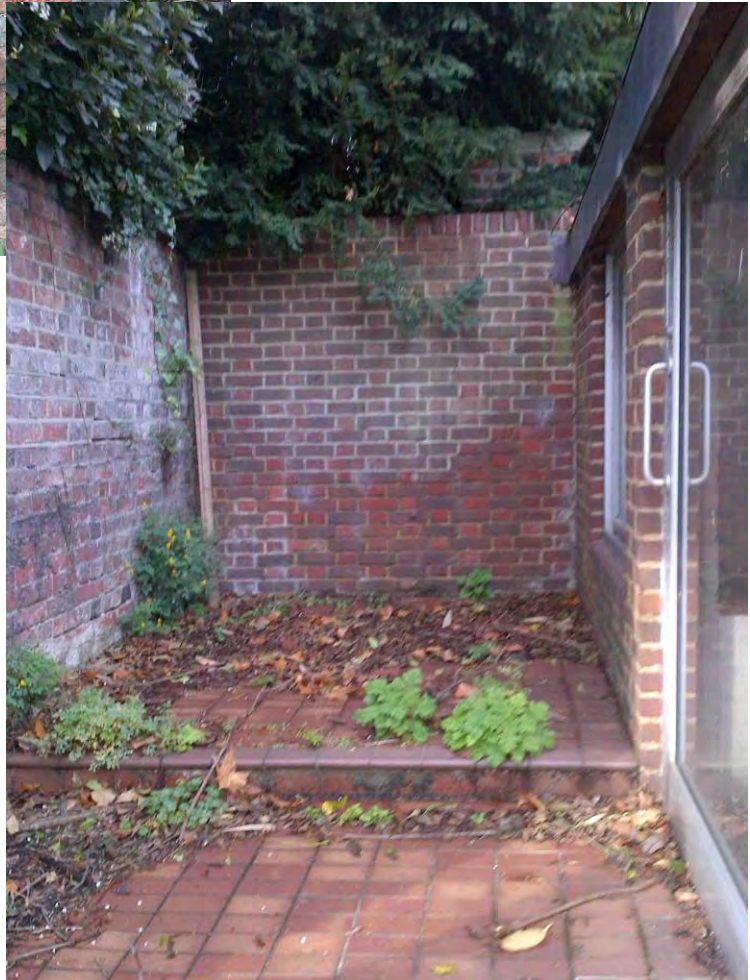
- TP3 was excavated in the north-east part of the rear garden, at the intersection between south and east facing sections of the rear retaining wall (see location plan). Section A (east facing part of retaining wall) revealed the same foundations as were described in TP1 section B and TP2, however were founded at a greater depth, with the base of the brickwork and concrete slab at depths of 0.95m and 1.2m bgl respectively. In section B (south facing part of retaining wall), the base of the brickwork was found at ground level, below which was a 0.28m thick concrete slab which extended southwards beyond the area investigated by the trial pit.

Photo 8: Eastern part of rear retaining wall. Note the more modern brickwork compared with the retaining wall to the west. During the Ground Investigation, TP3 revealed different foundations beneath this section of the retaining wall, compared with the foundations described beneath the rest of the rear retaining wall, indicating it was constructed at a later date. Annex on right.
