ARBORICULTURAL ASSESSMENT REPORT

For:	Client:	Crawford & Company (Nottingham)
	Insurer:	[REDACTED]
Site:	Policyholder:	[REDACTED]
	Risk Address:	14a Downshire Hill, London, NW3 1NR
Refs:	OCA Ref:	56971
	Client Ref:	SU1403227
	Insurer Ref:	[REDACTED]

Report By:	Sue Lawson		
Title:	Consulting Arborist	Date:	Amended to include SI 15/01/15

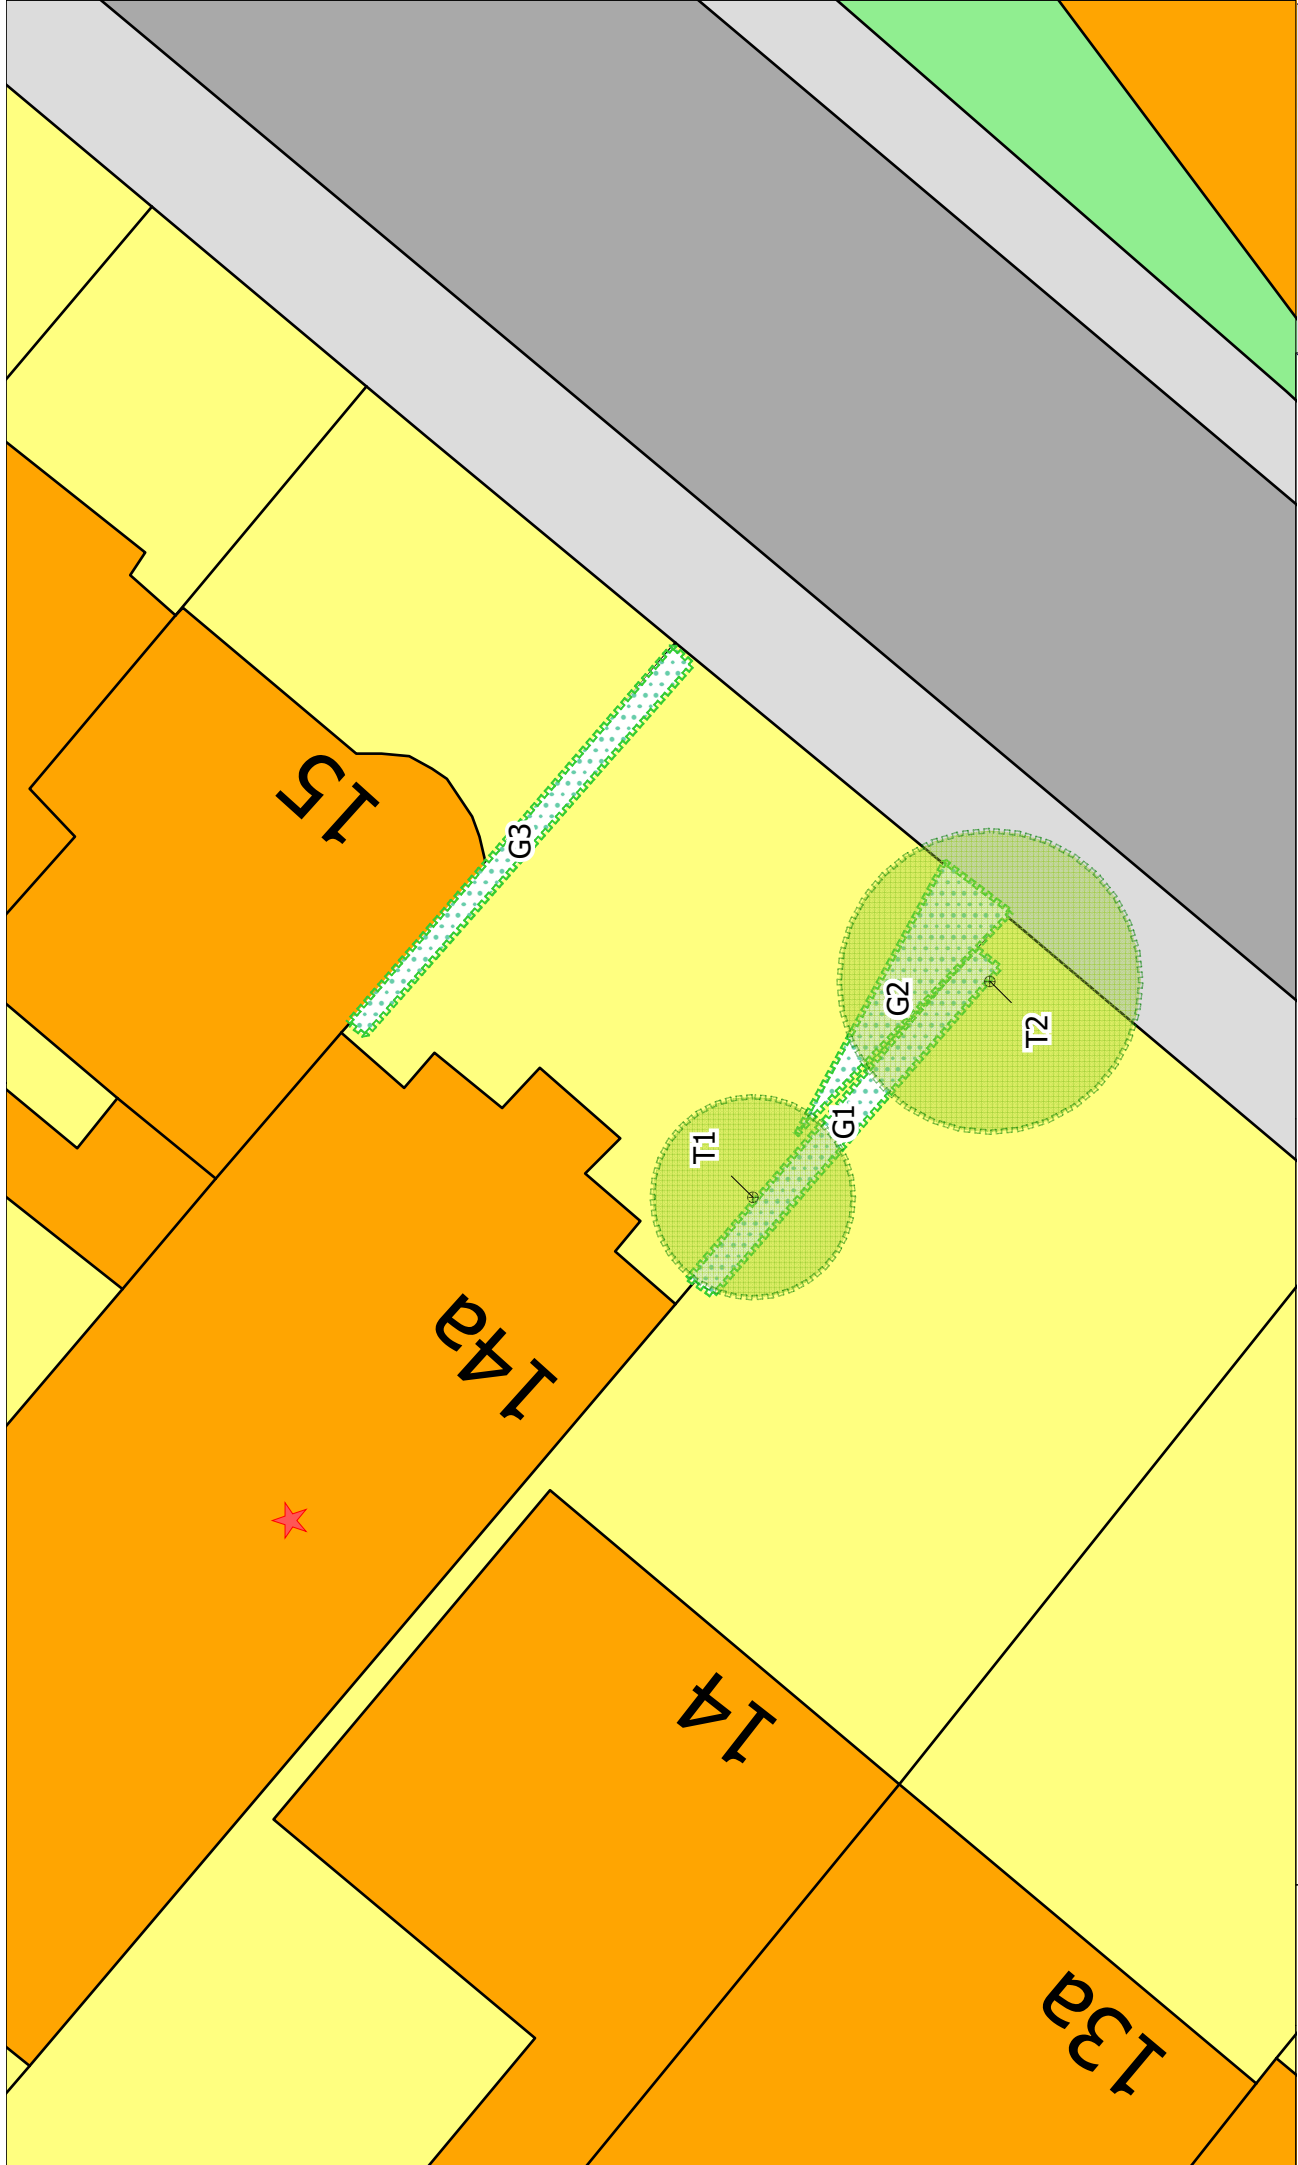
8.0 APPENDIX 2: SITE PLAN

At this stage, we consider that T1 (young Ash), G1 (Viburnum hedge) and T2 (Hawthorn) are situated within potential influencing distance and their positions are consistent with the area of damage. We consider that T1, G1 and possibly T2 are the likely cause of the current vegetation-related clay shrinkage subsidence. Monitoring is currently underway and we would recommend that T1 be removed along with the section of G1 closest to the house in the first instance. Should movement of the property continue following these works, we consider that removal of T2 may be required.

Tree No:	Species	Works Required
T1	Ash	Fell and treat stump.
G1	Viburnum hedge	Fell the section of hedge within 1.5m of the property and treat stumps.

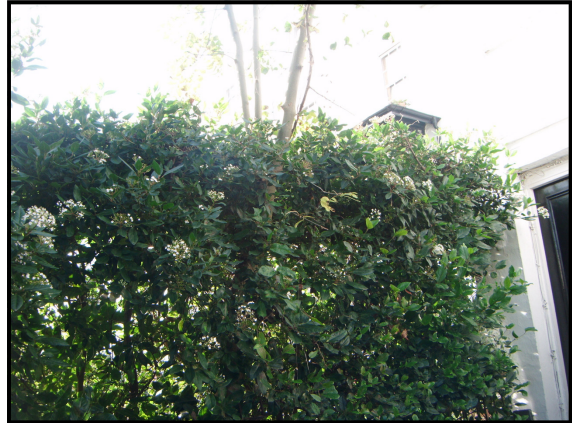
2. T1 Ash and G1 Viburnum

The site investigation confirms the presence of a shrinkable clay soil. Roots have been identified from beneath the foundation at the front left corner of the property which are consistent with the position and species of T1 (Ash). The engineer has confirmed that damage is consistent with vegetation-related clay shrinkage subsidence.
