TECHNICAL REPORT ON A SUBSIDENCE CLAIM

Crawford Reference: SU1403227

[REDACTED]
14a Downshire Hill
London
NW3 1NR

SUBSIDENCE CLAIM

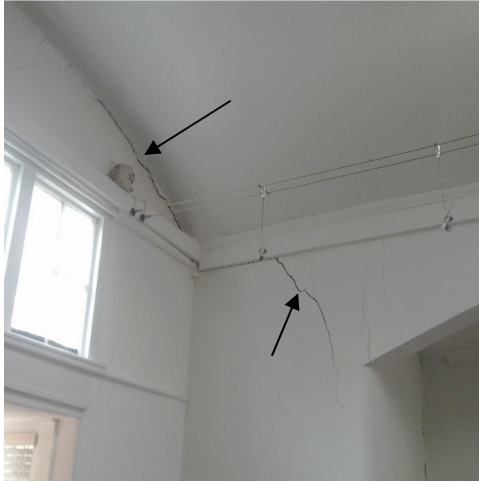
Cracking to front of main room

12mm diagonal crack to the main left wall (and to the right of the entrance) extends up the ceiling, and half way around the curved wall/ceiling junction of the front wall.

2mm parallel diagonal crack to the crack described above.

6mm vertical crack in the front left corner

In structural terms the damage falls into Category 3 of Table 1, Building Research Establishment⁹ Digest 251, which describes it as “moderate”.

The pattern and nature of the cracks is indicative of an episode of subsidence. The cause of movement appears to be clay shrinkage.

The timing of the event, the presence of shrinkable clay beneath the foundations and the proximity of vegetation where there is damage indicates the shrinkage to be root induced. This is a commonly encountered problem and probably accounts for around 70% of subsidence claims notified to insurers.

The cause of the movement needs to be dealt with first. We have completed a soil risk analysis (VISCAT Assessment) and we are satisfied that your neighbour's ash and bay can be removed. Our Mitigation Unit will liaise with your neighbour in this respect.

Following completion of the tree management works, we will undertake a suitable period of monitoring to confirm stability has been achieved before undertaking repairs to the property.

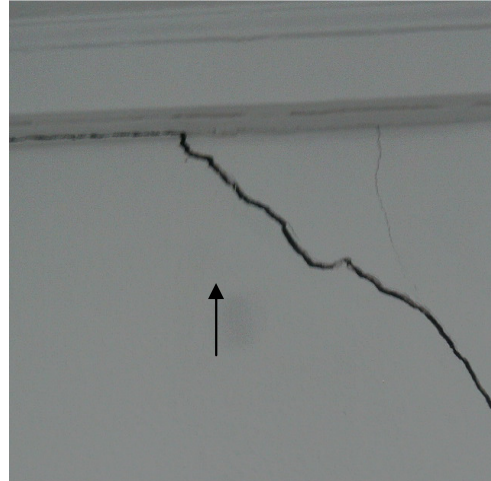
Close up of primary crack

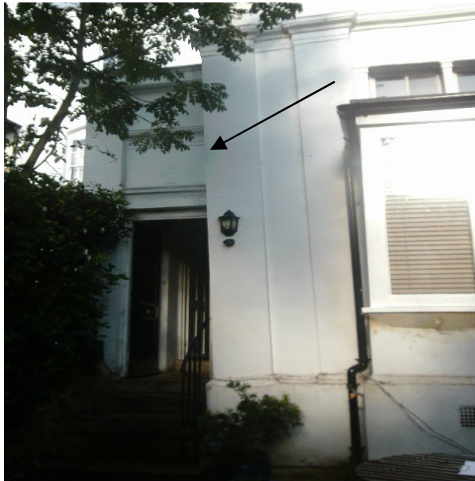
Historic lean to left corner.

Historic lean of the front left corner of the main structure, by up to 75mm

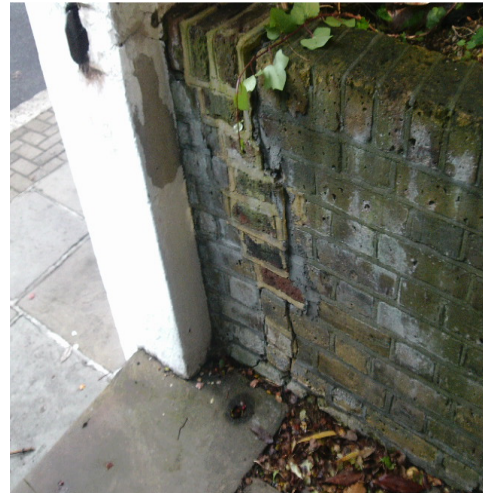
Damage to front garden wall

10mm cracks to front wall with 15mm lateral displacement of short return wall by gate, due to failure as a retaining wall, and unrelated to subsidence

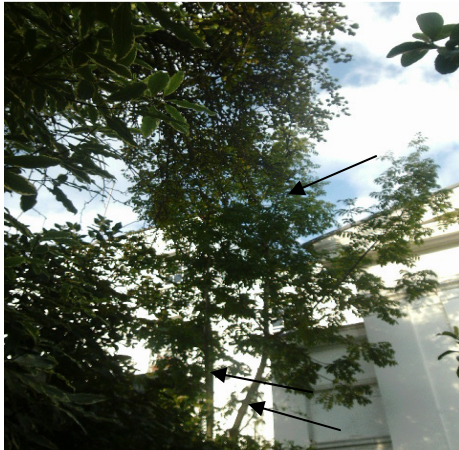
Type	Height	Distance	Ownership
Ash sapling	5 m	1 m	No 14 Downshire Hill
Bay	2 m	0.2m	No 14 Downshire Hill
Hawthorn	5 m	5 m	No 14 Downshire Hill

Ash sapling arrowed

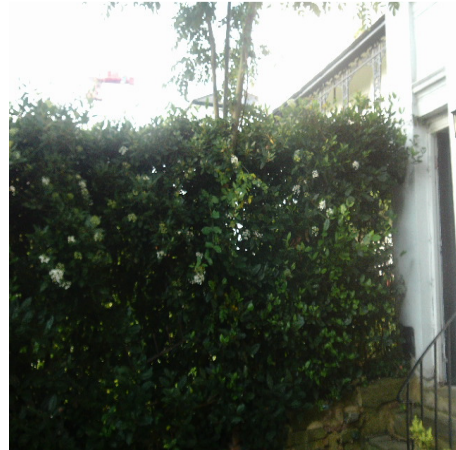
Bay hedge on left hand boundary

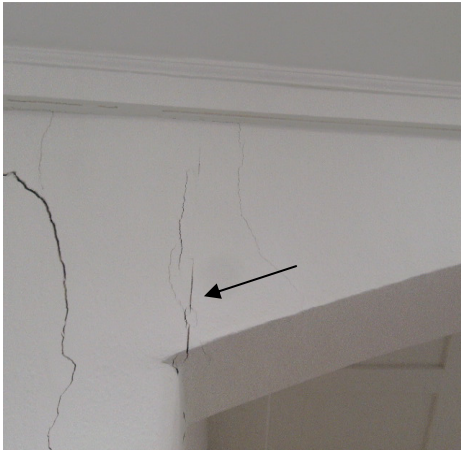
Series of 2mm vertical cracks to the front springing point of the arch

Cracking over arch springing point
