ARBORICULTURAL ASSESSMENT REPORT

For:	Client:	Crawford & Company (Nottingham)
	Insurer:	[REDACTED]
Site:	Policyholder:	[REDACTED]
	Risk Address:	14a Downshire Hill, London, NW3 1NR
Refs:	OCA Ref:	56971
	Client Ref:	SU1403227
	Insurer Ref:	[REDACTED]

Report By:	Sue Lawson		
Title:	Consulting Arborist	Date:	Amended to include SI 15/01/15

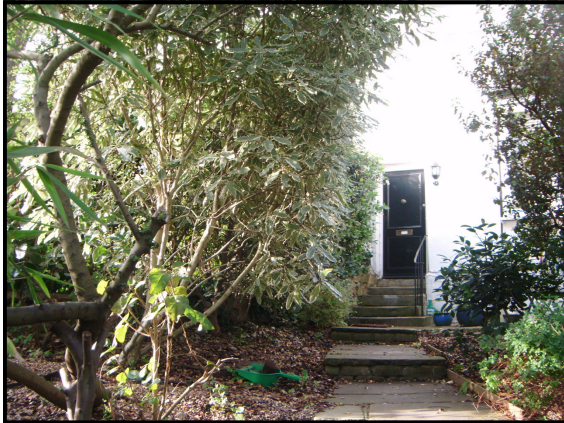
At this stage, we consider that T1 (young Ash), G1 (Viburnum hedge) and T2 (Hawthorn) are situated within potential influencing distance and their positions are consistent with the area of damage. We consider that T1, G1 and possibly T2 are the likely cause of the current vegetation-related clay shrinkage subsidence. Monitoring is currently underway and we would recommend that T1 be removed along with the section of G1 closest to the house in the first instance. Should movement of the property continue following these works, we consider that removal of T2 may be required.

1. G1 Viburnum

Tree No:	Species	Works Required
T1	Ash	Fell and treat stump.
G1	Viburnum hedge	Fell the section of hedge within 1.5m of the property and treat stumps.

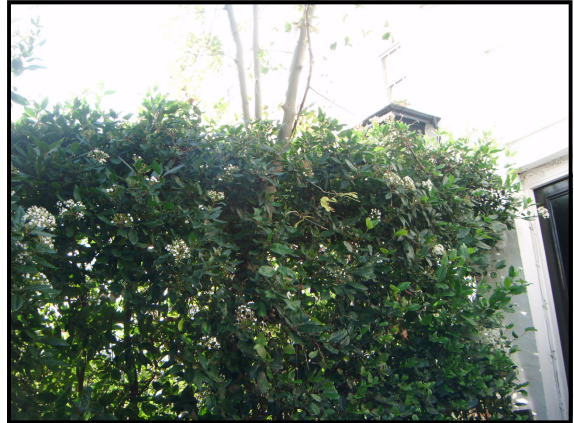
The site investigation confirms the presence of a shrinkable clay soil. Roots have been identified from beneath the foundation at the front left corner of the property which are consistent with the position and species of T1 (Ash). The engineer has confirmed that damage is consistent with vegetation-related clay shrinkage subsidence.

2. T1 Ash and G1 Viburnum

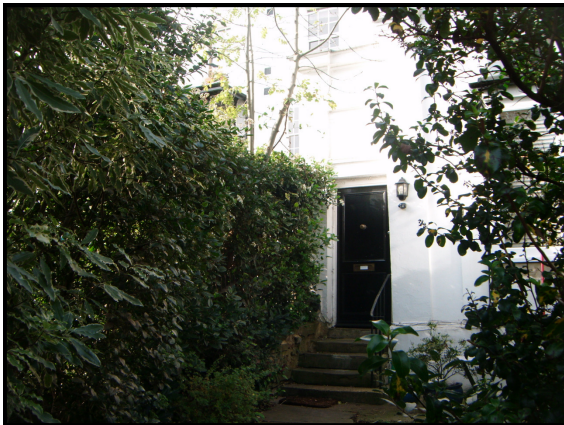
3. T1 Ash and G1 Viburnum
