Chartered Loss Adjusters

INTRODUCTION

We have been asked by [REDACTED] to comment on movement that has taken place to the above property. We are required to briefly describe the damage, establish a likely cause and list any remedial measures that may be needed.

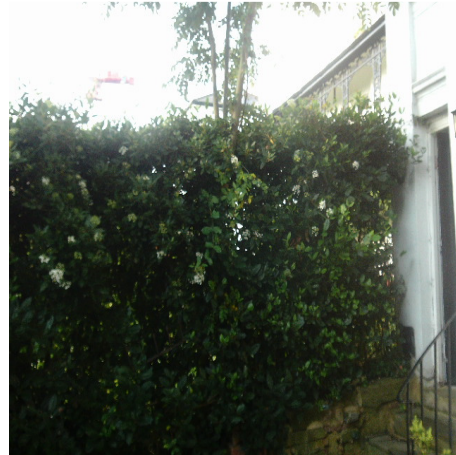
Bay hedge on left hand boundary

The cause of the movement needs to be dealt with first. We have completed a soil risk analysis (VISCAT Assessment) and we are satisfied that your neighbour's ash and bay can be removed. Our Mitigation Unit will liaise with your neighbour in this respect.

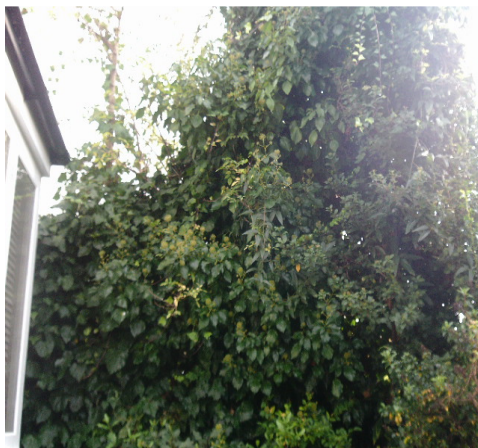
Vegetation to the right hand side

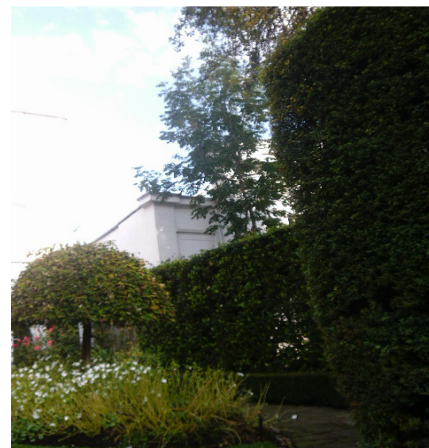
Vegetation photographed from no 14

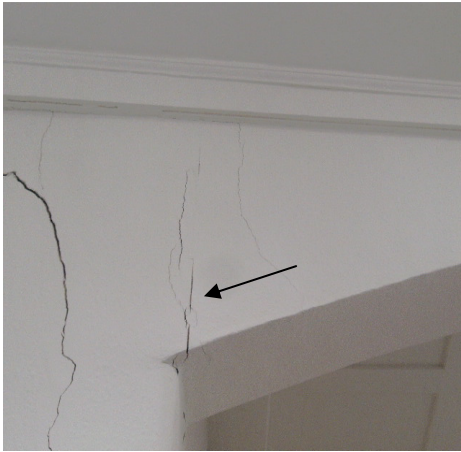
Series of 2mm vertical cracks to the front springing point of the arch

Cracking over arch springing point
