Tree Health & Visual Tree Assessment

**Site Address: Wildwood Lodge, North End,
London NW3 7HH**

Date: 13th January 2015

Job Reference No. JM/150109R/sh

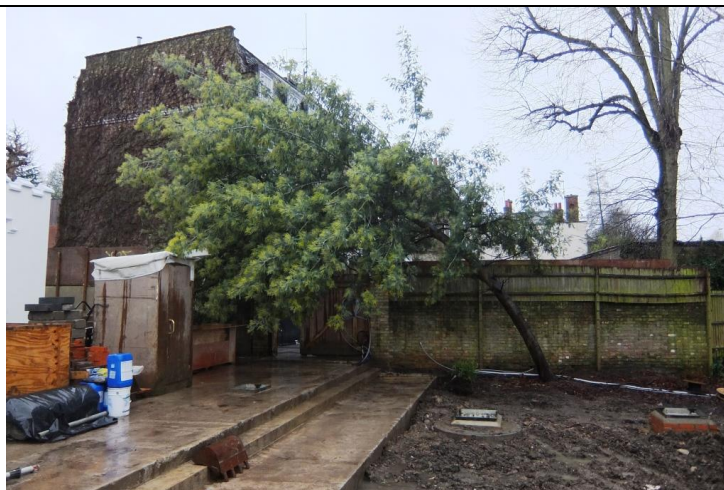
Photograph 1 – As viewed from the east inside the site at Wildwood Lodge

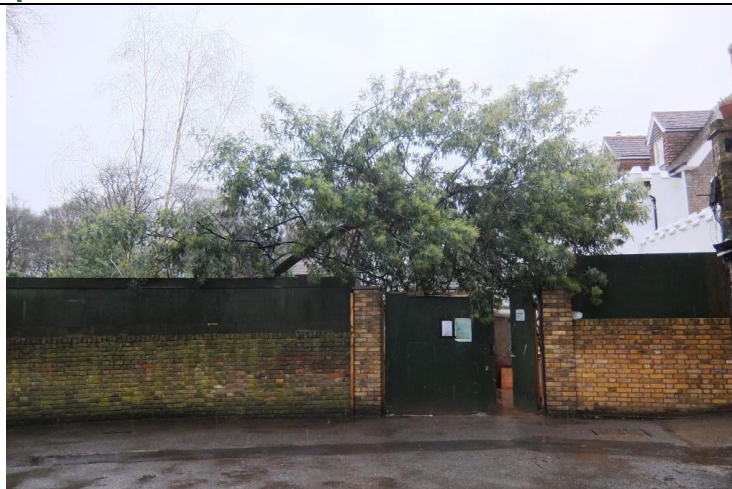
Photograph 2 – As viewed from the west from Parfit Close

- ❑ The view of the tree to anyone outside of the site is limited to that shown in photograph 2 included above, which demonstrates the declining branches, lean and poor form.

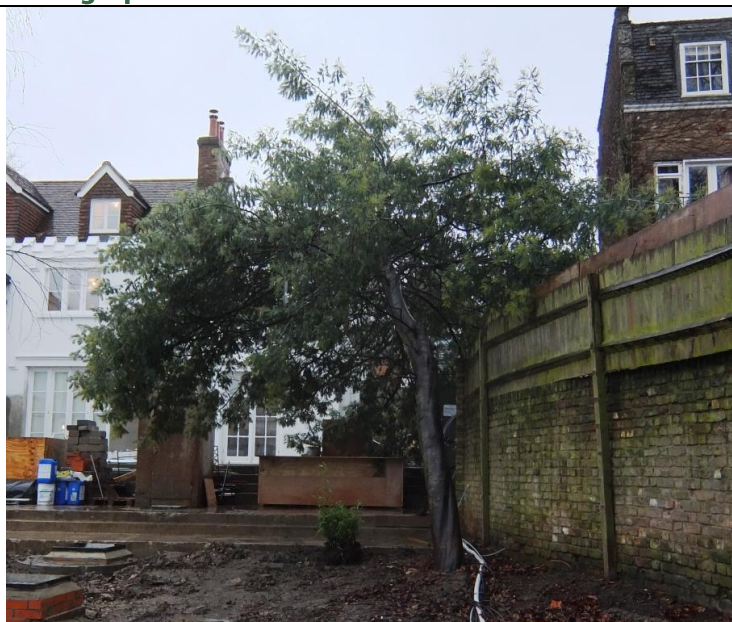
Photograph 3 – A view of the tree from the north within the site
