Arboricultural Appraisal Report

Subsidence Damage Investigation at:

9 Rosslyn Hill
London
NW3 5UL

CLIENT:	Crawford & Company
CLIENT REF:	SU1300377
POLICYHOLDER:	Mr Gonzalez Ramirez
MWA REF:	NW160413.02
MWA CONSULTANT:	Giles Mercer
REPORT DATE:	23rd December 2013

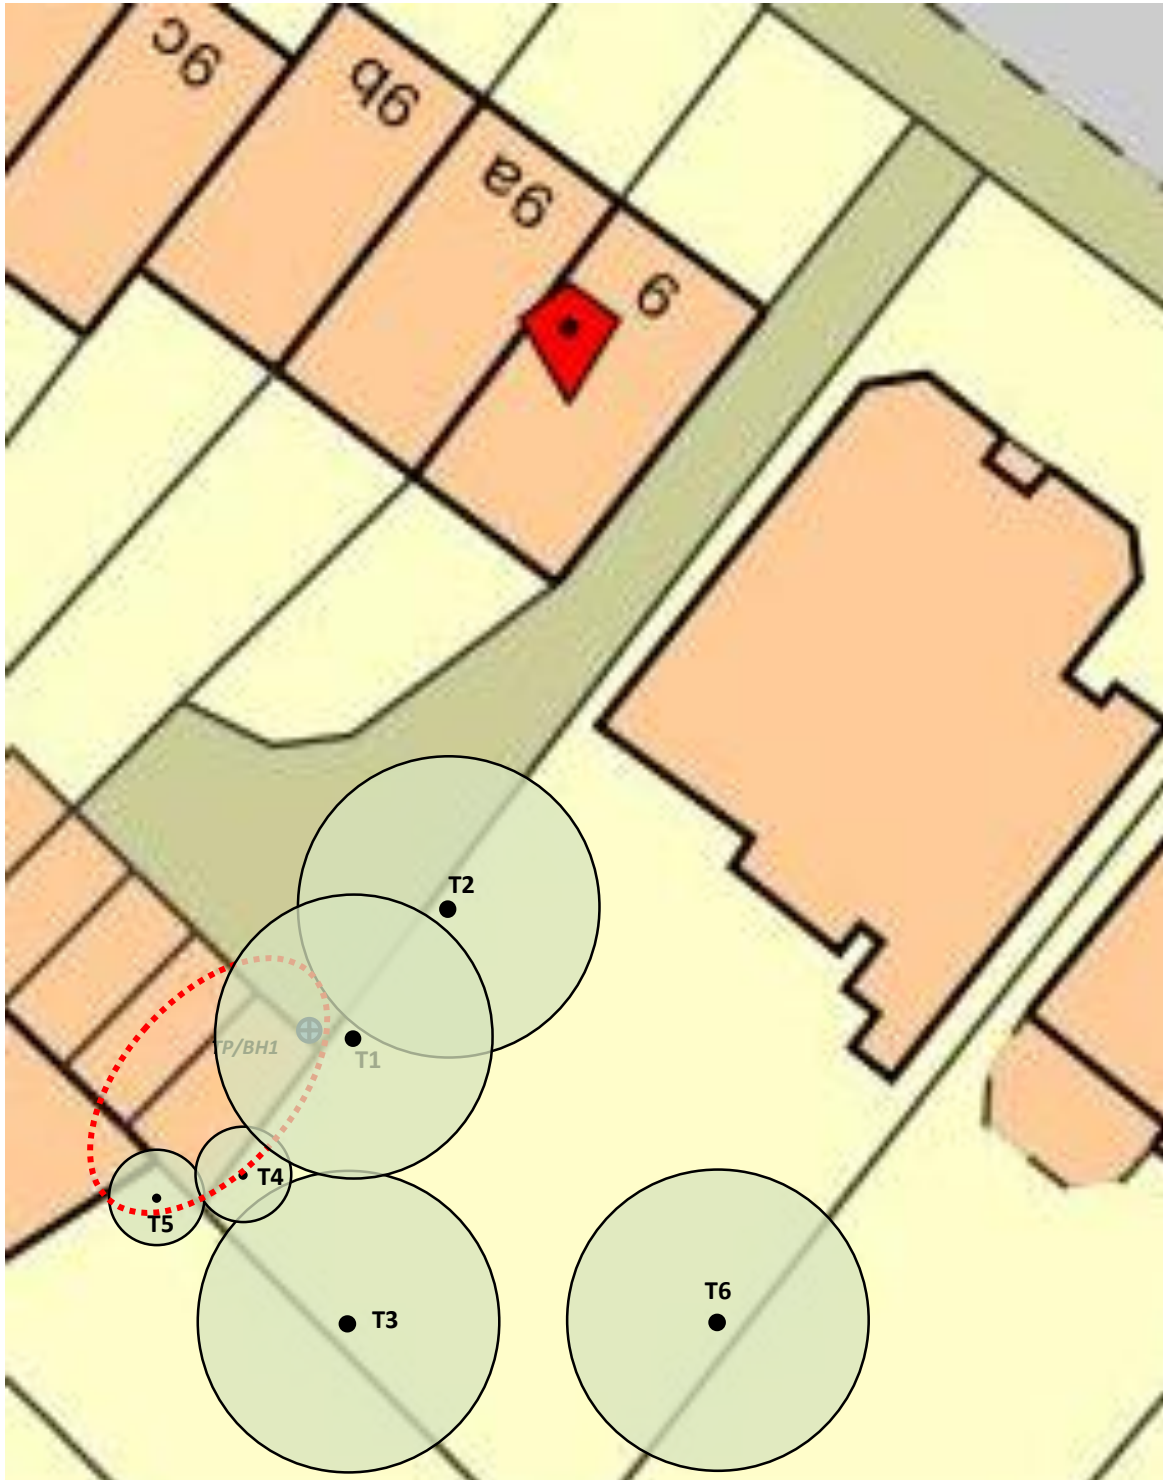
SITE PLAN

Approximate areas of damage

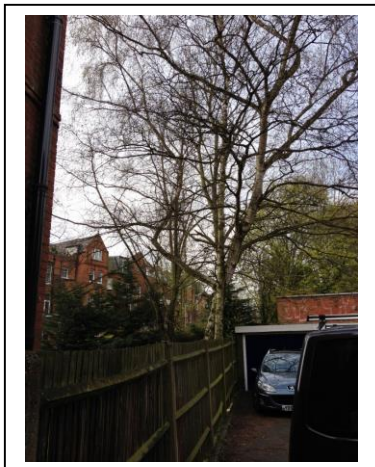
View of T1 & T2

Our survey of the site identified the Ash (T6) and in the absence of any other significant Ash trees in the vicinity we believe that this is the most likely source of the recovered roots. Whilst no roots were recovered from the Sycamore (T1), the Birch (T2) the Lime (T3) and the Laburnum (T5), given their size, species profile and position relative to the observed damage it is our opinion that these represent the most significant vegetative influence and the primary cause of the observed damage and accordingly we have made recommendations in respect of this. The ash, although implicated by the root identification, is considered to be a secondary influence.

In order to mitigate current damage and allow soils beneath the property to recover such that an effective repair solution can be implemented we recommend that the Sycamore (T1), the Birch (T2), the Lime (T3), the Laburnum (T5) and the Ash (T6) be removed completely.

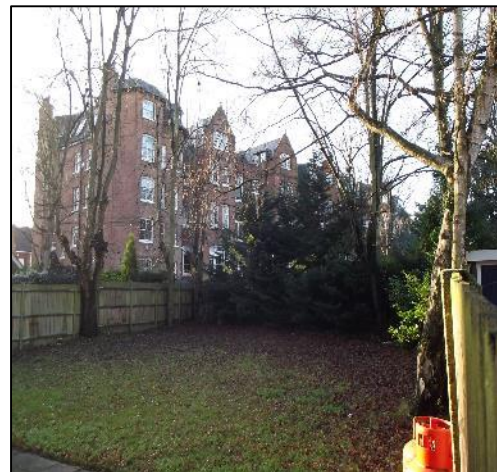
View of T6

Samples of roots were recovered from underside of foundations in TP/BH1. These roots were identified microscopically as having emanated from *Fraxinus* spp. (Ash).

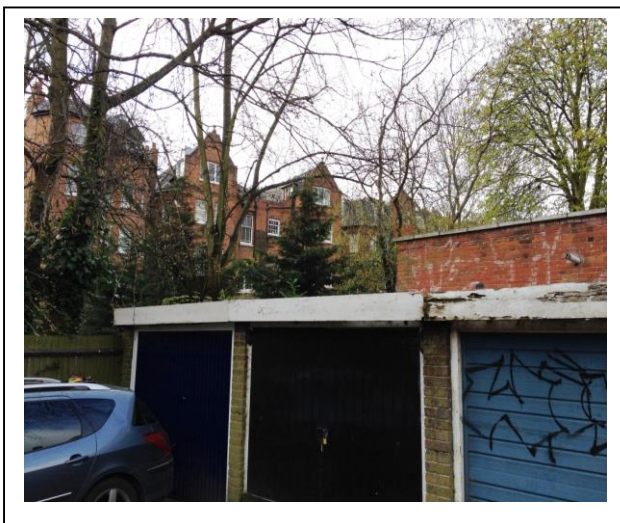
View of Garage

The damage presents as various stepped tapering and horizontal cracks were noted to the left hand flank ranging up to 10mm in width; mastic repairs were evident to some of the cracks, 10mm vertical tapering crack to the rear wall at midpoint with mastic repair evident, 12mm gap evident between the concrete floor slab and right hand party wall.

At the time of the Engineers' inspection, in structural terms the damage falls into Category 3 of Table 1, Building Research Establishment Digest 251 (1995), which describes it as moderate affecting building serviceability.
