TECHNICAL REPORT ON A SUBSIDENCE CLAIM

Crawford Reference: SU1300377

**9 Rosslyn Hill
London
NW3 5UL**

SUBSIDENCE CLAIM

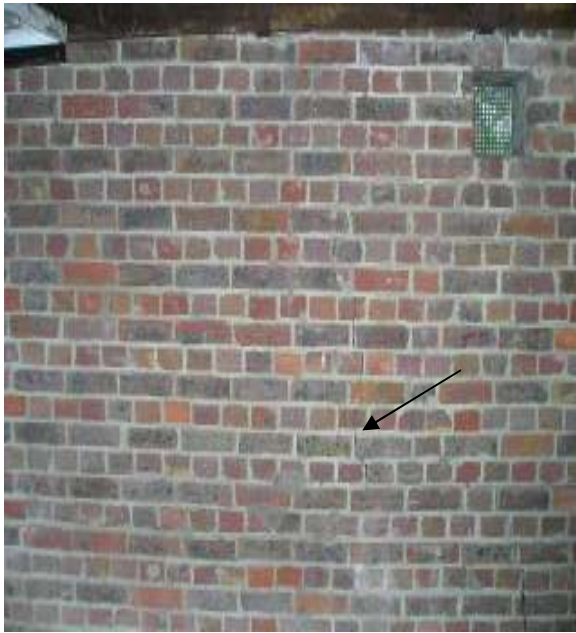
Cracking to left hand flank

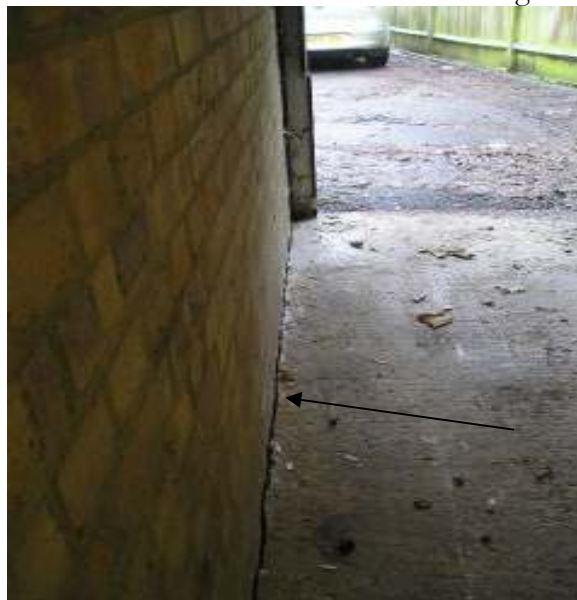
View of movement between slab and right hand party wall
