## ARBORICULTURAL IMPACT ASSESSMENT REPORT:

Spedan Tower Cottage  
17 Branch Hill  
Hampstead  
NW3 7NA

Ref: SHH/17BRH/AIA/01

Date: 15<sup>th</sup> July 2014

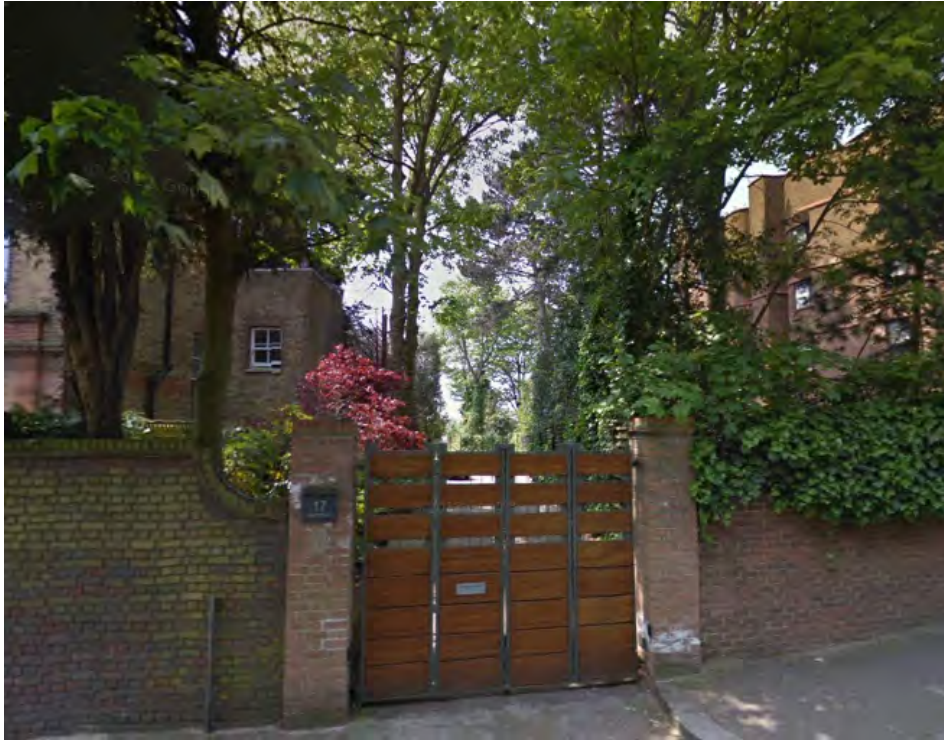
Photograph 1: Entrance to Spedan Tower Cottage, 17 Branch Hill, Hampstead NW3 7NA

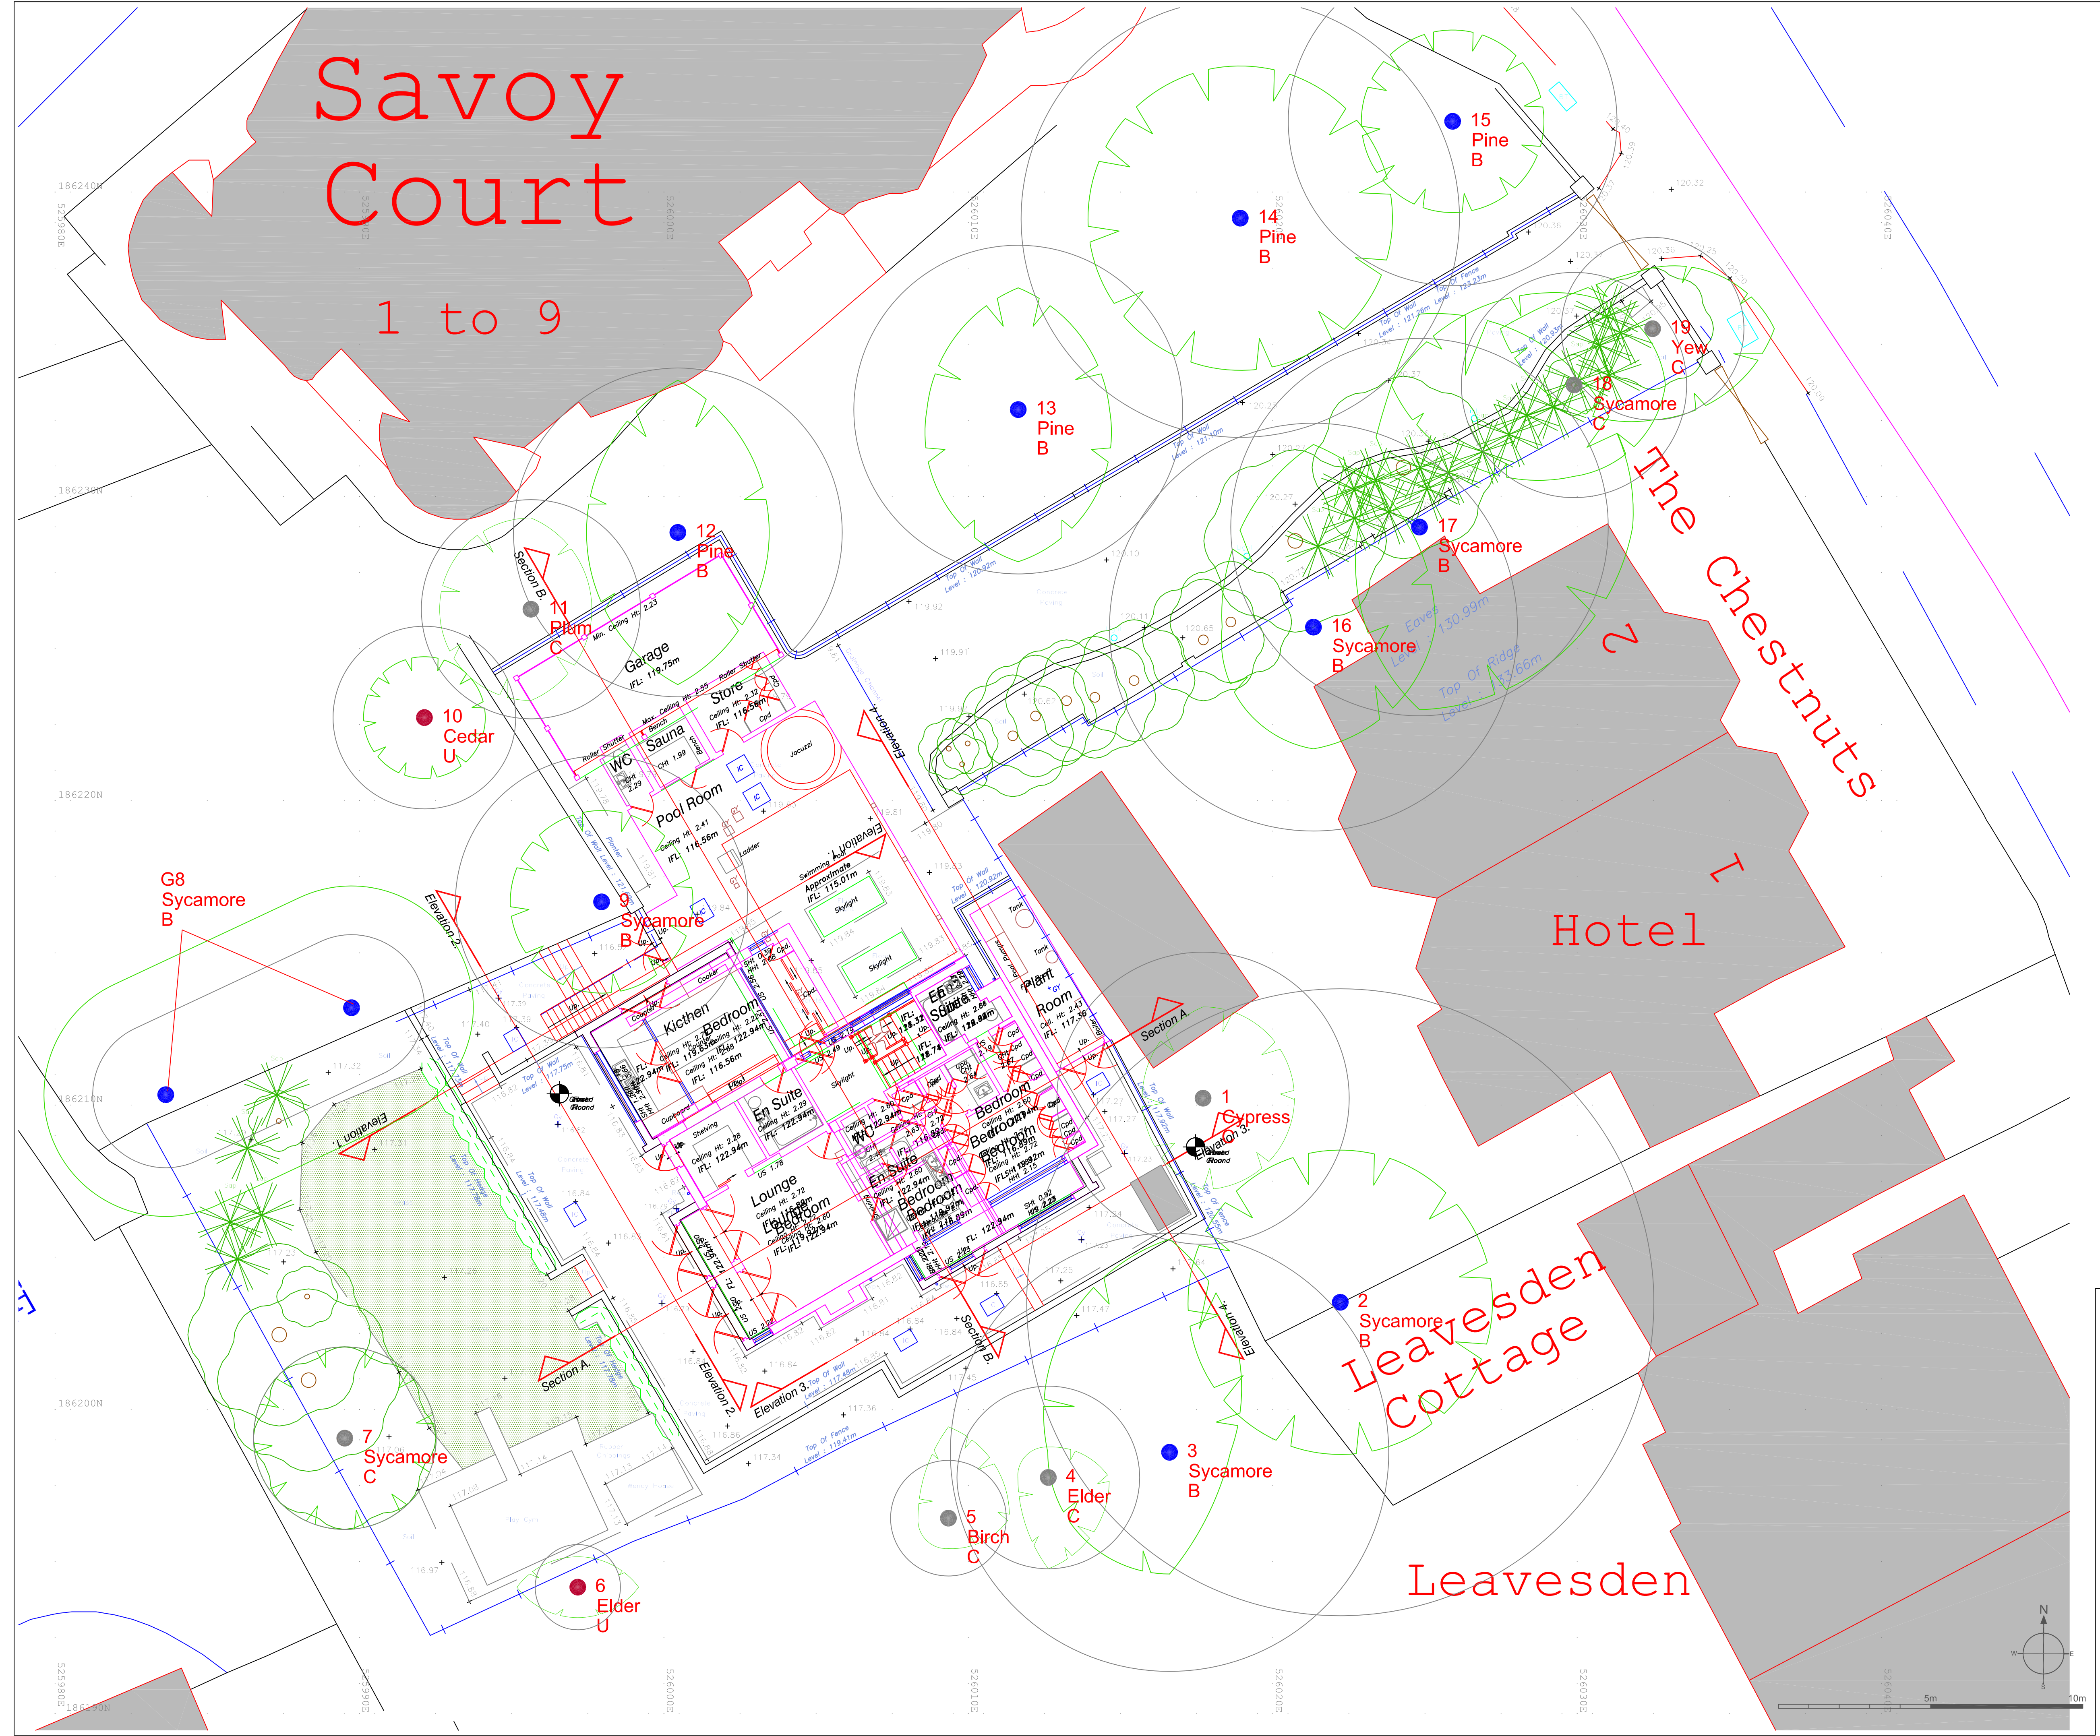
- 4.1.11 In this instance, the potentially significant constraints provided by the off-site category B trees T2, T3, G8, T9 and T12. It is likely that the existing level changes, boundary walls and the existing hard landscaping/build development has effectively minimised the significant roots from the off-site trees, in particular T9. Further investigations are recommended to test this assumption.

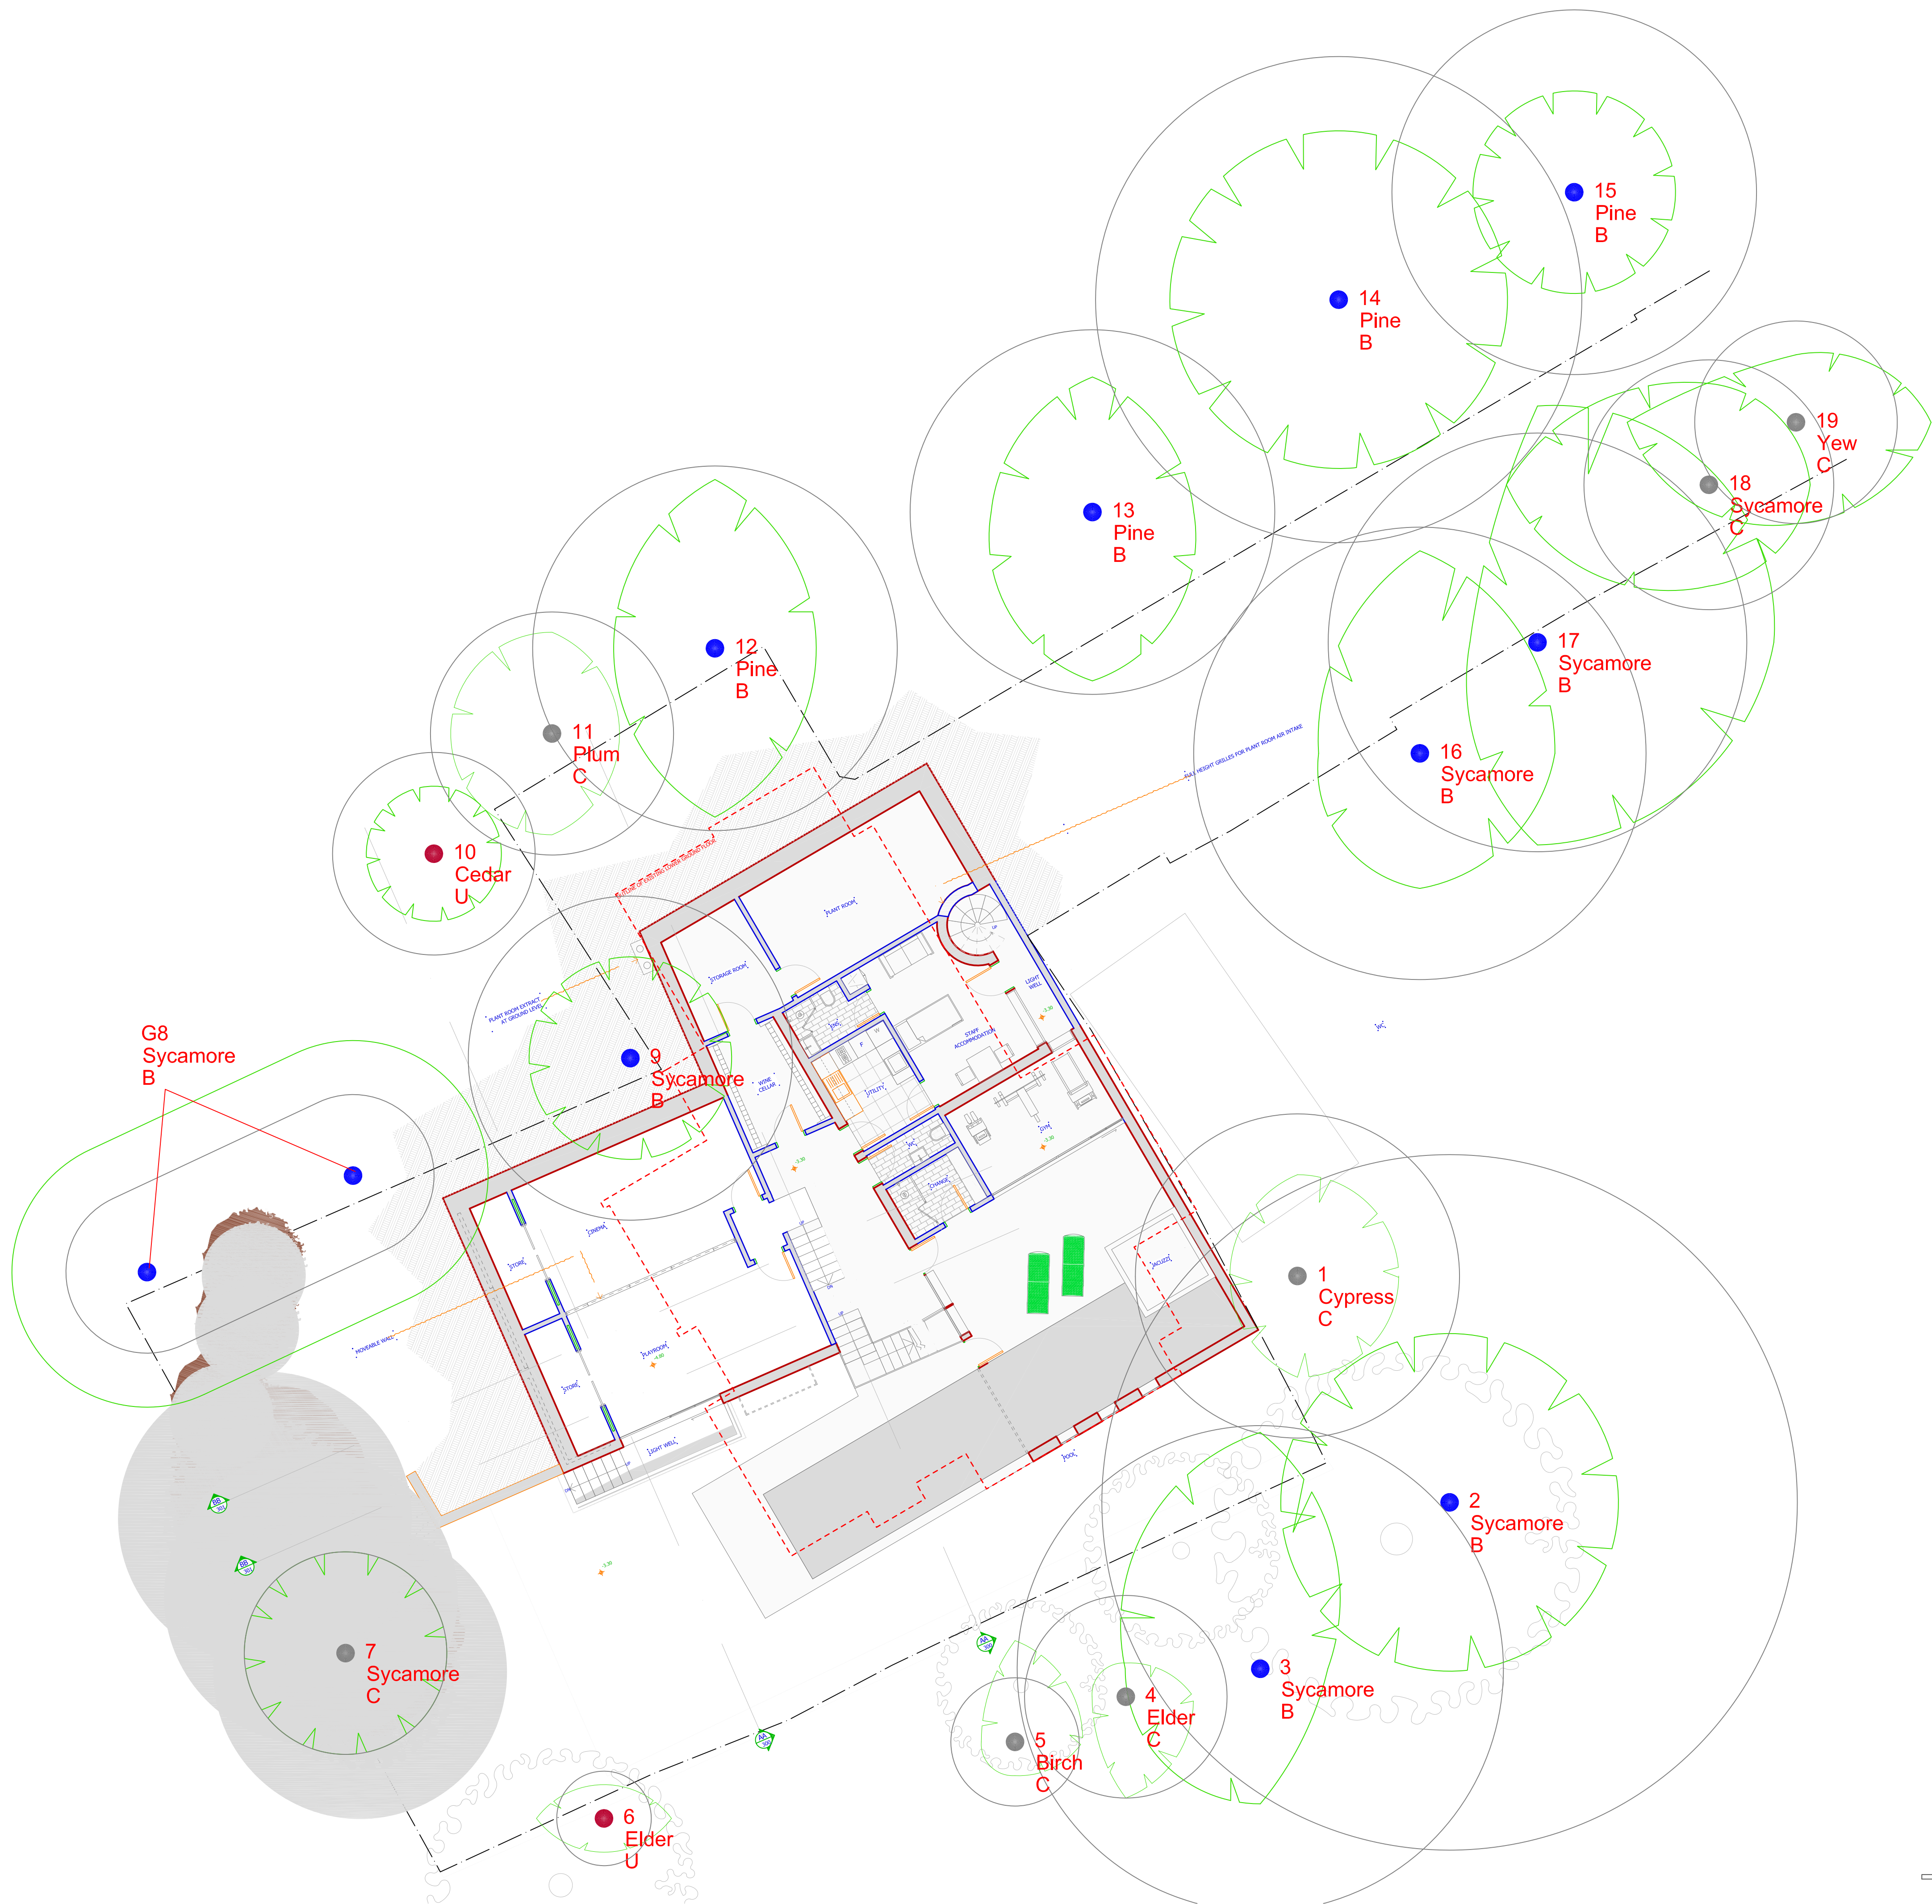
### ARBORICULTURAL IMPACT ASSESSMENT PLAN

- 1.3 The principal primary impacts in the current proposals are summarised as follows:
- T1 - off-site Category C Leyland cypress: Demolition of existing building/hard landscaping within theoretical RPA (16.2%); New basement excavation 8.4m<sup>2</sup> (11.6%) and proposed elevations within overhanging canopy. The overall impact is low as the proposed basement is all existing hard standing with intervening boundary wall. The existing surfaces within the RPA should be removed by airspade/hand (subject to proposed mitigation)

- T9 – off-site Category B (TPO) sycamore: Demolition of existing building/hard landscaping within theoretical RPA totalling 49m<sup>2</sup> (67.7%), but existing basement within 1m of T9's stem (see red dotted line on AIA plan in Appendix 5) and substantive level difference between properties: there is an area of new basement excavation totalling 9.6m<sup>2</sup> (13.3%) of the theoretical RPA and within 1.3m of stem, but the ground in question stands c.3m below the base of the tree on the other side of a retaining wall, so no actual impact is anticipated. Thus the total area affected by elevations and basement at 35.3m<sup>2</sup> (49%) of the RPA, is dismissed as a desktop impact only. It is also worth noting that the total area of proposed development within T9's RPA is lower than the removal of the existing (35m<sup>2</sup> as opposed to 49m<sup>2</sup>). Thus, the theoretical impacts to T9 are rated low / non-existent in practice, although further investigations are recommended to prove this point.

- 6.3.2 The path of new basement foundations through RPAs will be manually excavated to 750mm depth under arboricultural supervision; any roots encountered within the trenches / pits will be cleanly pruned back to an appropriate junction with a sharp pruning saw or secateurs back to a junction. Roots larger than 25mm diameter may only be cut in consultation with an arboriculturalist

- 6.3.3 Any replacement paving/hard landscaping will require a no-dig construction technique, either using a cellular confinement system with no fines aggregate for the sub-base or simply building upon the existing sub-base without disturbing the ground below. Choice of construction method will initially depend upon root penetration within the existing sub-grade. The key principle is not to excavate in the presence of roots and to provide a porous surface to promote healthy soil water relations for future root growth.
