ARBORICULTURAL ASSESSMENT REPORT

For:	Client:	Oriel Services Limited
	Insurer:	[REDACTED]
Site:	Policyholder:	[REDACTED]
	Risk Address:	15 Fairhazel Gardens, London NW6 3QJ
Refs:	OCA Ref:	57572
	Client Ref:	7850065
	Insurer Ref:	[REDACTED]

Report By:	Margaret MacQueen		
Title:	Consultant Arborist	Date:	31 December 2014

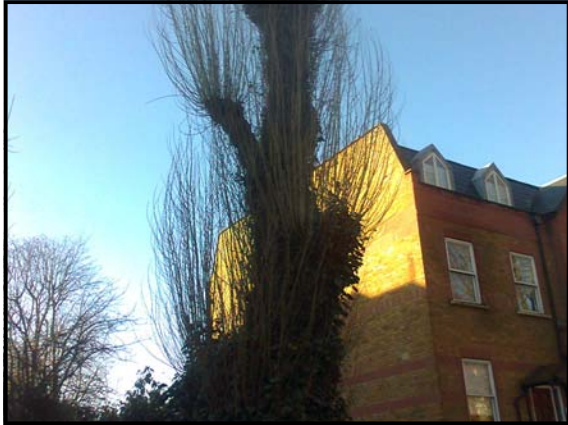
1. T1 Lombardy Poplar

Tree No	Common Name	Age Class	Condition	Height (m)	Crown Spread (m)	Stem diam. (mm)	Dist to bldg (m)	Pruning history	Recommendation	Tree work constraints	Notes	Owner address	Owner
T1	Lombardy Poplar	OM	P	14	3	800	8	Pollard. 2 years' regrowth.	Fell and treat stump.	None	Topped out at 12m	15 Fairhazel Gardens, London, NW6 3QJ	PH
T2	London Plane	MA	F	18	10	600	0.25	Reduced >5 years ago	Fell and treat stump.	None	Past topped out at 10m	70 Aberdare Gardens, London, NW6 3QD	P3P
T3	London Plane	MA	F	18	10	600	3	Reduced >5 years ago	No work required.	N/A		70 Aberdare Gardens, London, NW6 3QD	P3P
T4	London Plane	MA	F	18	10	600	5	Reduced >5 years ago	No work required.	N/A		70 Aberdare Gardens, London, NW6 3QD	P3P
T5	London Plane	MA	F	18	10	600	8	Reduced >5 years ago	No work required.	N/A		70 Aberdare Gardens, London, NW6 3QD	P3P
T6	London Plane	MA	F	18	10	600	12	No significant past tree works	No work required.	N/A		70 Aberdare Gardens, London, NW6 3QD	P3P

Tree No:	Species	Works Required
T1	Lombardy Poplar	Fell and treat stump
T2	London Plane	Fell and treat stump

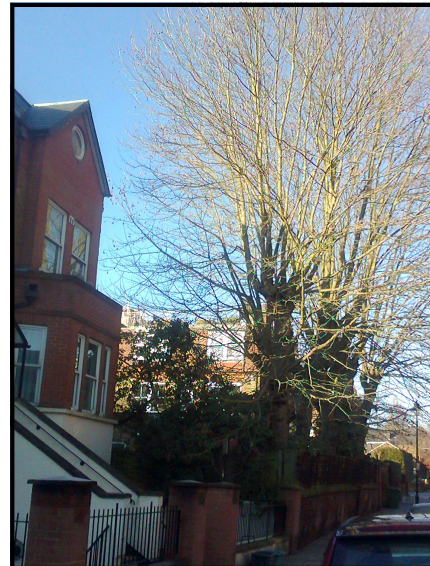
4. T2 to T7 looking north

T7	London Plane	MA	F	18	10	600	14	Reduced >5 years ago	No work required.	N/A		70 Aberdare Gardens, London, NW6 3QD	P3P
