**Feasibility Report**

**Works to Rear Garden  
Boundary Wall**

**1-3 Englands Lane,  
London NW3 4YA**

**London Borough of Camden**

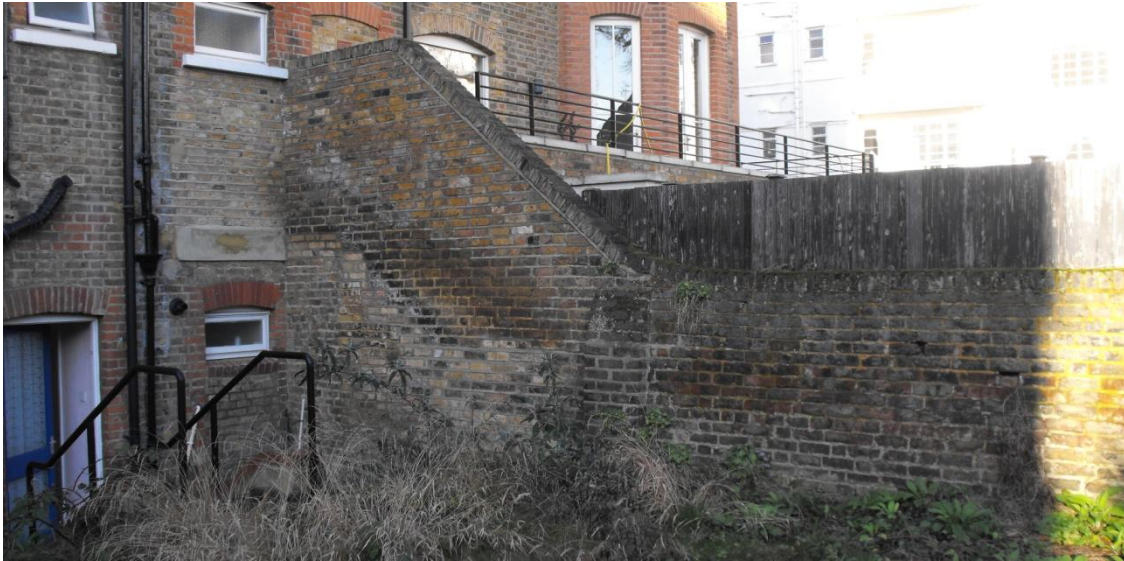
#### 3.2 Section A: Between the House and the First Pier (Figure one)

3.2.1 The brickwork joins into the property at high level (approximately 4m above ground level), sloping down to approximately 1.47m above ground level at the first pier. This section of the wall at the time of the survey showed minimal deflection.

*Figure 1: Sections A&B, damp patches visible*

3.2.2 It is assumed that external steps adjoin the wall on the side of No.1 (although this needs to be confirmed) with damp patches on the side of No. 3 suggesting that water is soaking through the brickwork. There is also a small damp section on the rear wall of No.3 at first floor level.

3.2.3 Apart from the damp patches the brickwork to this area is in good condition and the pointing has been renewed recently.

3.2.4 It is recommended that this section of wall has additional investigations carried out to the side of No.1 to identify the source of the damp and to identify if any preventative measures are required and practicable. No other works to this part of the wall are recommended at this time.

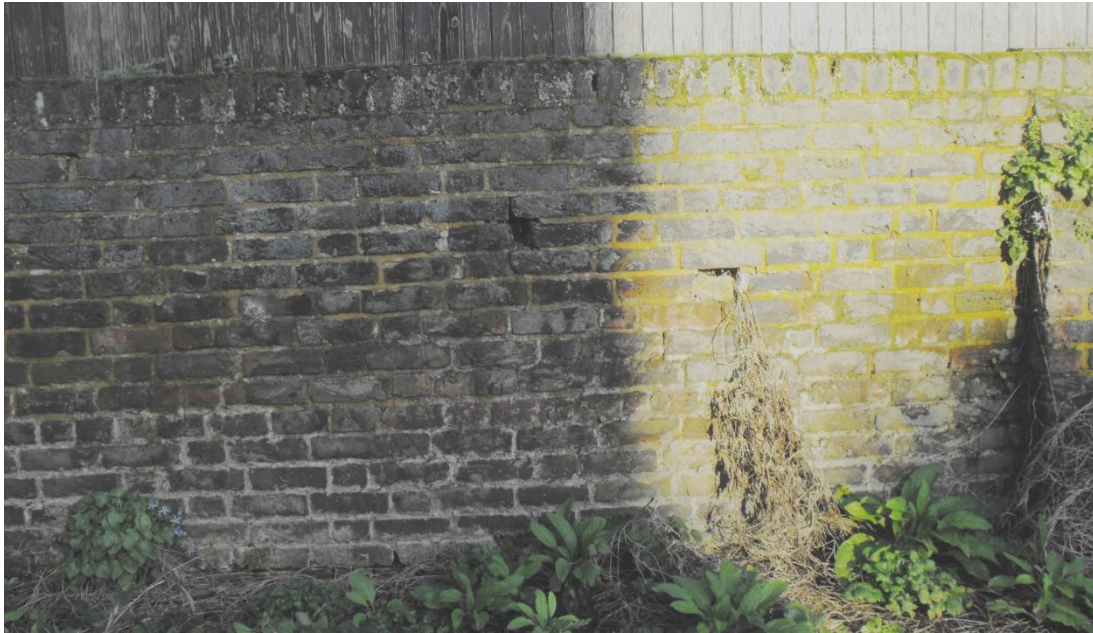
### 3.3 Section B: Between the First Pier and the Second Pier (Figure 2)

- 3.3.1 The lower level wall to Section B (approximately 1.47m above ground level) has timber fence panels above. The pointing is in good condition to this area. The brickwork condition is reasonable, but contains 2no voids where bricks are missing. The centre of the wall between the piers has noticeable deflection at approximately 30-50mm towards No.1.

**Figure 2: Section B, note missing bricks**

- 3.3.2 It is recommended that this section of wall is dismantled and rebuilt with suitable foundations.
- 3.3.3 The timber fence above the wall is in poor decorative condition, but does not show signs of decay. It is recommended that it is treated with preservative.

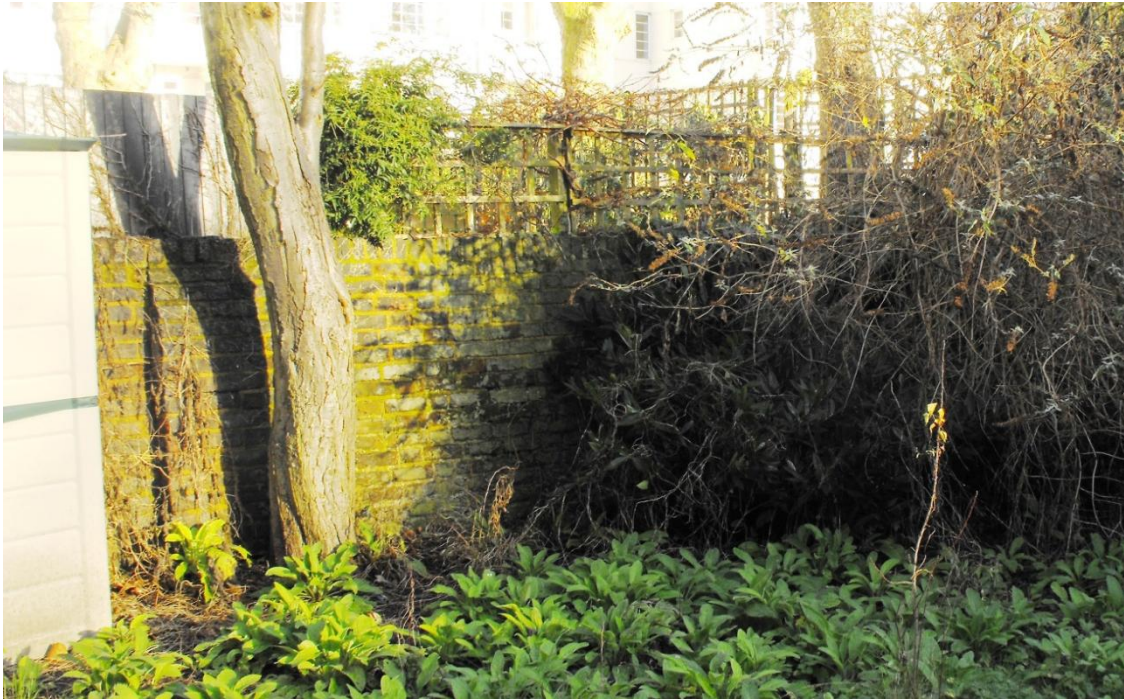
### 3.4 Section C: Between the Second and Third Pier (Figure 3)

- 3.4.1 The wall continues in the same construction as Section B. The brickwork and pointing to this area is in poorer condition than previously noted, especially at low level.
- 3.4.2 The third pier is deflecting towards No.1 by more than 100mm. This is likely to be caused by the root action of the adjacent tree (see section 3.5 below), which is touching the pier, and likely to be exacerbated by shallow foundations. Cracking was not noted in this area. *Figure 3* below shows the close proximity of the tree to the wall.

**Figure 3: Third pier and adjacent tree.**

3.4.3 It is recommended that

- i. the wall carefully dismantled;
- ii. new foundations constructed and wall reconstructed to the same height and appearance as existing.
