**Record photographs of internal redecoration and minor works in progress.**

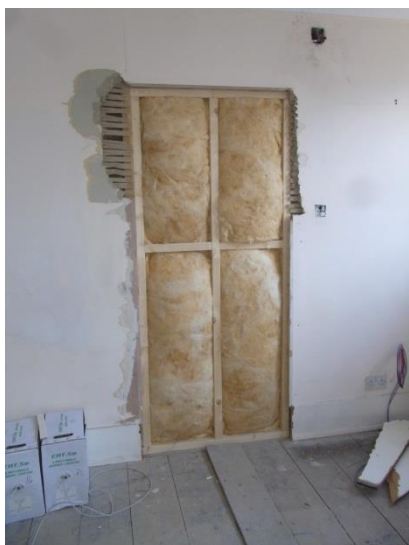
3<sup>rd</sup> Floor. Recent opening between small and large front rooms closed off. (Ref. 7).

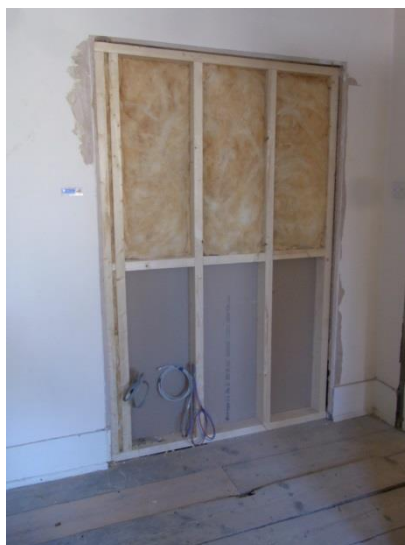
3<sup>rd</sup> Floor. Recent opening between large front and rear rooms closed off. (Ref. 6).

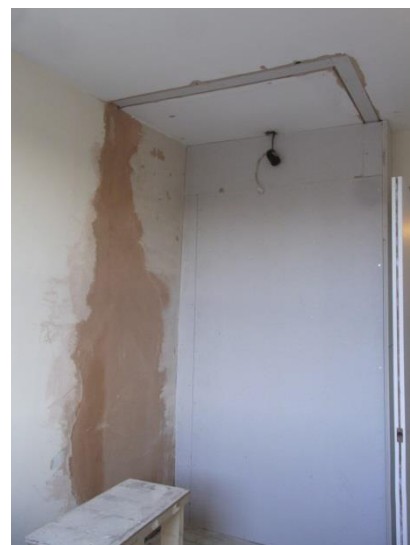
3<sup>rd</sup> Floor. Plasterboard partition between rear small room and wc relocated. (Ref. 4).

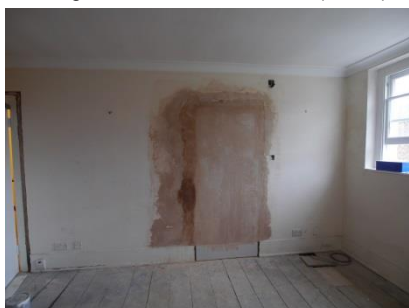
3<sup>rd</sup> Floor. Recent opening between small and large front rooms closed off. (Ref. 7).

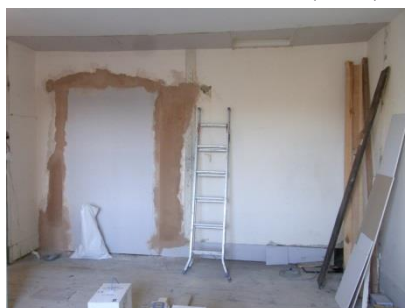
3<sup>rd</sup> Floor. Recent opening between large front and rear rooms closed off. (Ref. 6).

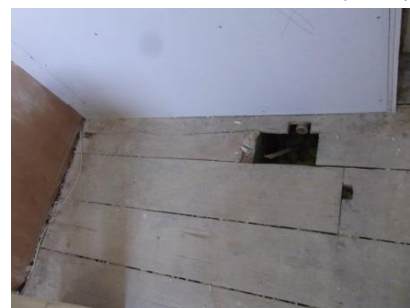
3<sup>rd</sup> Floor. Original floorboards beneath plasterboard partition. (Ref 4).

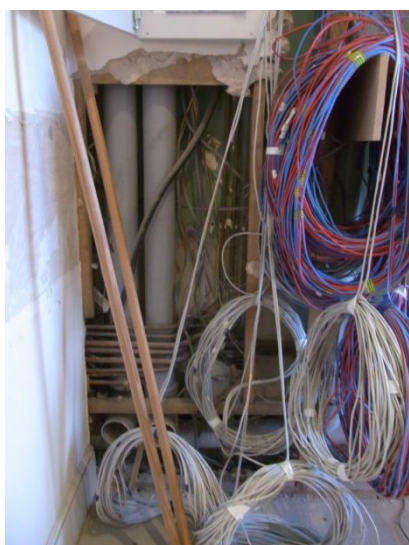
2<sup>nd</sup> Floor. Wiring and pipework behind plasterboard false wall. (Ref. 3).

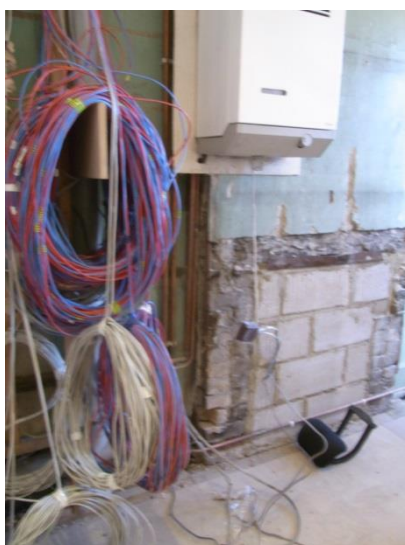
2<sup>nd</sup> Floor. Wiring and pipework behind plasterboard false wall. (Ref. 3).

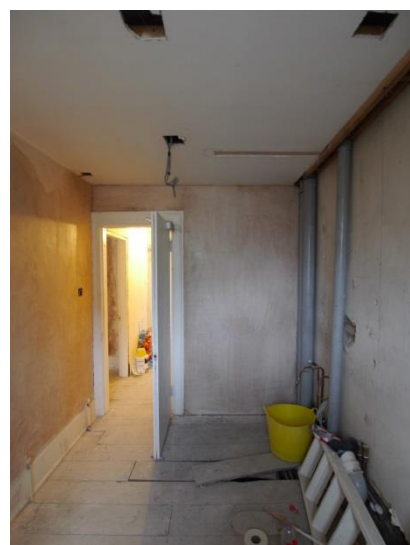
3<sup>rd</sup> Floor older plasterboard added around door opening, on top of laths. (Ref.9)

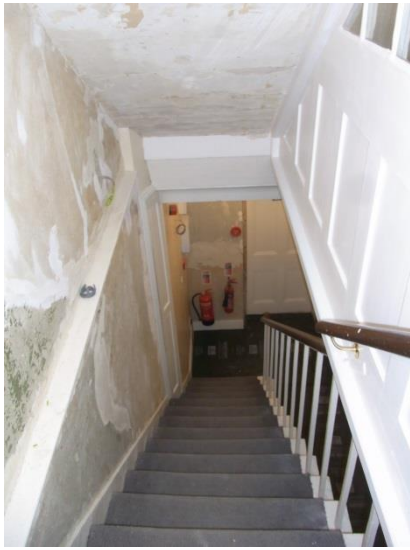
Basement Staircase redecoration.  
Panelling revealed.

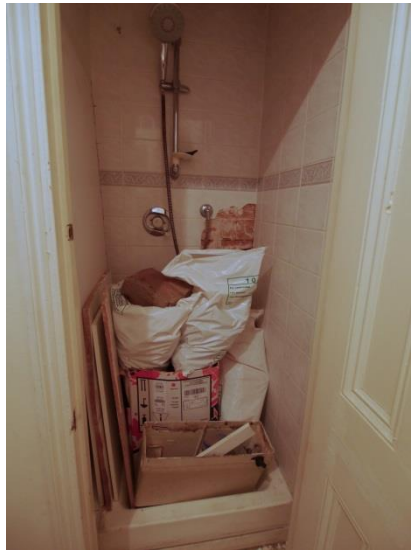
Basement Shower room to be stripped out.  
(Ref. 2).

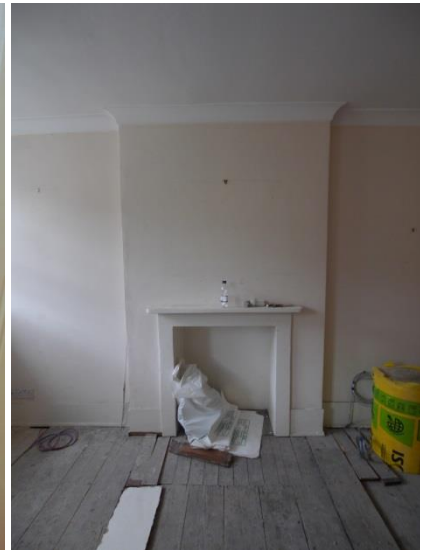
2<sup>nd</sup> Floor - recent cornices, original  
fireplaces and skirtings.

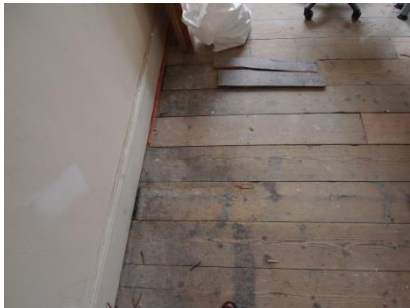
Existing floorboards repaired.

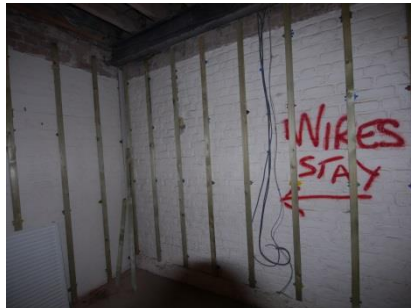
Basement annexe. Plasterboard dry lining.

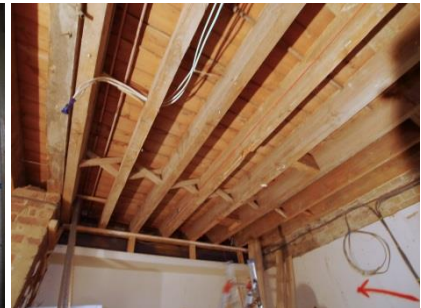
Basement annexe exposing non-original  
ceiling/floor joists. (Ref. 1)
