Report No: S28233
Refurbishment Inspection

43-45 BEDFORD SQUARE
London

EC Harris LLP

Date: 04/08/2011

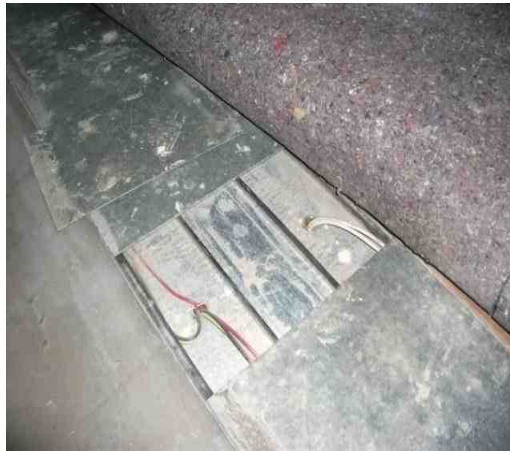
Description: Debris
Extent: 9lm
Product Type: Debris
Damage: N/A
Surface Treatment: N/A
Asbestos Type: **No Asbestos Detected**

Recommendations: N/A

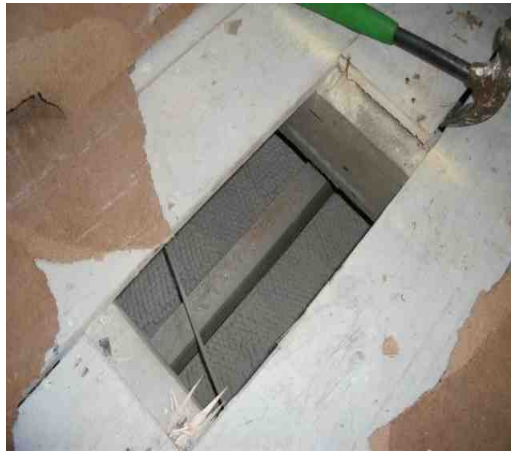
Description: Debris
Extent: 40sqm
Product Type: Debris
Damage: N/A
Surface Treatment: N/A
Asbestos Type: **No Asbestos Detected**

Recommendations: N/A

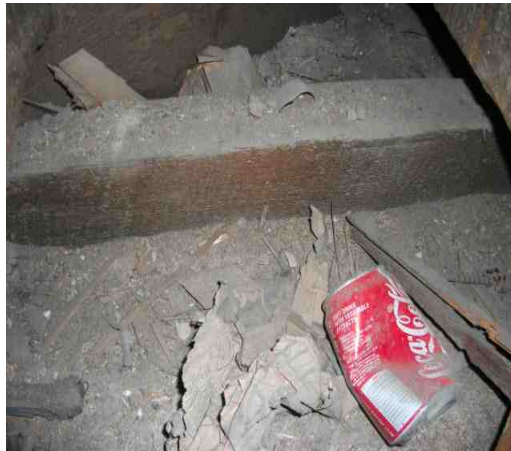
Description: Debris A
Extent: 40sqm
Product Type: Debris
Damage: N/A
Surface Treatment: N/A
Asbestos Type: **No Asbestos Detected**

Recommendations: N/A

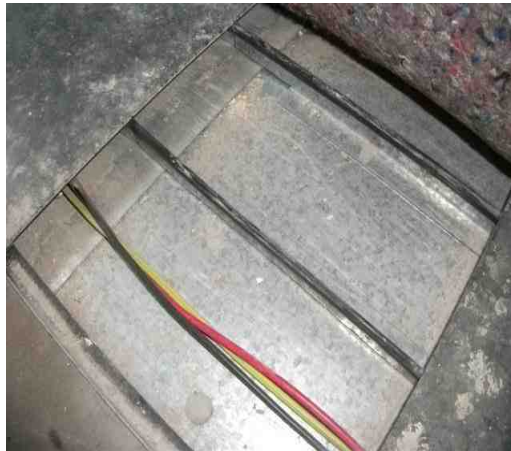
Description: Debris A
Extent: 9lm
Product Type: Debris
Damage: N/A
Surface Treatment: N/A
Asbestos Type: **No Asbestos Detected**

Recommendations: N/A

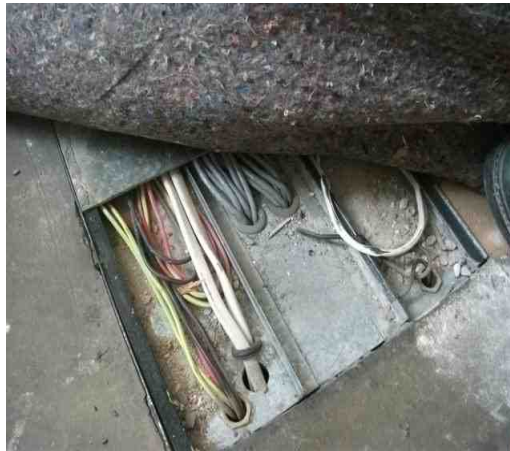
Description: Debris
Extent: 2lm
Product Type: Debris
Damage: N/A
Surface Treatment: N/A
Asbestos Type: **No Asbestos Detected**

Recommendations: N/A

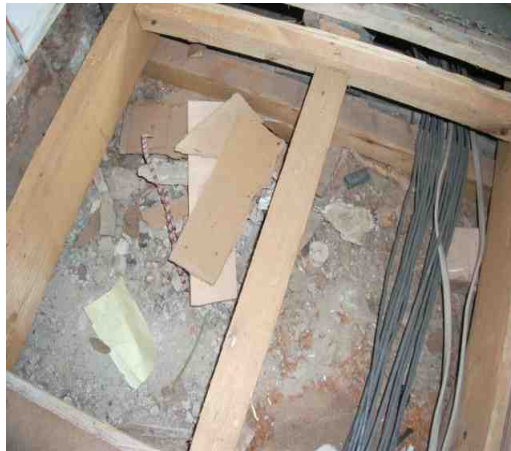
Description: Debris
Extent: 10sqm
Product Type: Debris
Damage: N/A
Surface Treatment: N/A
Asbestos Type: **No Asbestos Detected**

Recommendations: N/A

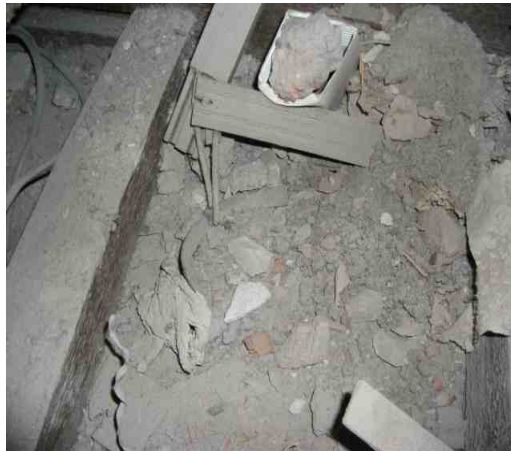
Description: Debris
Extent: 40sqm
Product Type: Debris
Damage: N/A
Surface Treatment: N/A
Asbestos Type: **No Asbestos Detected**

Recommendations: N/A

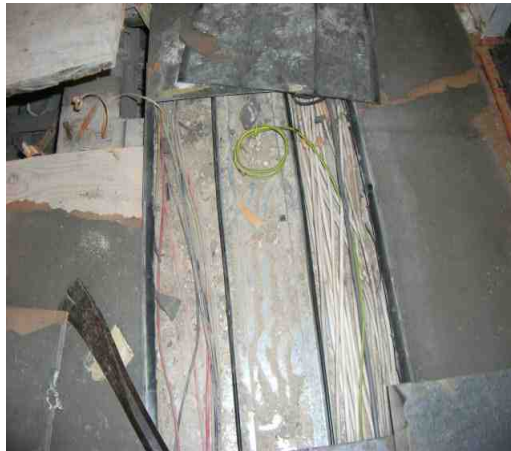
Description:	Debris	
Extent:	10lm	Score:
Product Type:	Debris	3
Damage:	High damage or delamination of materials, sprays & lagging, Visible debris	3
Surface Treatment	Unsealed Laggings & Sprays	3
Asbestos Type	Chrysotile	1
Material Assessment Score		10

Recommendations: Remove (Restrict Access to Material)

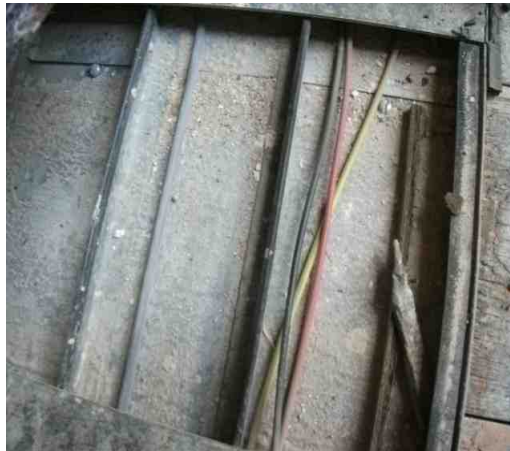
Description: Debris
Extent: 10lm
Product Type: Debris
Damage: N/A
Surface Treatment: N/A
Asbestos Type: **No Asbestos Detected**

Recommendations: N/A

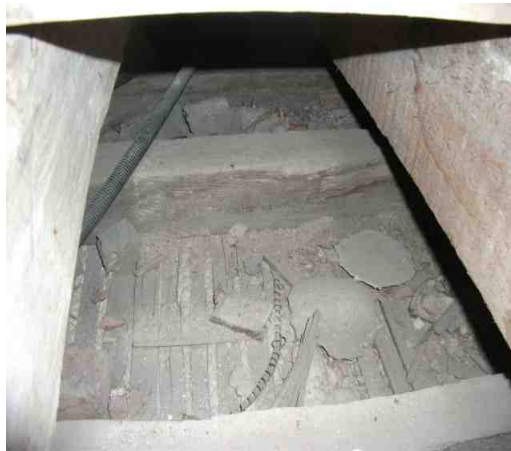
Description: Debris
Extent: 50sqm
Product Type: Debris
Damage: N/A
Surface Treatment: N/A
Asbestos Type: **No Asbestos Detected**

Recommendations: N/A

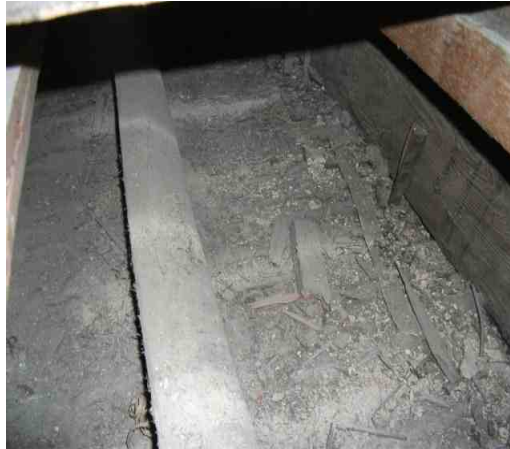
Description: Debris
Extent: 60sqm
Product Type: Debris
Damage: N/A
Surface Treatment: N/A
Asbestos Type: **No Asbestos Detected**

Recommendations: N/A

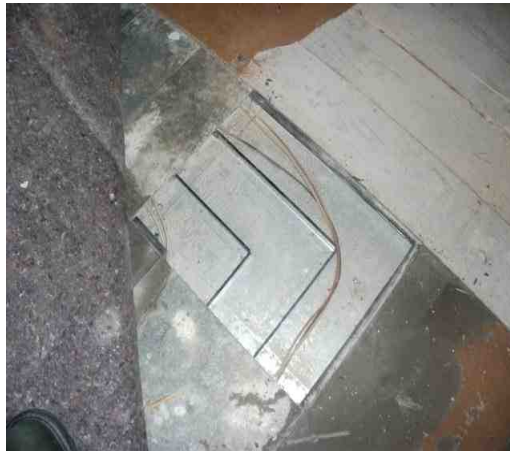
Description: Debris
Extent: 10lm
Product Type: Debris
Damage: N/A
Surface Treatment: N/A
Asbestos Type: **No Asbestos Detected**

Recommendations: N/A

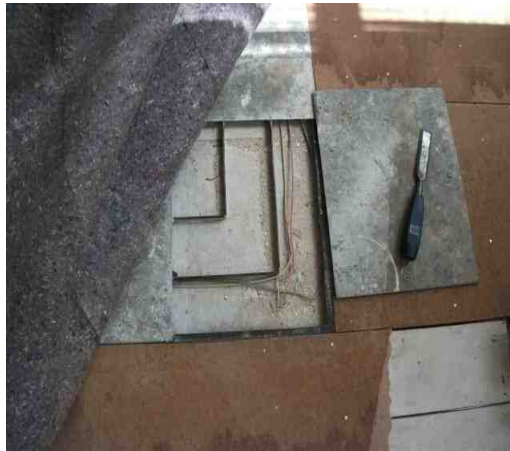
Description: Debris A
Extent: 10lm
Product Type: Debris
Damage: N/A
Surface Treatment: N/A
Asbestos Type: **No Asbestos Detected**

Recommendations: N/A

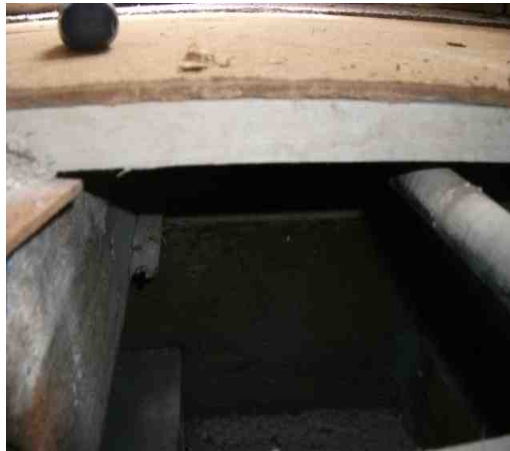
Description: Debris A
Extent: 60sqm
Product Type: Debris
Damage: N/A
Surface Treatment: N/A
Asbestos Type: **No Asbestos Detected**

Recommendations: N/A

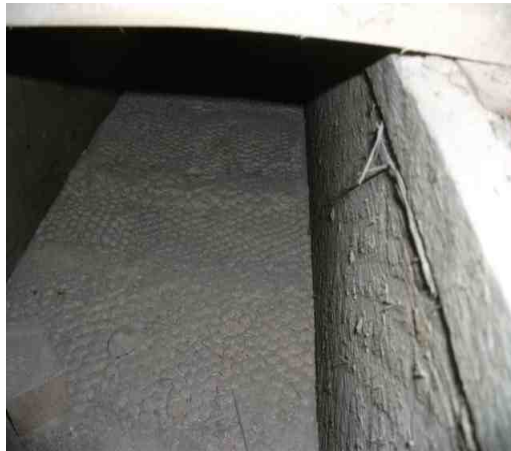
Description: Debris
Extent: 9sqm
Product Type: Debris
Damage: N/A
Surface Treatment: N/A
Asbestos Type: **No Asbestos Detected**

Recommendations: N/A

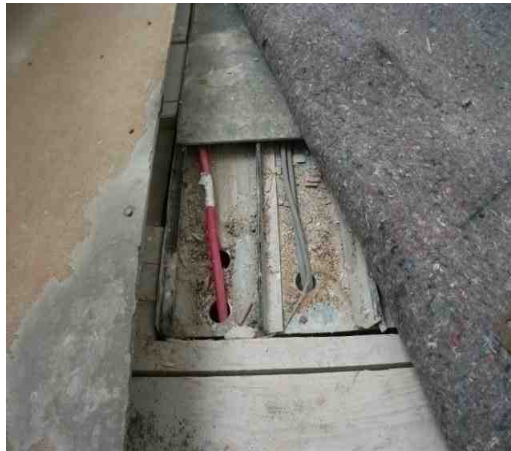
Description: Debris
Extent: 3lm
Product Type: Debris
Damage: N/A
Surface Treatment: N/A
Asbestos Type: **No Asbestos Detected**

Recommendations: N/A

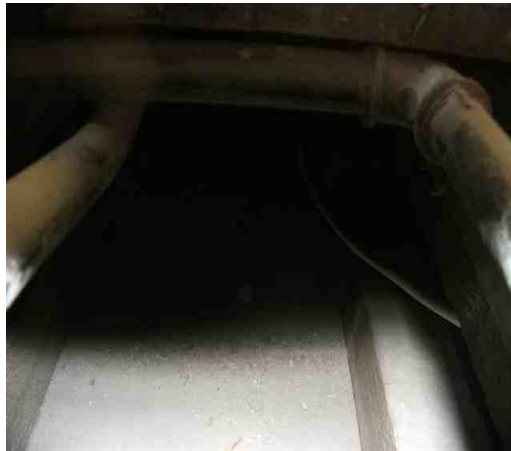
Description: Debris
Extent: 40sqm
Product Type: Debris
Damage: N/A
Surface Treatment: N/A
Asbestos Type: **No Asbestos Detected**

Recommendations: N/A

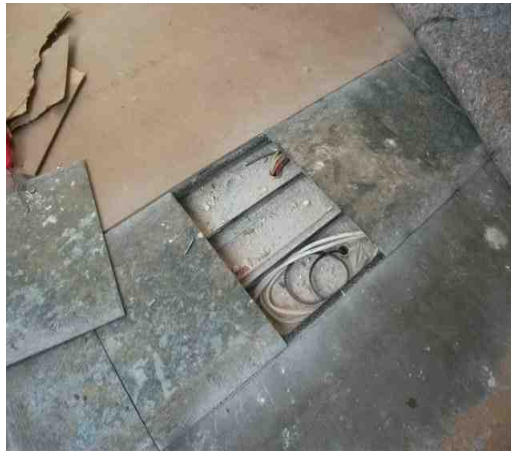
Description: Debris
Extent: 10lm
Product Type: Debris
Damage: N/A
Surface Treatment: N/A
Asbestos Type: **No Asbestos Detected**

Recommendations: N/A

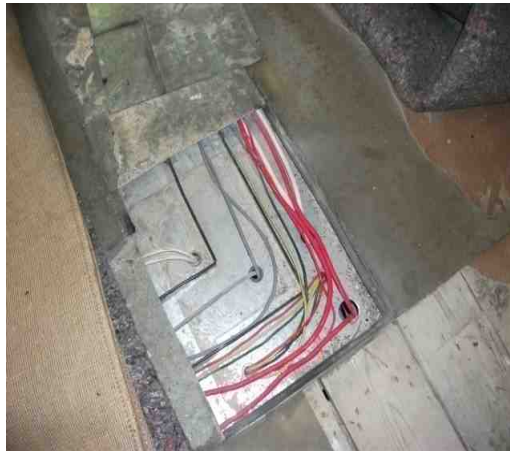
Description: Debris
Extent: 20lm
Product Type: Debris
Damage: N/A
Surface Treatment: N/A
Asbestos Type: **No Asbestos Detected**

Recommendations: N/A

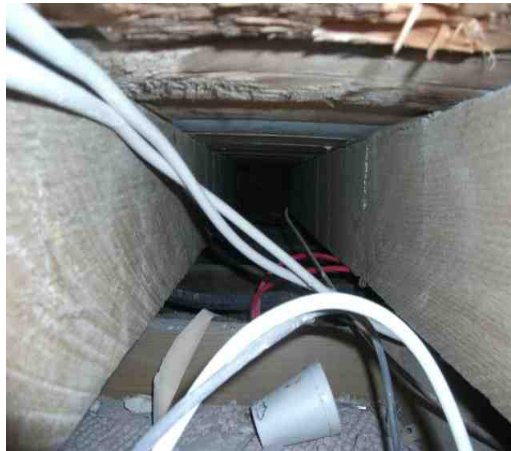
Description:	Debris	
Extent:	50sqm	Score:
Product Type:	Debris	3
Damage:	High damage or delamination of materials, sprays & lagging, Visible debris	3
Surface Treatment	Unsealed Laggings & Sprays	3
Asbestos Type	Chrysotile	1
Material Assessment Score		10

Recommendations: Remove (Restrict Access to Material)

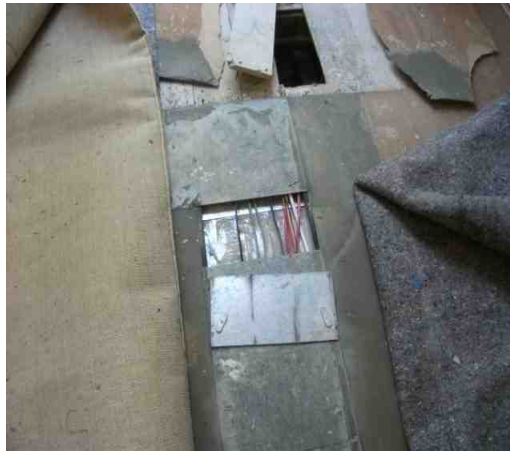
Description: Debris A
Extent: 20lm
Product Type: Debris
Damage: N/A
Surface Treatment: N/A
Asbestos Type: **No Asbestos Detected**

Recommendations: N/A

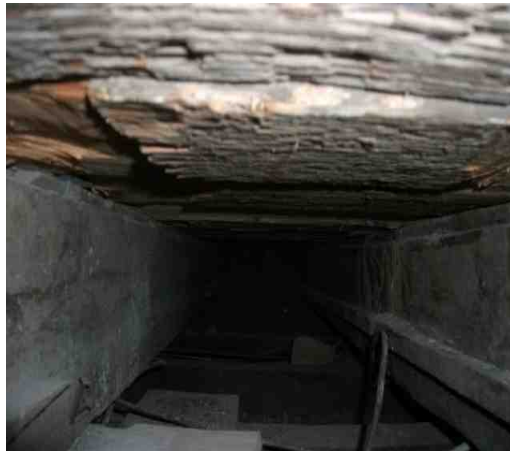
Description: Debris A
Extent: 50sqm
Product Type: Debris
Damage: N/A
Surface Treatment: N/A
Asbestos Type: **No Asbestos Detected**

Recommendations: N/A

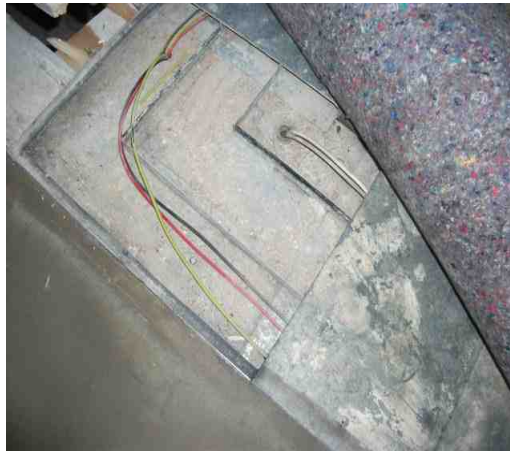
Description:	Debris B	
Extent:	20lm	Score:
Product Type:	Debris	3
Damage:	High damage or delamination of materials, sprays & lagging, Visible debris	3
Surface Treatment	Unsealed Laggings & Sprays	3
Asbestos Type	Chrysotile	1
Material Assessment Score		10

Recommendations: Remove (Restrict Access to Material)

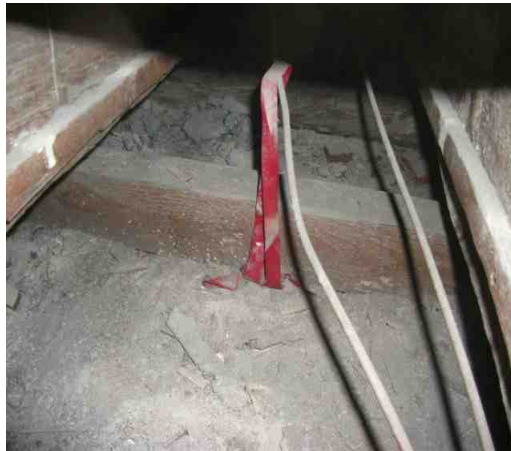
Description: Debris B
Extent: 50sqm
Product Type: Debris
Damage: N/A
Surface Treatment: N/A
Asbestos Type: **No Asbestos Detected**

Recommendations: N/A

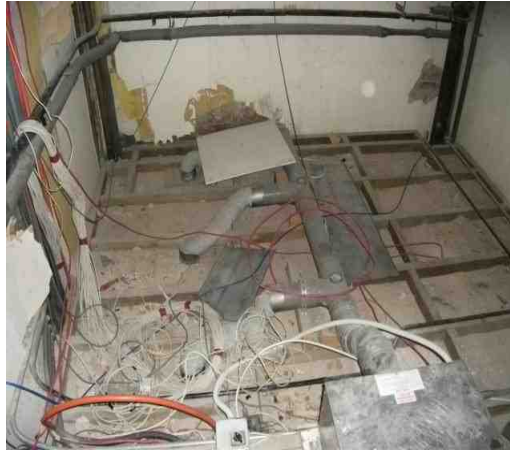
Description: Debris
Extent: 12sqm
Product Type: Debris
Damage: N/A
Surface Treatment: N/A
Asbestos Type: **No Asbestos Detected**

Recommendations: N/A

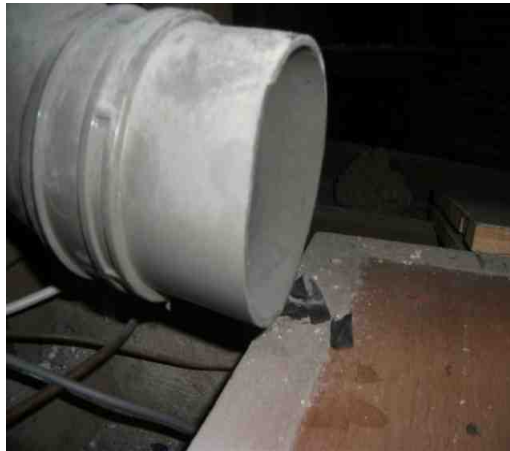
Description:	Debris	
Extent:	9lm	Score:
Product Type:	Debris	3
Damage:	High damage or delamination of materials, sprays & lagging, Visible debris	3
Surface Treatment	Unsealed Laggings & Sprays	3
Asbestos Type	Chrysotile	1
Material Assessment Score		10

Recommendations: Remove (Restrict Access to Material)

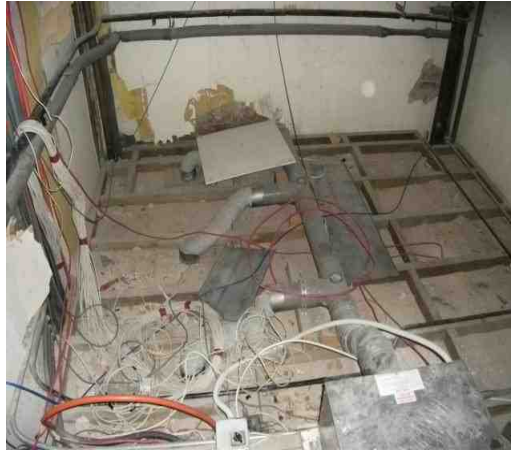
Description: All materials
Extent:
Product Type:
Damage: N/A
Surface Treatment: N/A
Asbestos Type: **No Asbestos Detected**

Recommendations: N/A
