| Christ Church | | |
| Hampstead | | |
| South Elevation | | |
| Proposed Repairs | | |

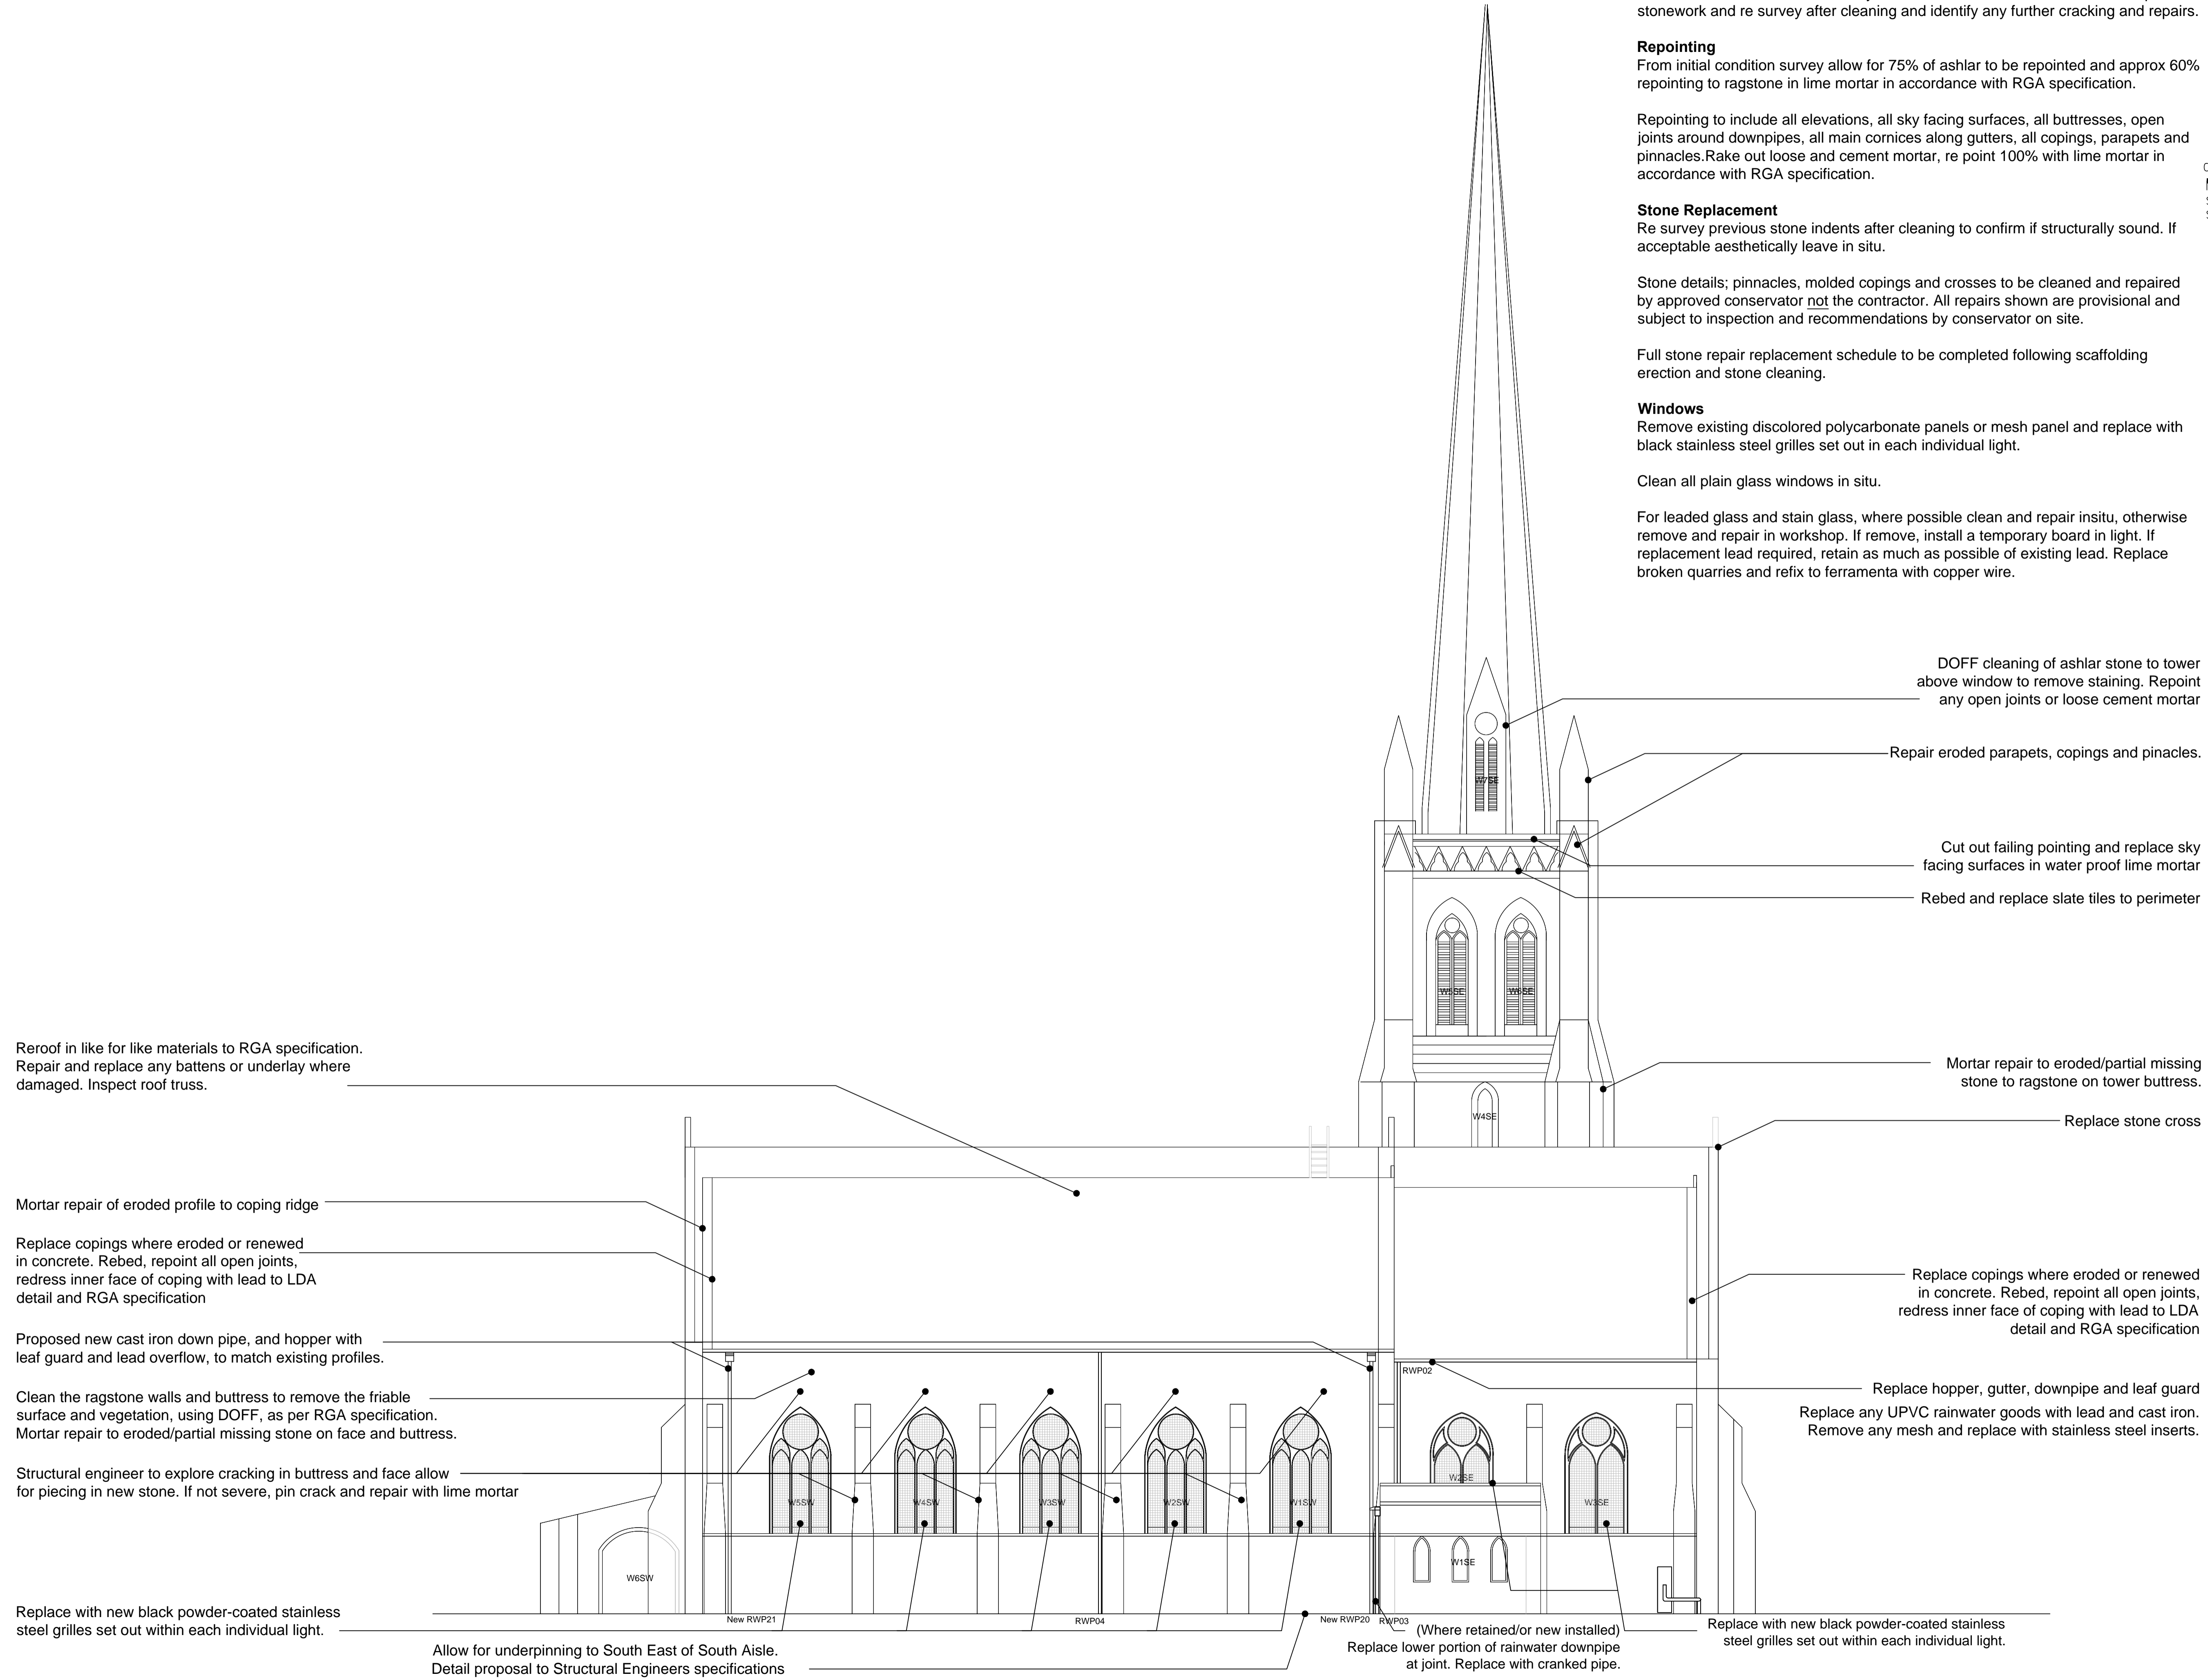
Mortar repair of eroded profile to coping ridge

Clean the ragstone walls and buttress to remove the friable surface and vegetation, using DOFF, as per RGA specification. Mortar repair to eroded/partial missing stone on face and buttress.

Structural engineer to explore cracking in buttress and face allow for piecing in new stone. If not severe, pin crack and repair with lime mortar

Allow for underpinning to South East of South Aisle. Detail proposal to Structural Engineers specifications

Repair eroded parapets, copings and pinnacles.

Mortar repair to eroded/partial missing stone to ragstone on tower buttress.

Reroof in like for like materials to RGA specification. Repair and replace any battens or underlay where damaged. Inspect roof truss.

Replace copings where eroded or renewed in concrete. Rebed, repoint all open joints, redress inner face of coping with lead to LDA detail and RGA specification

Proposed new cast iron down pipe, and hopper with leaf guard and lead overflow, to match existing profiles.

Replace with new black powder-coated stainless steel grilles set out within each individual light.

(Where retained/or new installed) Replace lower portion of rainwater downpipe at joint. Replace with cranked pipe.

DOFF cleaning of ashlar stone to tower above window to remove staining. Repoint any open joints or loose cement mortar

Cut out failing pointing and replace sky facing surfaces in water proof lime mortar

Rebed and replace slate tiles to perimeter

Replace stone cross

Replace hopper, gutter, downpipe and leaf guard. Replace any UPVC rainwater goods with lead and cast iron. Remove any mesh and replace with stainless steel inserts.
