**FOR PLANNING**

JOB TITLE		
Christ Church Hampstead		
DRAWING TITLE		
East Elevation		
Proposed Repairs		
JOB No	DWG No	REV
537A	D04	A
DRAWN BY	SCALE (AT A1)	DATE
JMc	1:100 (1:200@A3)	Dec14

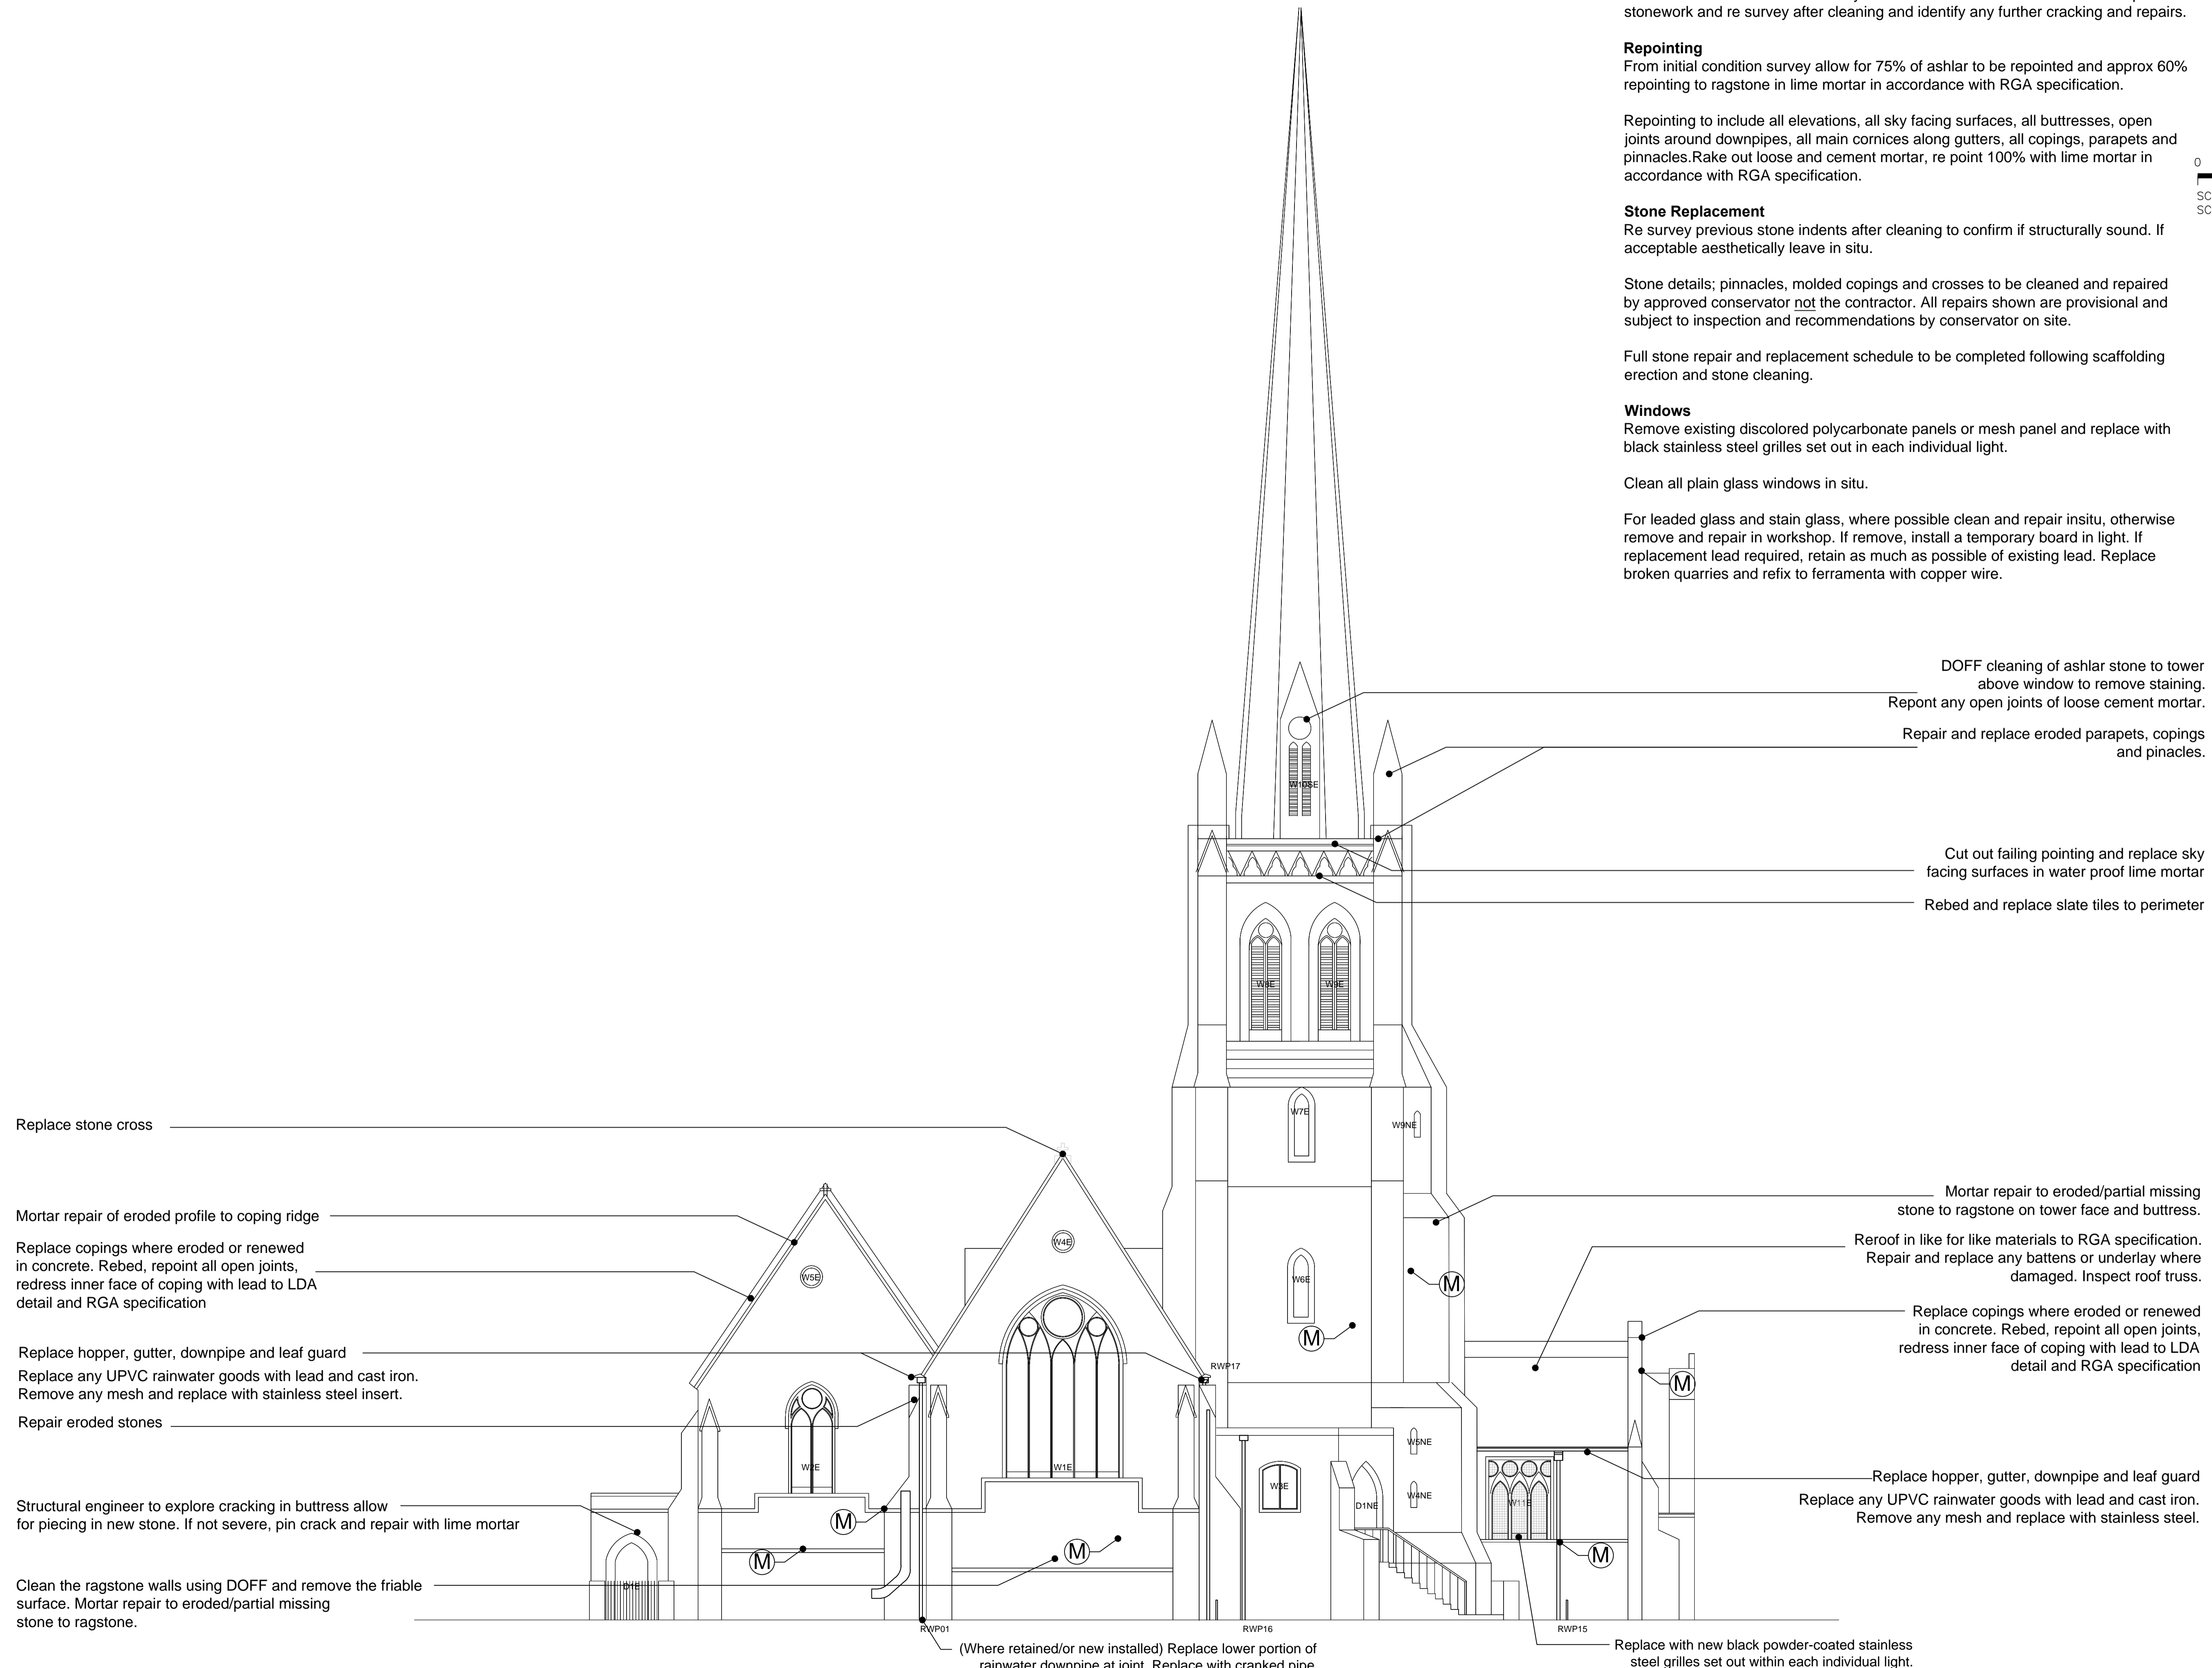
Missing Stone - mortar repair or key in replacement stone

Black powder coated stainless steel grilles

DOFF cleaning of ashlar stone to tower above window to remove staining. Repoint any open joints of loose cement mortar.  
 Repair and replace eroded parapets, copings and pinnacles.  
 Cut out failing pointing and replace sky facing surfaces in water proof lime mortar  
 Rebed and replace slate tiles to perimeter

Replace stone cross  
 Mortar repair of eroded profile to coping ridge  
 Replace copings where eroded or renewed in concrete. Rebed, repoint all open joints, redress inner face of coping with lead to LDA detail and RGA specification  
 Replace hopper, gutter, downpipe and leaf guard  
 Replace any UPVC rainwater goods with lead and cast iron. Remove any mesh and replace with stainless steel insert.  
 Repair eroded stones  
 Structural engineer to explore cracking in buttress allow for piecing in new stone. If not severe, pin crack and repair with lime mortar  
 Clean the ragstone walls using DOFF and remove the friable surface. Mortar repair to eroded/partial missing stone to ragstone.

Mortar repair to eroded/partial missing stone to ragstone on tower face and buttress.  
 Reroof in like for like materials to RGA specification. Repair and replace any battens or underlay where damaged. Inspect roof truss.  
 Replace copings where eroded or renewed in concrete. Rebed, repoint all open joints, redress inner face of coping with lead to LDA detail and RGA specification

Replace hopper, gutter, downpipe and leaf guard  
 Replace any UPVC rainwater goods with lead and cast iron. Remove any mesh and replace with stainless steel.

(Where retained/or new installed) Replace lower portion of rainwater downpipe at joint. Replace with cranked pipe.  
 Replace with new black powder-coated stainless steel grilles set out within each individual light.
