| Christ Church Hampstead | | |
| East Elevation | | |
| Existing Condition | | |
| 537A | SU04 | A |

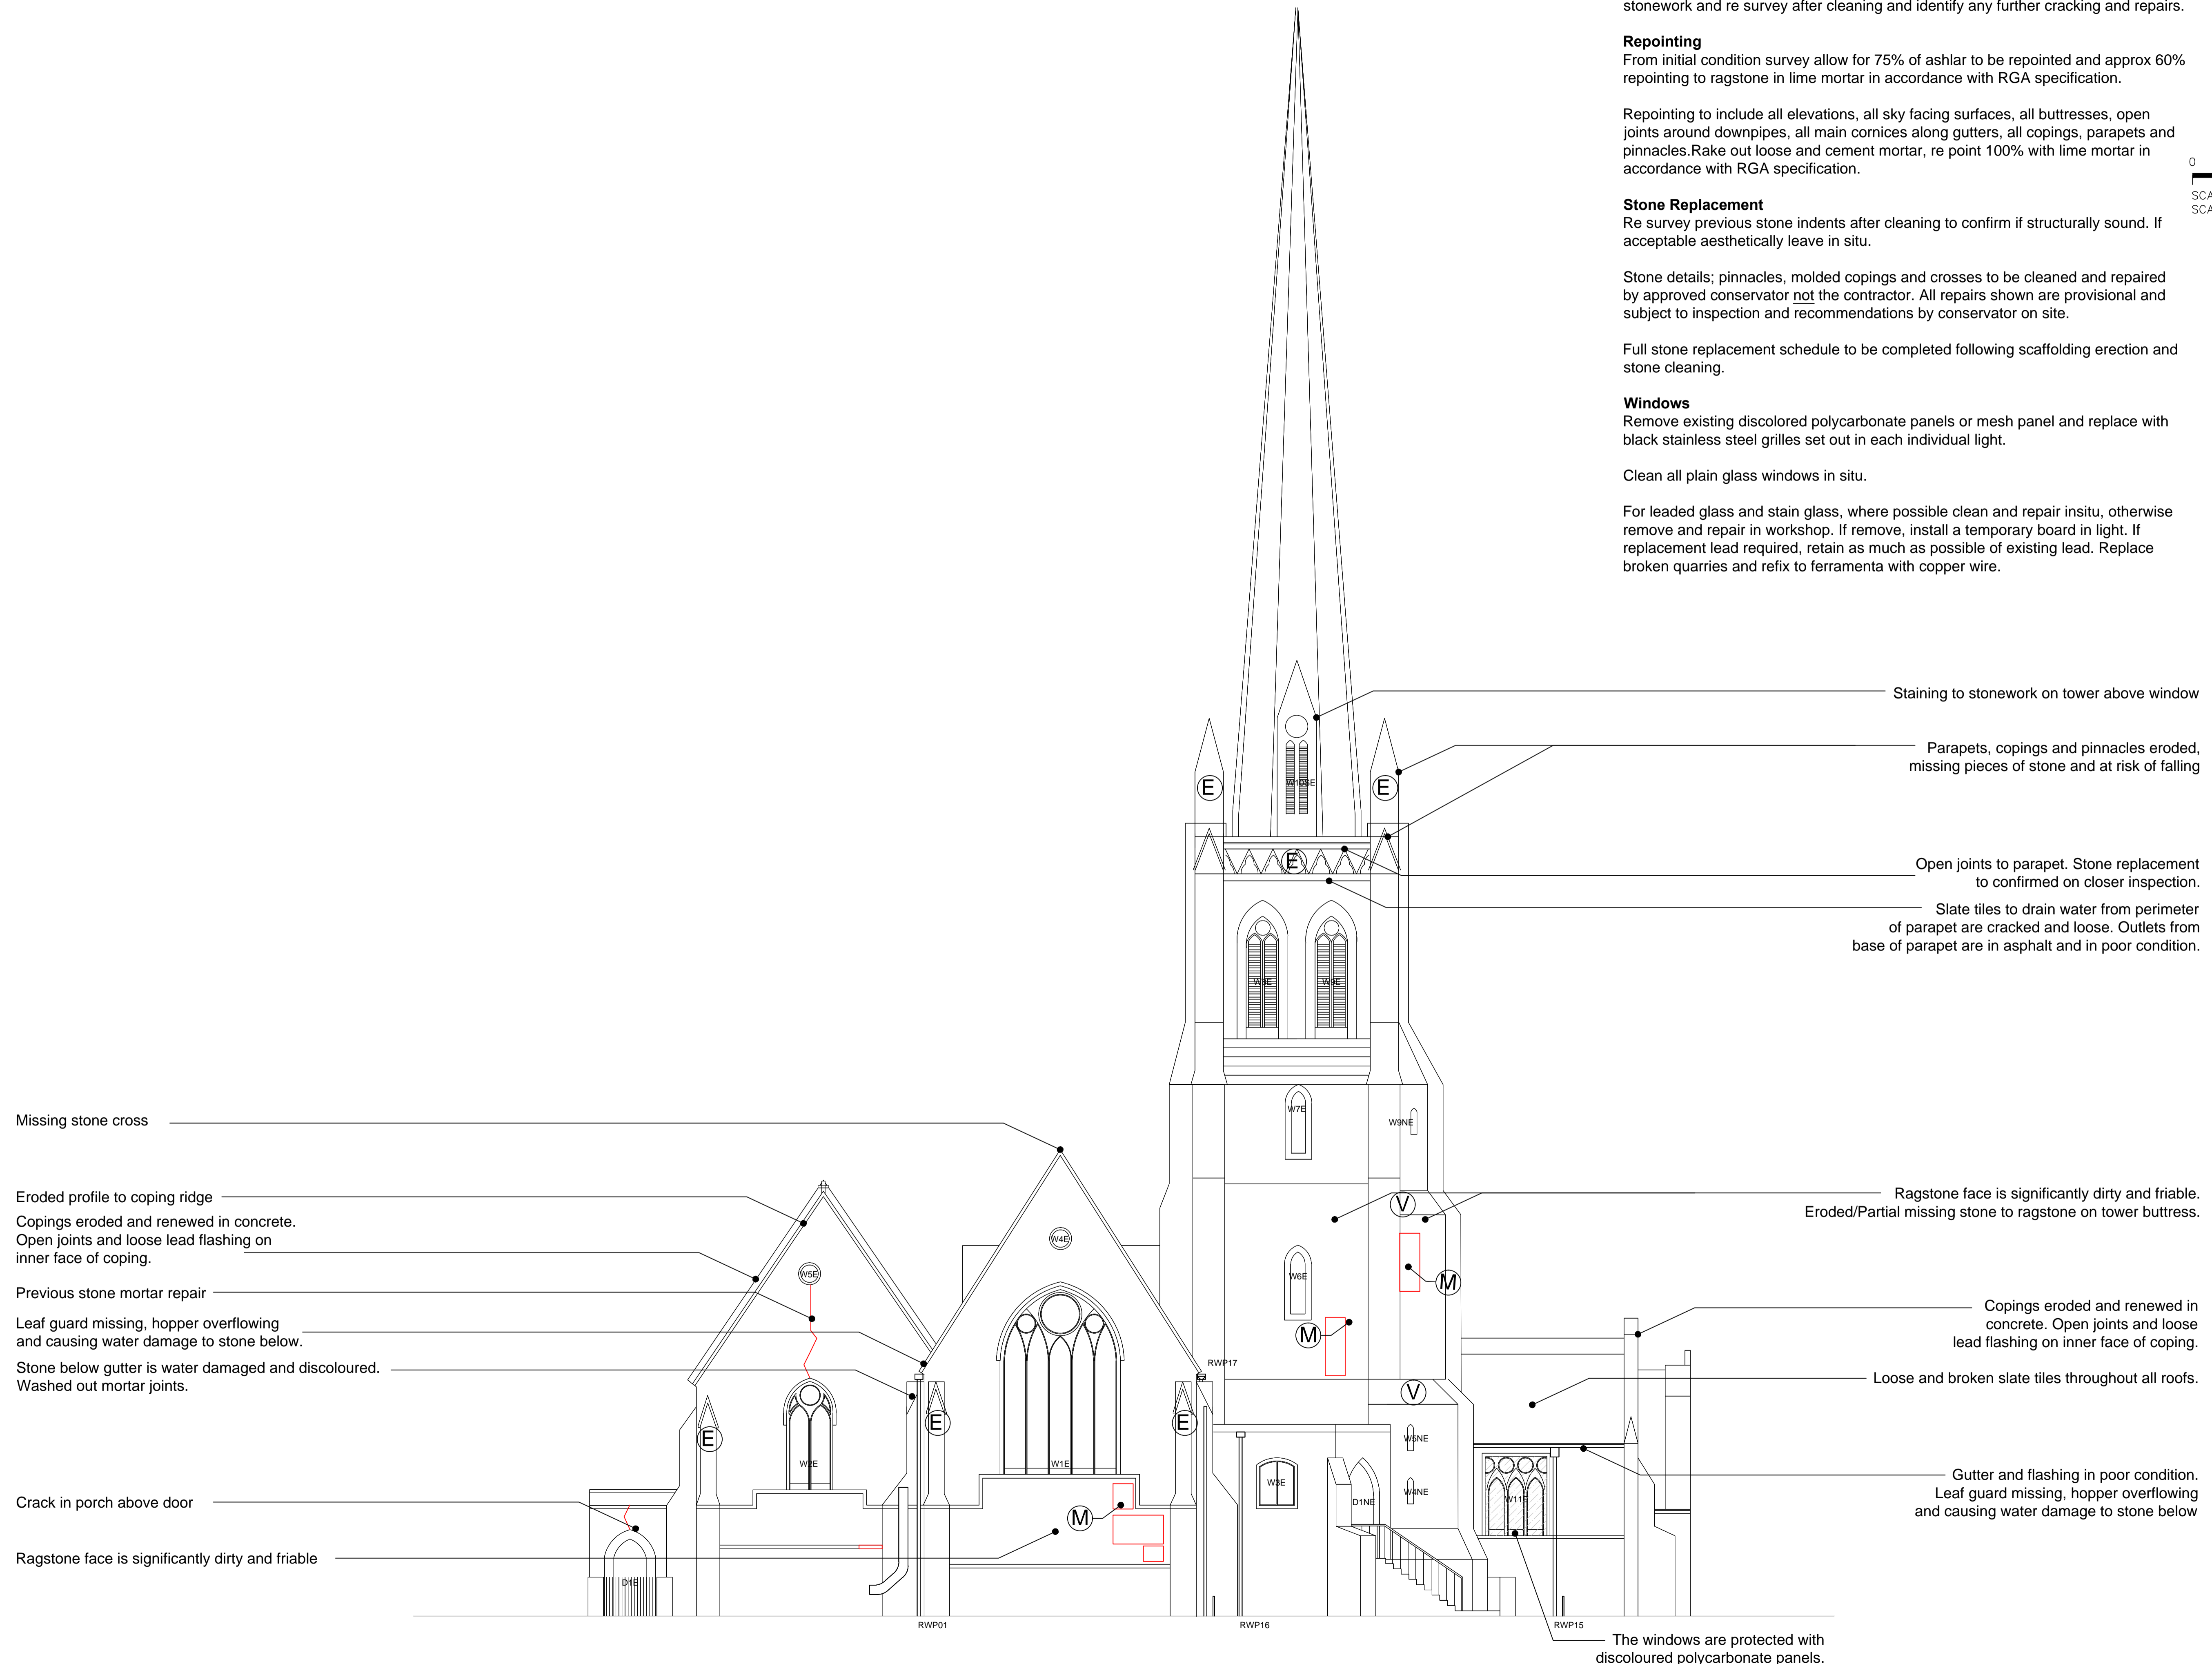
Existing grey metal mesh
-

Existing polycarbonate panel

Vegetation - Algae/Moss build up
-

Missing Stone - Partial or whole stone missing
-

Eroded Stone - Due to weathering/water damage

Due to limited roof access, inspection undertaken from ground level and tower parapet. Carry out a closer roof inspection, by scaffolding, to ascertain any repairs required to slates, battens, underlay, gutters and flashing's. Replace slates and lead flashing to all areas of roof as RGA condition survey and specification and LDA recommendations.

All areas to be DOFF cleaned early in contract. Conservation Architect to explore stonework and re survey after cleaning and identify any further cracking and repairs.

From initial condition survey allow for 75% of ashlar to be repointed and approx 60% repointing to ragstone in lime mortar in accordance with RGA specification.

Repointing to include all elevations, all sky facing surfaces, all buttresses, open joints around downpipes, all main cornices along gutters, all copings, parapets and pinnacles. Rake out loose and cement mortar, re point 100% with lime mortar in accordance with RGA specification.

Re survey previous stone indents after cleaning to confirm if structurally sound. If acceptable aesthetically leave in situ.

Stone details; pinnacles, molded copings and crosses to be cleaned and repaired by approved conservator not the contractor. All repairs shown are provisional and subject to inspection and recommendations by conservator on site.

Remove existing discoloured polycarbonate panels or mesh panel and replace with black stainless steel grilles set out in each individual light.

For leaded glass and stain glass, where possible clean and repair insitu, otherwise remove and repair in workshop. If remove, install a temporary board in light. If replacement lead required, retain as much as possible of existing lead. Replace broken quarries and refix to ferramenta with copper wire.
