FOR DAC

JOB TITLE		
Christ Church Hampstead		
DRAWING TITLE		
North Elevation Existing Condition		
JOB NO	DWG NO	REV
537A	SU05	A
DRAWN BY	SCALE (AT A1)	DATE
JMc	1:100 (1:200@A3)	Dec14

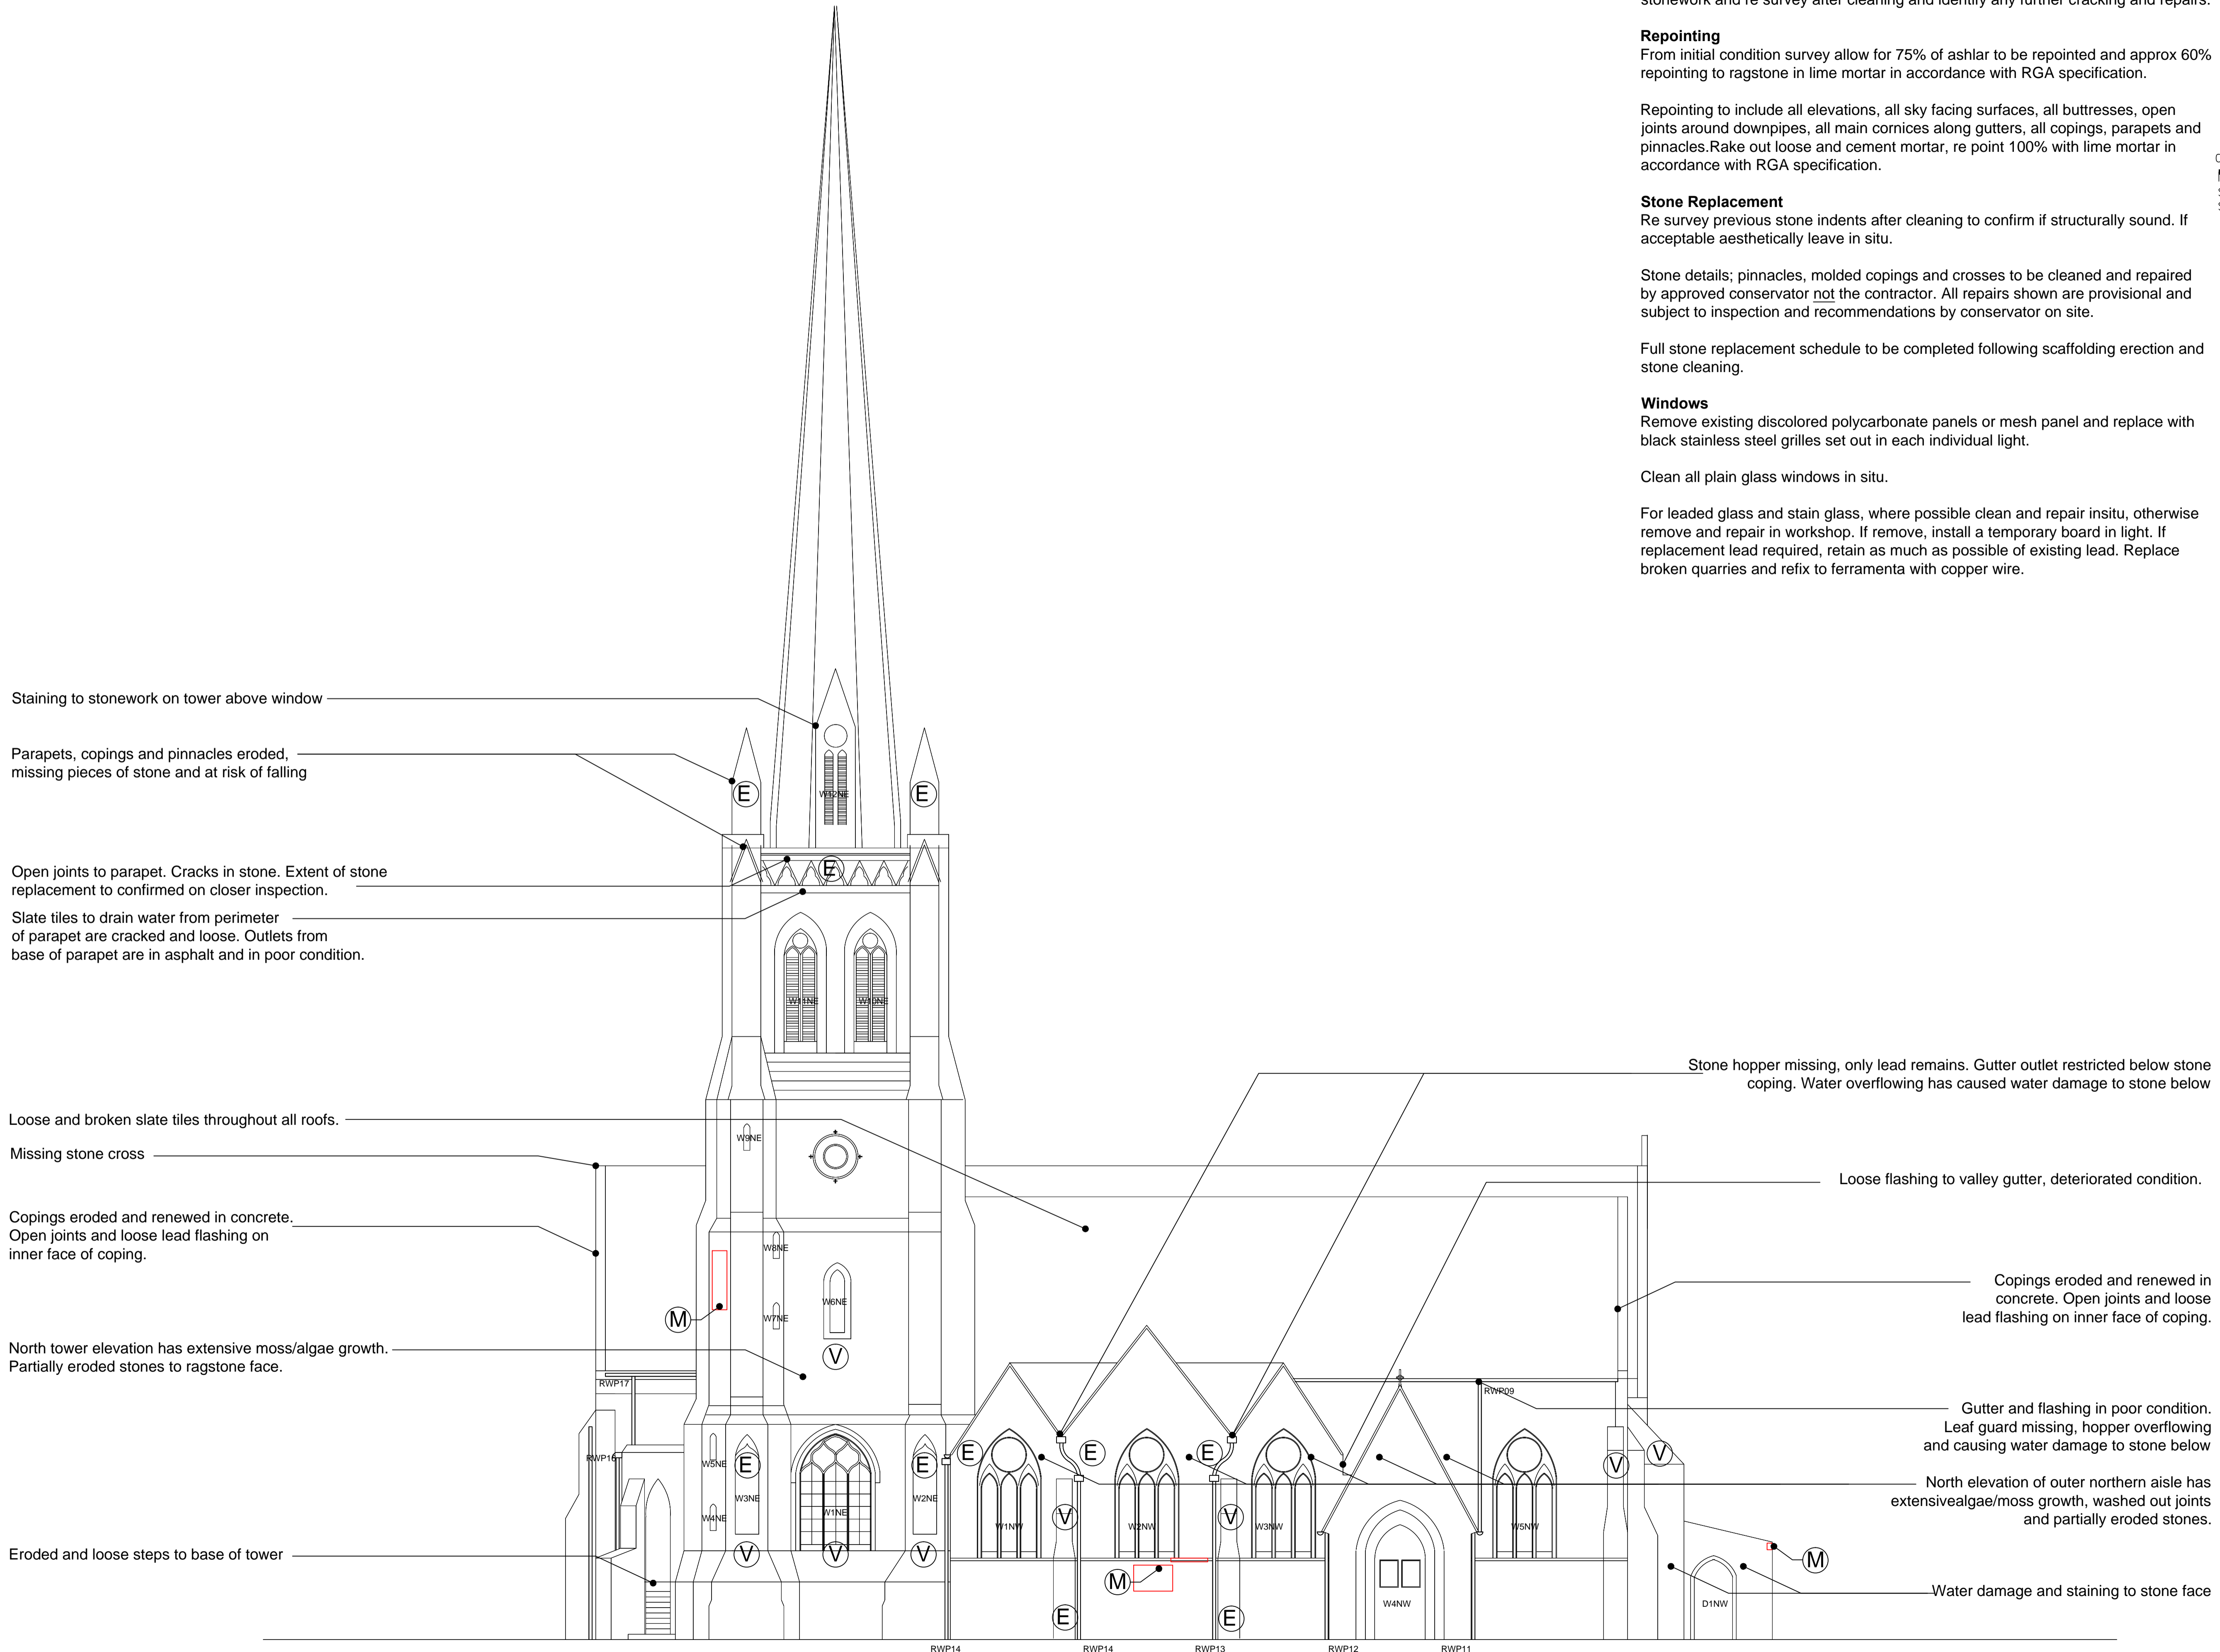
Due to limited roof access, inspection
 undertaken from ground level and
 tower parapet. Carry out a closer roof
 inspection, by scaffolding, to ascertain
 any repairs required to slates, battens,
 underlay, gutters and flashing's.
 Replace slates and lead flashing to all
 areas of roof as RGA condition survey
 and specification and LSA
 recommendations.

All areas to be DOFF cleaned early in contract. Conservation Architect to explore
 stonework and re survey after cleaning and identify any further cracking and repairs.

From initial condition survey allow for 75% of ashlar to be repointed and approx 60%
 repointing to ragstone in lime mortar in accordance with RGA specification.

Repointing to include all elevations, all sky facing surfaces, all buttresses, open
 joints around downpipes, all main cornices along gutters, all copings, parapets and
 pinnacles. Rake out loose and cement mortar, re point 100% with lime mortar in
 accordance with RGA specification.

Re survey previous stone indents after cleaning to confirm if structurally sound. If
 acceptable aesthetically leave in situ.

Stone details; pinnacles, molded copings and crosses to be cleaned and repaired
 by approved conservator not the contractor. All repairs shown are provisional and
 subject to inspection and recommendations by conservator on site.

Full stone replacement schedule to be completed following scaffolding erection and
 stone cleaning.

Remove existing discolored polycarbonate panels or mesh panel and replace with
 black stainless steel grilles set out in each individual light.

Clean all plain glass windows in situ.

For leaded glass and stain glass, where possible clean and repair insitu, otherwise
 remove and repair in workshop. If remove, install a temporary board in light. If
 replacement lead required, retain as much as possible of existing lead. Replace
 broken quarries and refix to ferramenta with copper wire.
