**Refurbishment and  
Demolition Asbestos  
Survey Report  
of  
95 Hillway, Highgate  
N6 6AB**

**Survey Report Number: P0900  
Date: 28.10.2014**

**Surveyor: Daniel Lukaszewski**

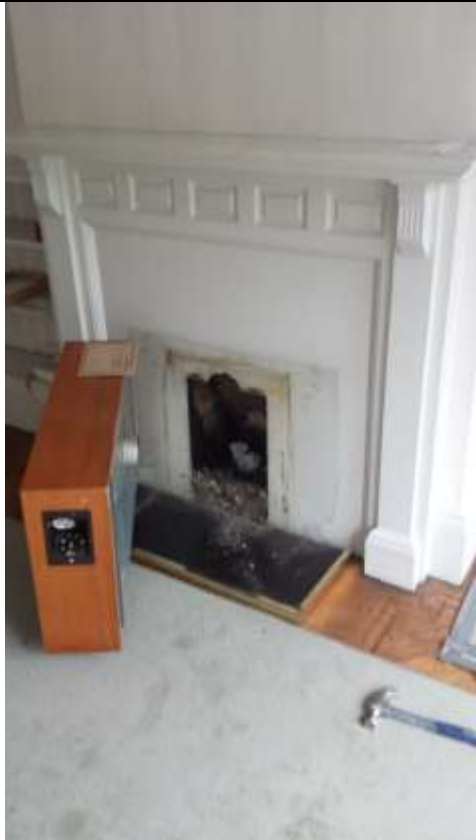
Sample Ref. No.		1A		
	Building:		Main		
	Floor:		Ground		
	Room/Area		Living Room – Fire place		
	Component:		Belgian board (cement based)		
	Approx. Amount of Material:		1sqm		
	Asbestos Type:		Chrysotile		
<b>Material Assessment</b>					
Product Type	1	Surface treatment:	1	Potential to release asbestos fibres.	5/
Extent of Damage	2	Asbestos type	1	Score(out of 12)	Low
Comments:	Board behind fireplace. Asbestos rope may be present behind board.				
Inspection:	N/A				
Recommendation:	Remove before works start. If any works are planned which may disturb this material, then it should be removed by Asbestos Removal Contractor and disposed of in accordance with the Hazardous Waste regulations. These works are Non-Licensed Asbestos Removal works.				
Notification to HSE required	No

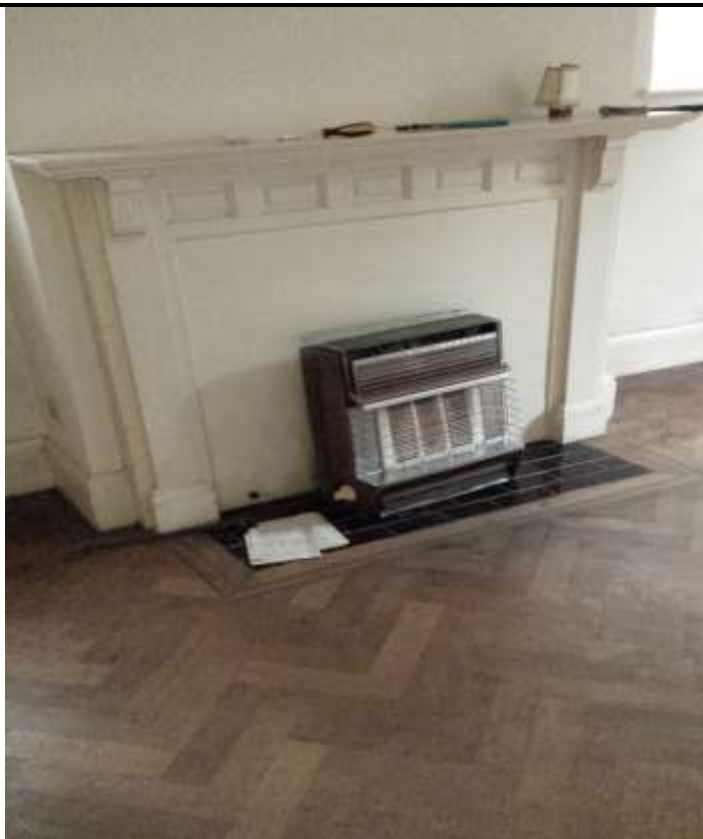
<b>Sample Ref. No.</b> <div style="text-align: right;"><b>2A</b></div>				
	<b>Building:</b> <div style="text-align: right;"><b>Main</b></div>				
	<b>Floor:</b> <div style="text-align: right;"><b>Ground</b></div>				
	<b>Room/Area</b> <div style="text-align: right;"><b>Dining Room – Fire place</b></div>				
	<b>Component:</b> <div style="text-align: right;"><b>Belgian board (Cement based)</b></div>				
	<b>Approx. Amount of Material:</b> <div style="text-align: right;"><b>1sqm</b></div>				
	<b>Asbestos Type:</b> <div style="text-align: right;"><b>Chrysotile</b></div>				
<b>Material Assessment</b>					
Product Type	1	Surface treatment:	1	Potential to release asbestos fibres.	5/
Extent of Damage	2	Asbestos type	1	Score(out of 12)	Low
Comments:	Board behind fireplace. Asbestos rope may be present behind board.				
Inspection:	N/A				
Recommendation:	Remove before works start. If any works are planned which may disturb this material, then it should be removed by Asbestos Removal Contractor and disposed of in accordance with the Hazardous Waste regulations. These works are Non-Licensed Asbestos Removal works.

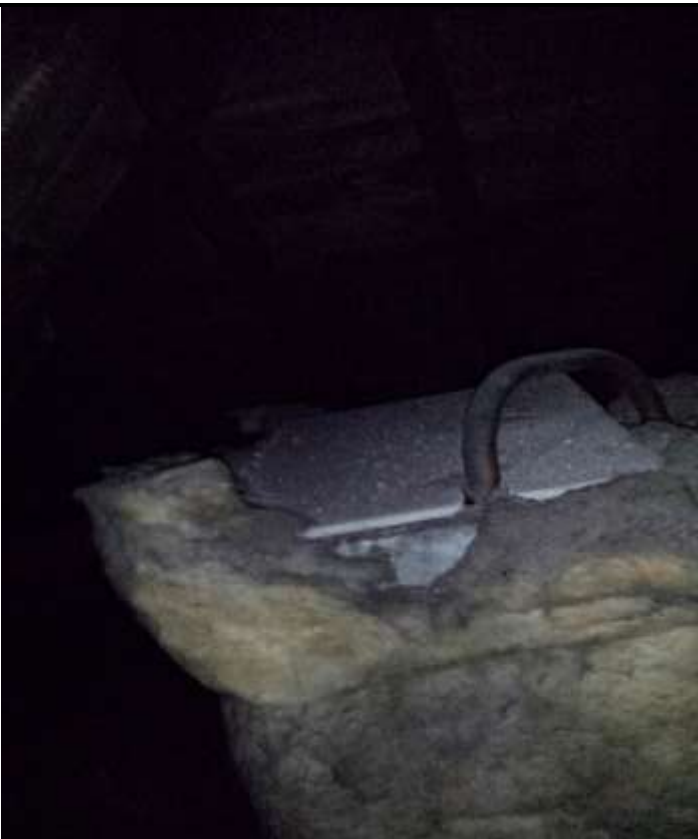
Sample Ref. No.		4A		
	Building:		Main		
	Floor:		Loft		
	Room/Area		Water tank cover		
	Component:		Insulation board		
	Approx. Amount of Material:		0.5 sqm		
	Asbestos Type:		Chrysotile Amosite		
<b>Material Assessment</b>					
Product Type	2	Surface treatment:	2	Potential to release asbestos fibres.	7/
Extent of Damage	1	Asbestos type	2	Score(out of 12)	Medium
Comments:	Board is loose.				
Inspection:	N/A				
Recommendation:	Remove before works start. If any works are planned which may disturb this material, then it should be removed by Asbestos Removal Contractor and disposed of in accordance with the Hazardous Waste regulations. These works are Non-Licensed Asbestos Removal works.				
Notification to HSE required	No

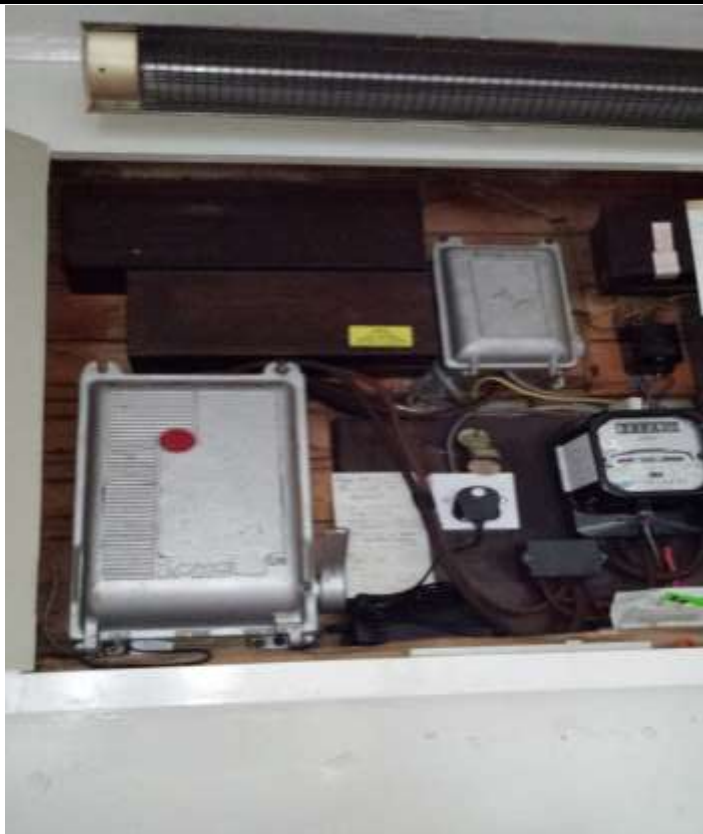
<b>Sample Ref. No.</b> <b>6A Strongly presumed</b>				
	<b>Building:</b> <b>Main</b>				
	<b>Floor:</b> <b>Ground</b>				
	<b>Room/Area</b> <b>Kitchen</b>				
	<b>Component:</b> <b>Fuse boxes flash guards</b>				
	<b>Approx. Amount of Material:</b> <b>2 Fuse boxes</b>				
	<b>Asbestos Type:</b> <b>Chrysotile</b>				
<b>Material Assessment</b>					
Product Type	2	Surface treatment:	2	Potential to release asbestos fibres.	6/
Extent of Damage	1	Asbestos type	1	Score(out of 12)	Medium
Comments:	No assess, strongly presumed to contain asbestos. To access fuse box alarm arrangements need to be taken into consideration.				
Inspection:	N/A				
Recommendation:	Remove before works start. If any works are planned which may disturb this material, then it should be removed by Asbestos Removal Contractor and disposed of in accordance with the Hazardous Waste regulations. These works are Non-Licensed Asbestos Removal works.

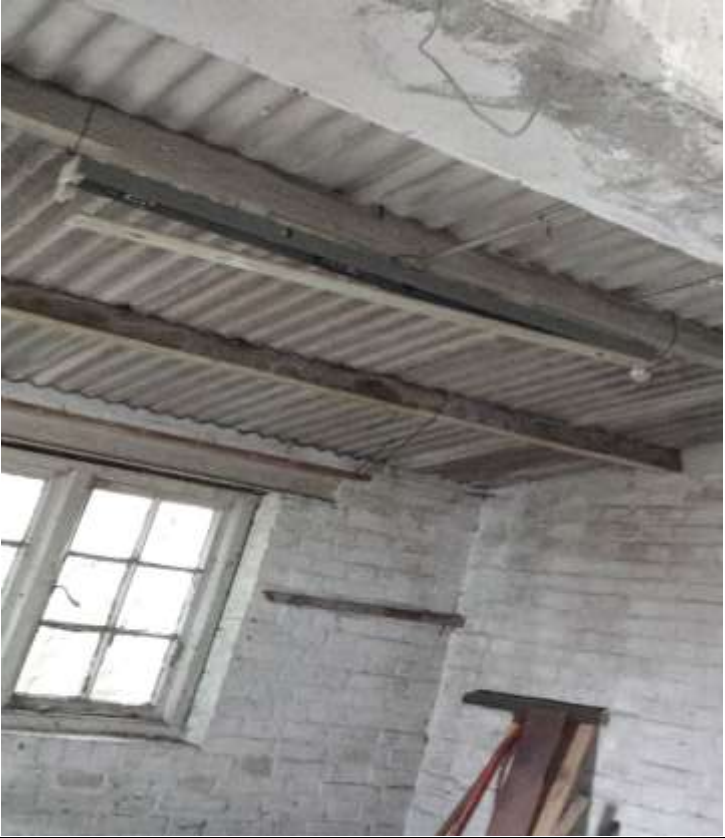
<b>Sample Ref. No.</b> <b>7A Strongly presumed</b>				
	<b>Building:</b> <b>Main</b>				
	<b>Floor:</b> <b>Ground</b>				
	<b>Room/Area</b> <b>Garage</b>				
	<b>Component:</b> <b>Cement corrugated roof sheets</b>				
	<b>Approx. Amount of Material:</b> <b>10sqm</b>				
	<b>Asbestos Type:</b> <b>Chrysotile</b> <b>Amosite</b>				
<b>Material Assessment</b>					
Product Type	1	Surface treatment:	1	Potential to release asbestos fibres.	4/
Extent of Damage	1	Asbestos type	1	Score(out of 12)	Low
Comments:	None.				
Inspection:	N/A				
Recommendation:	Remove before works start. If any works are planned which may disturb this material, then it should be removed by Asbestos Removal Contractor and disposed of in accordance with the Hazardous Waste regulations. These works are Non-Licensed Asbestos Removal works.				
Notification to HSE required	No

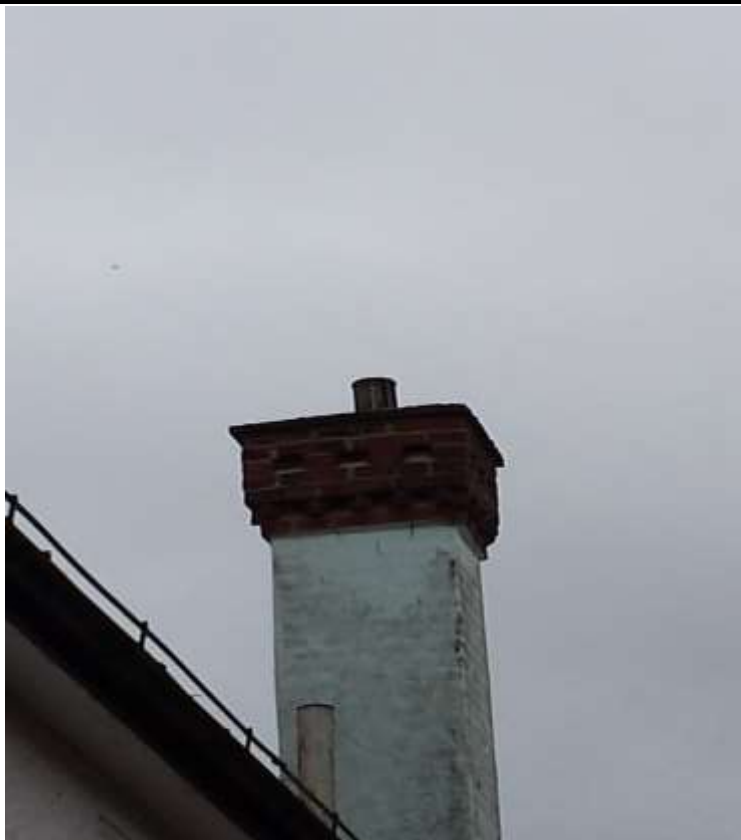
<b>Sample Ref. No.</b> <b>8A Strongly presumed</b>				
	<b>Building:</b> <b>Main</b>				
	<b>Floor:</b> <b>Roof</b>				
	<b>Room/Area</b> <b>Roof</b>				
	<b>Component:</b> <b>Cement chimney top</b>				
	<b>Approx. Amount of Material:</b> <b>One</b>				
	<b>Asbestos Type:</b> <b>Chrysotile</b>				
<b>Material Assessment</b>					
Product Type	1	Surface treatment:	1	Potential to release asbestos fibres.	4/
Extent of Damage	1	Asbestos type	1	Score(out of 12)	Low
<b>Exposure Assessment</b>					
Normal Occupant activity	0	Human exposure potential	0	Exposure Potential	3/
Likelihood of disturbance	0	Maintenance activity	1	Score(out of 12)	Very low
Comments:	No access.				
Inspection:	Every 12 months.				
Recommendation:	Manage. Very Low exposure risk. If any works are planned which may disturb this material, then it should be removed by Asbestos Removal Contractor and disposed of in accordance with the Hazardous Waste regulations. These works are Non-Licensed Asbestos Removal works.

<b>2.1 Note on actions:</b>	<p>Chimney top is recommended to be managed due hard access.</p> <p>Brickwork around windows and doors may contain a bitumen membrane. This can only be determined during demolition. This material is a Very Low exposure level material. If any membrane is detected it is recommended to stop the works. This material should be removed by Asbestos Removal Contractor and disposed of in accordance with the Hazardous Waste regulations. These works are Non-Licensed Asbestos Removal works.</p> <p>Remove all other asbestos materials prior to commencement of the works.</p>
<b>2.2 Areas not accessed:</b>	<ul style="list-style-type: none"><li>• No access behind asbestos fireplace board</li><li>• No access within brick work</li></ul>
<b>2.3 Possible fibrous materials present but presumed to be non-asbestos:</b>	<ul style="list-style-type: none"><li>• Non asbestos boiler form</li><li>• Loft insulation (all types)</li></ul>
