Charlie Ratchford Resource Centre - Tree Survey, Implications Assessment & Constraints Plan

Issue/Revision :	Draft	Final
Date:	August 2014	January 2015
Comments:		
Prepared by:	Tom Luck	Tom Luck
Signature:

Project
Crogsland Road, Camden, London.

Drawing Title
Tree Constraints Plan

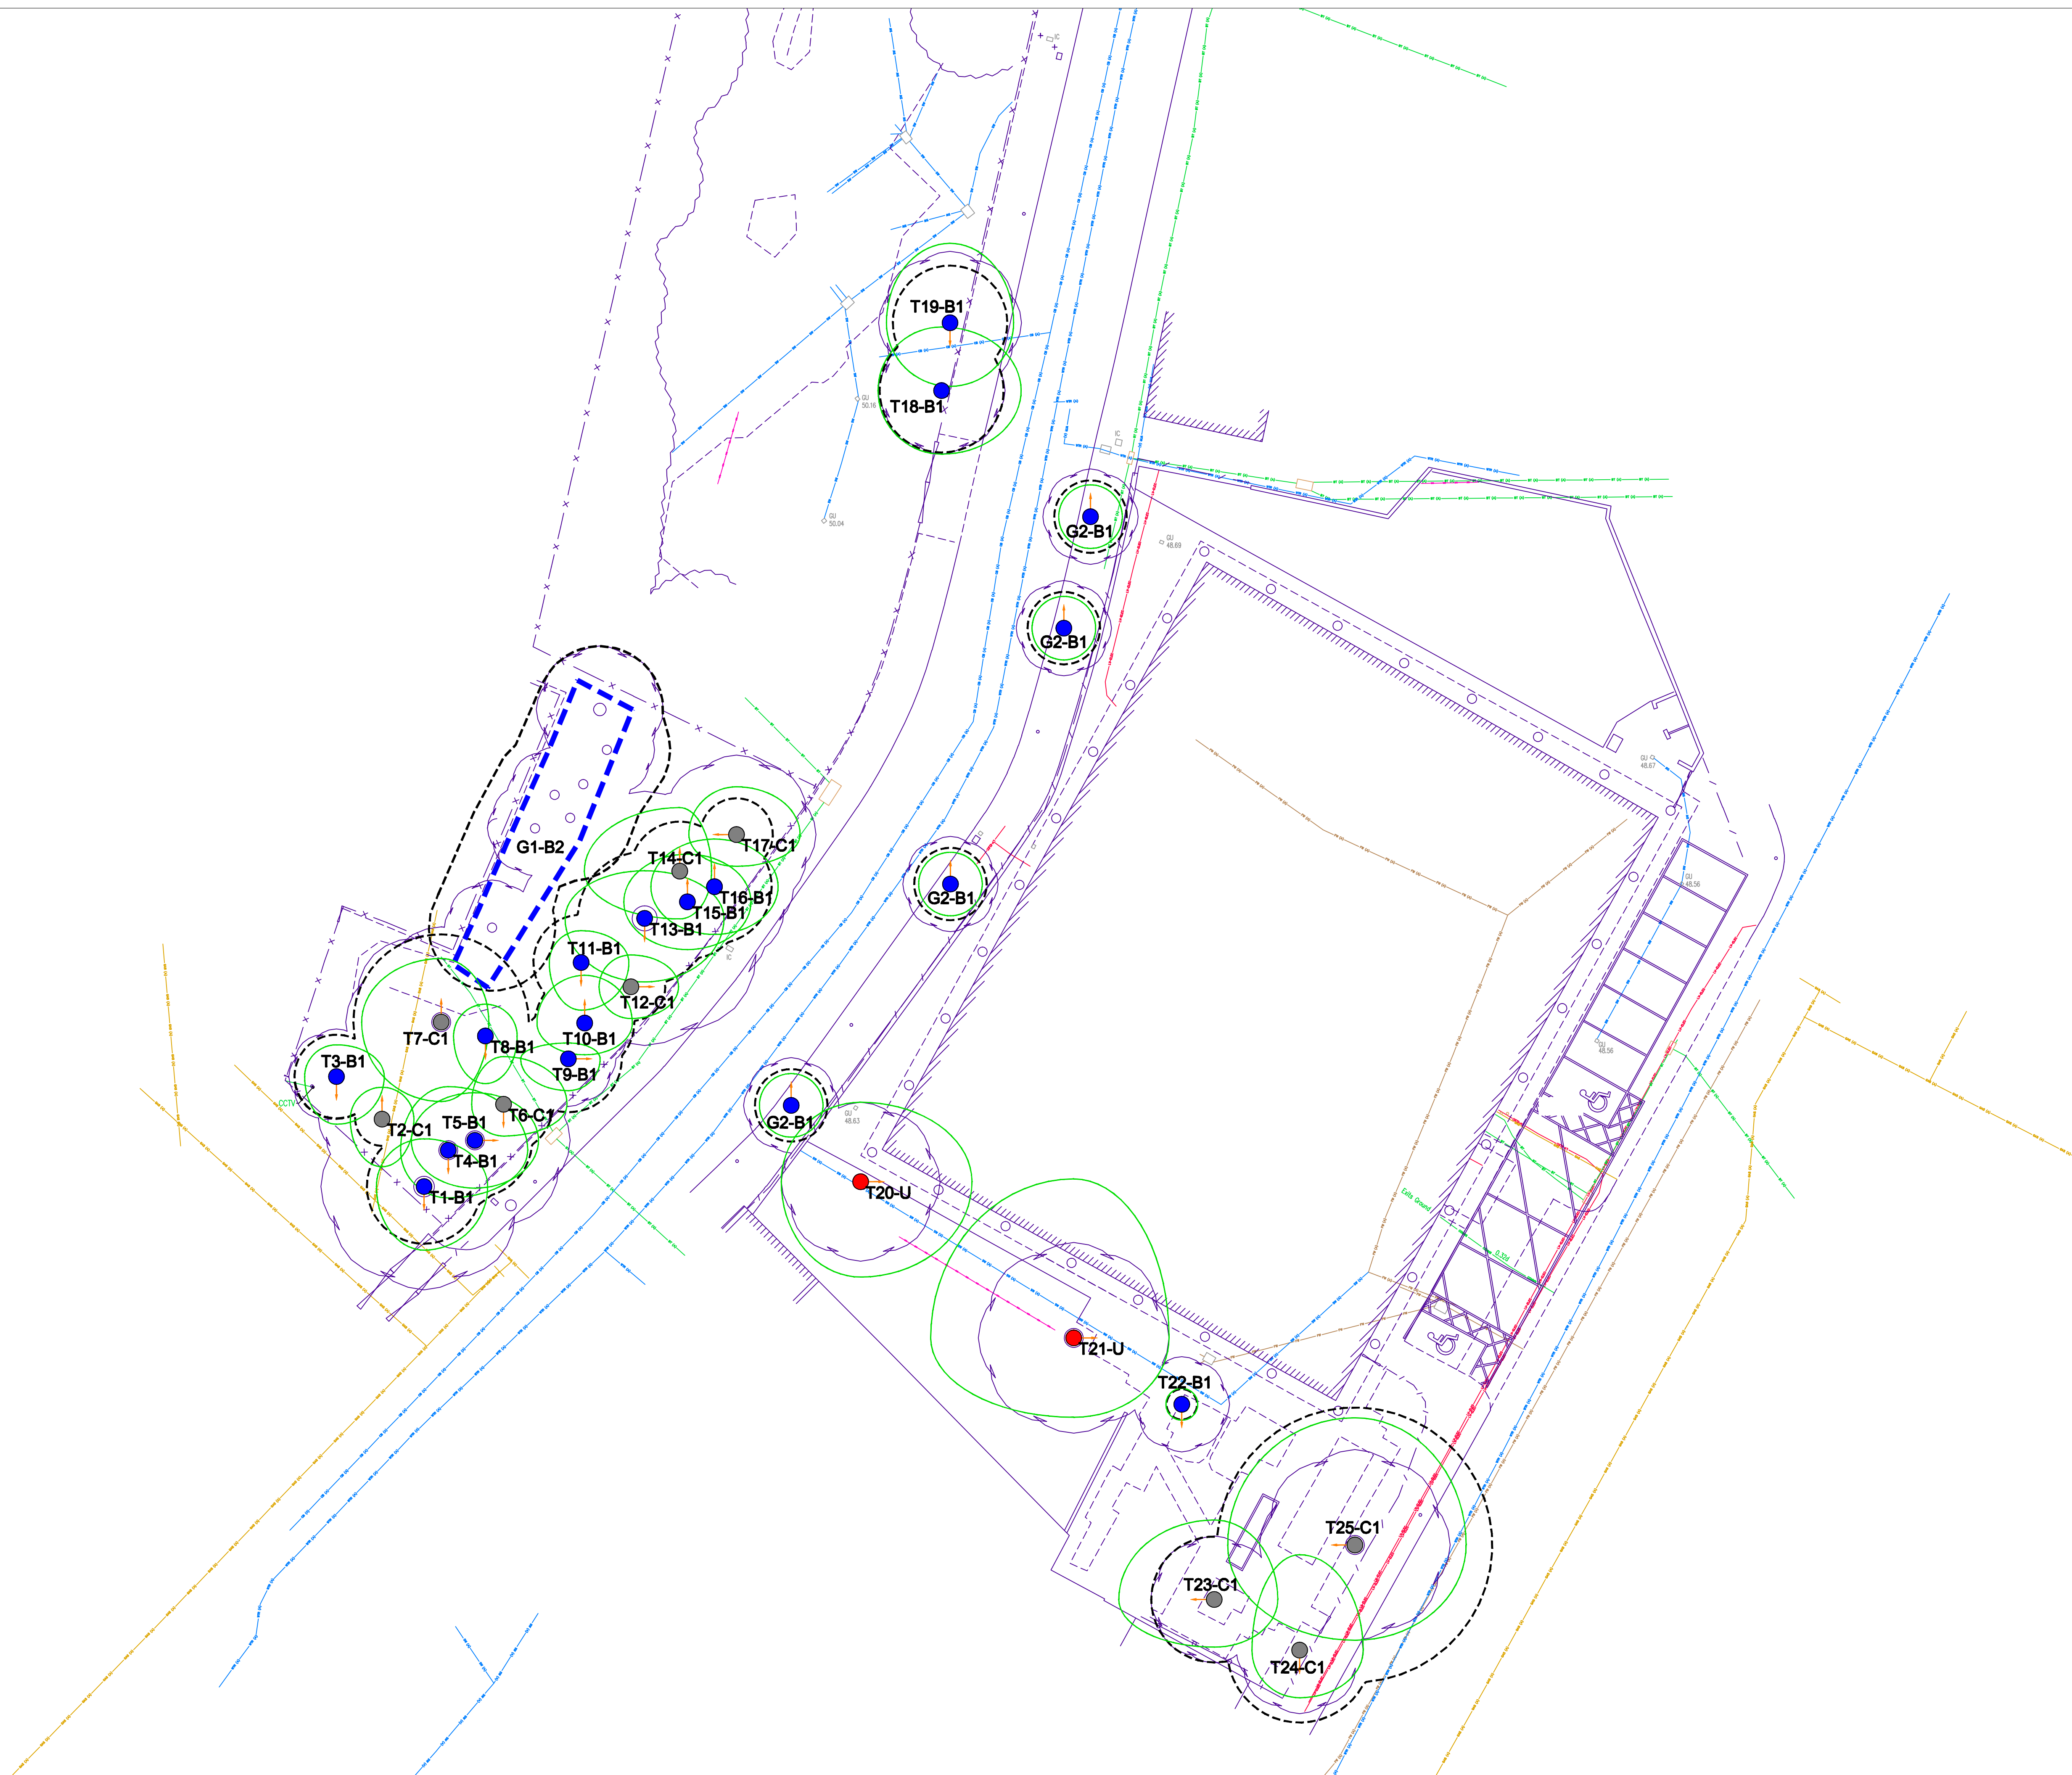
Tree Constraints Plan
showing existing
layout against tree
categories and root
protection zones.
