**REPORT ON:  
FAÇADE SURVEY –  
MELIÀ WHITE HOUSE HOTEL**

**TH / MWH**

**JULY 2014**

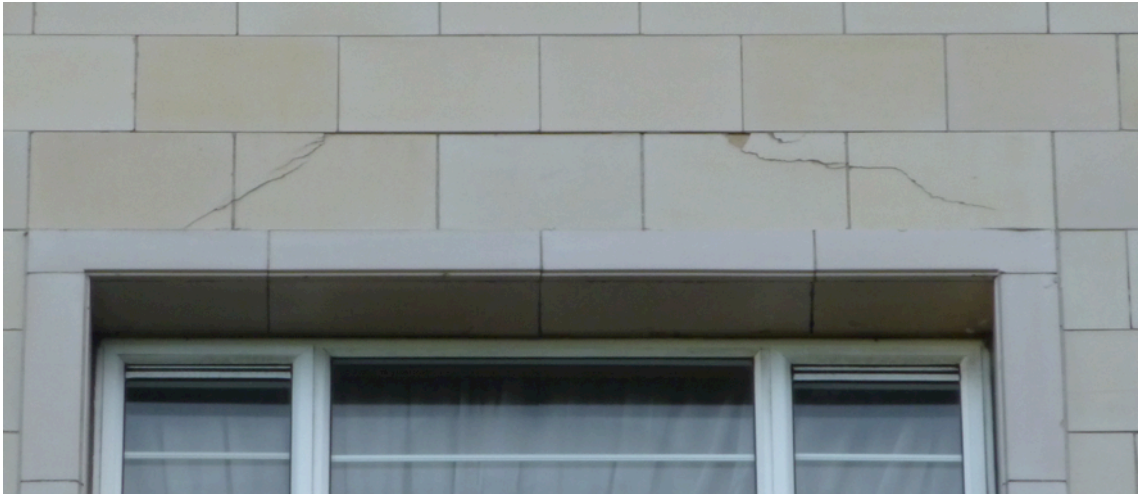
- 2.24. There were several windows with cracks running into open joints above forming an arch shape.

- 3.9. Similarly, lintels were typically part of the steel frame, thus susceptible to corrosion; where arch type cracks and open joints occur above windows, these are likely corrosion induced and should be repaired.

- 4.9. Repoint the vertical joints in the projecting stringcourses.
- 4.10. Repoint horizontal joints above all window heads with 1:3 lime mortar.
- 4.11. The rooftop and balcony waterproofing should be checked regularly to ensure there are no leaks.

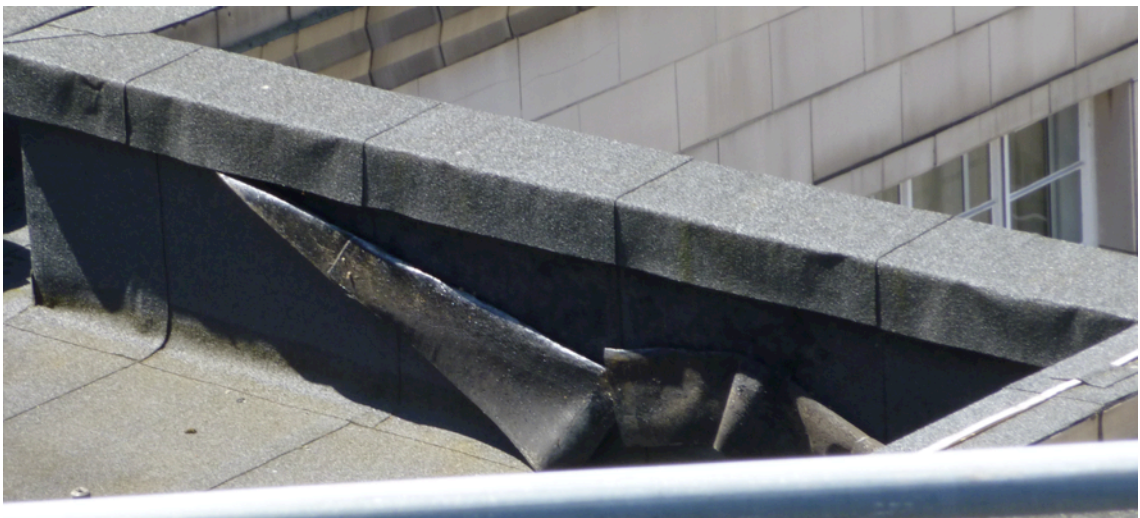
- 2.25. The cracks where observed near ground floor were generally stained, suggesting that these were long standing cracks.
- 2.26. There was very fine opening up of many of the vertical joints observed at low level.
- 2.27. There were mastic filled joints at the main corners; many of these had failed or were failing.
- 2.28. There were numerous small chips and spalled areas on the façade.
- 2.29. The roof waterproofing appeared to be functional. There were a few places where this needed to be re-attached.

- iv. At the corner of the staircases.
- 4.7. Replace the failed mastic to the vertical corner joints.
- 4.8. Replace the failed mastic fillet over the projecting stringcourses.

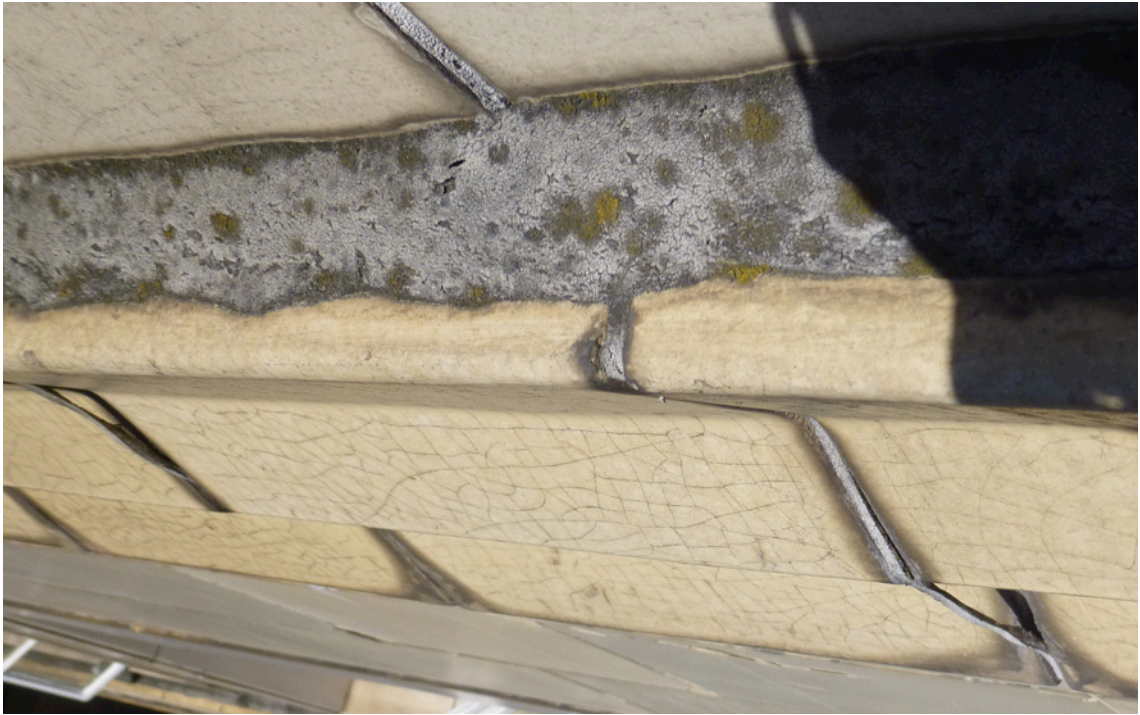
- 2.30. The fillet over the projecting stringcourses was mastic and was only loosely adhered in many places.

- 2.31. The pointing to the vertical joints to the stringcourses appeared to be mastic, much of which was coming out.
- 2.32. There were many cracks to the stone balustrade to the perimeter pavement. These were stained and appeared to be long-standing.
