# REPORT

on the impact on trees

of proposals for development

4 Tavistock Place, London, WC1H 9RA

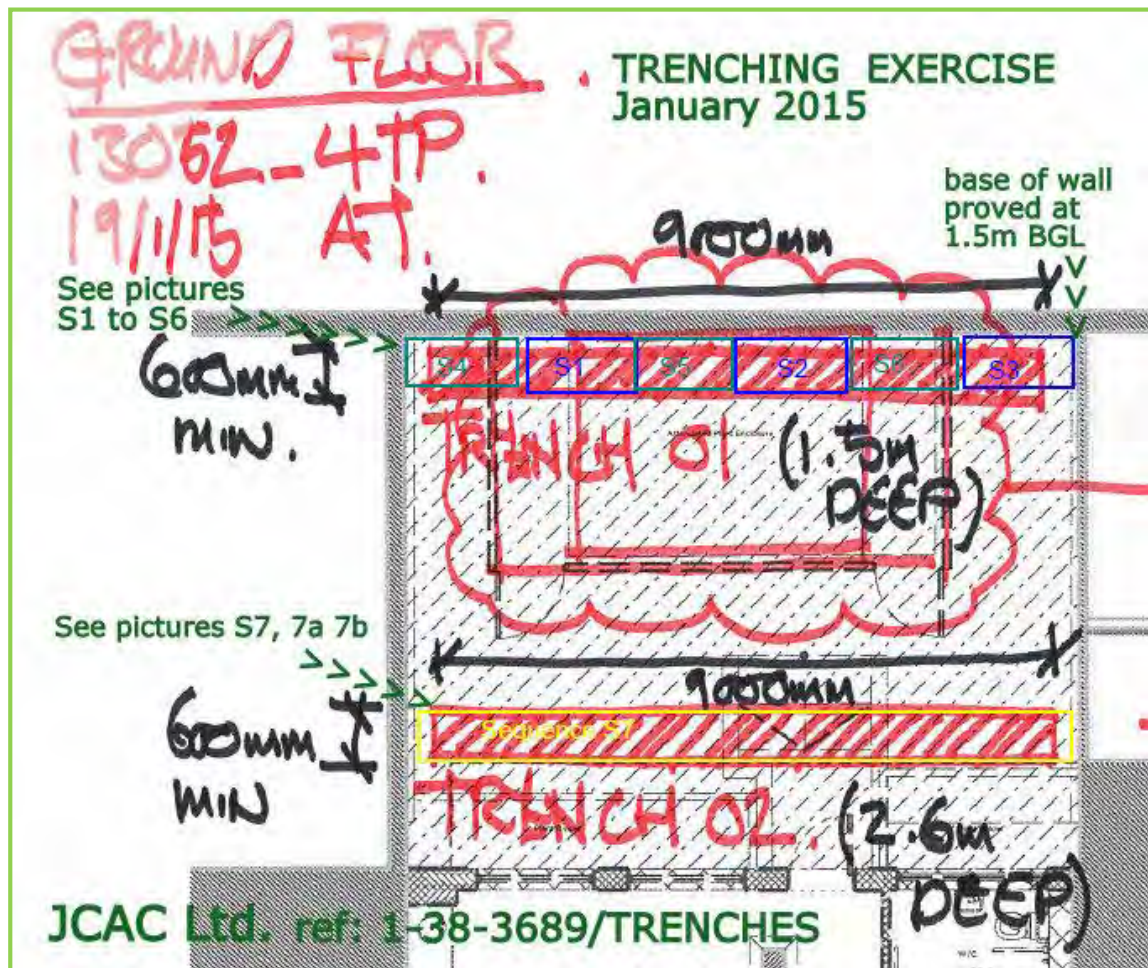
Images from trenching exercise - plan and photos

Two extensive trial strip trenches were excavated as shown in the images appended, to a depth of 1.5m (TRENCH 01- see appendix) and 2.6m (TRENCH 02) below garden level. These established that roots of the London planes had not underpassed the wall to any marked extent. It is of note that only very small diameter roots were encountered in both trenches, and minimally in the deeper trench 02. The sparse roots encountered (see photos S1-S6) appeared to have grown through the weak lime mortar of the unusually deeply founded wall. The subsoil encountered was mainly sand and gravel. This is, when well-compacted as was the case in the trenches, tends to be a poor medium for root development.

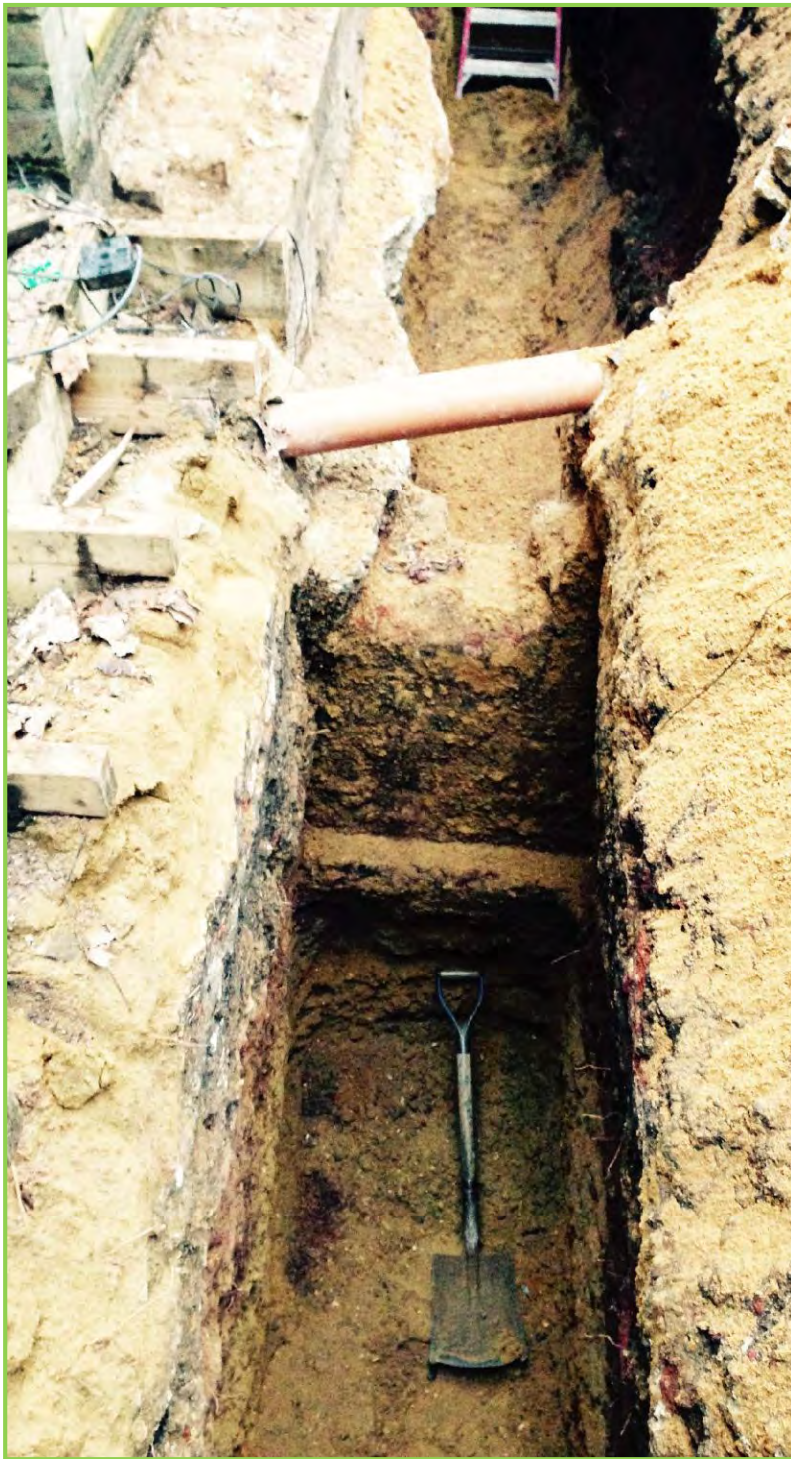
S7b

Trench bottomed out at  
2.6m below rear garden  
level

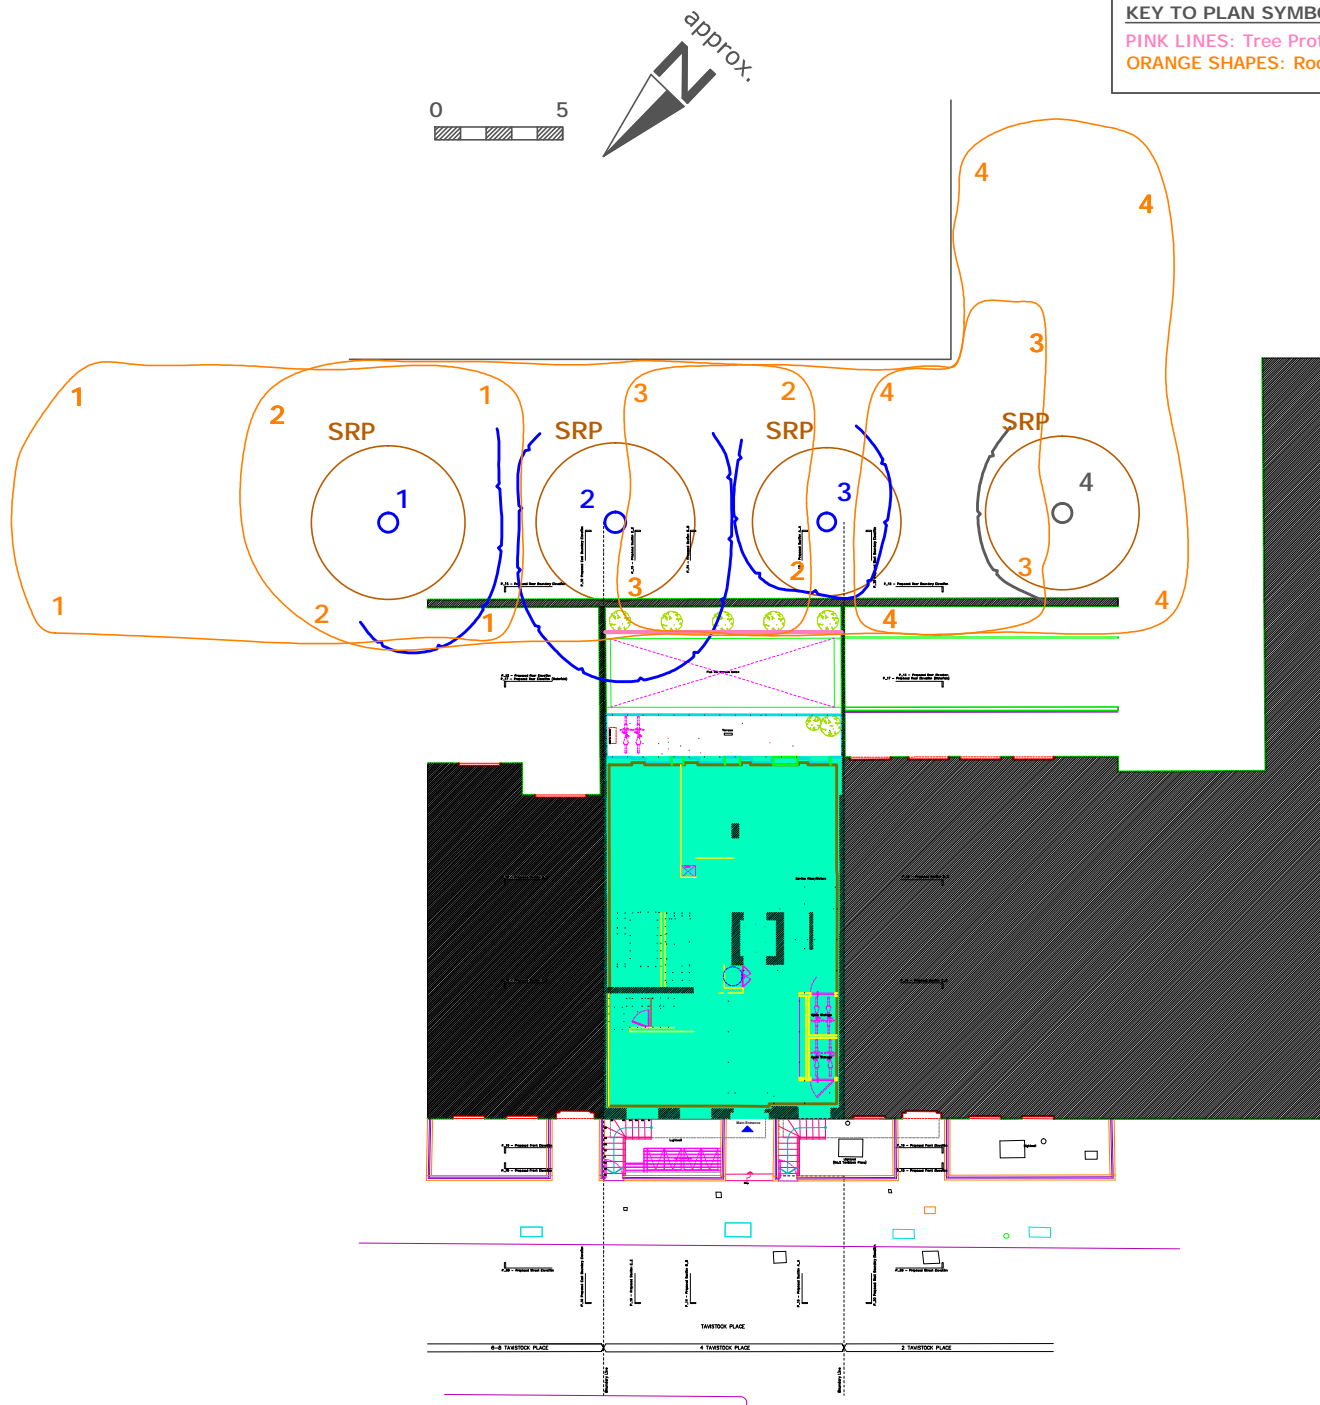
ref: 1-38-3689/P2  
rev. 24.02.15  
1:200 @ A3 scale

1-38-3689/P2 shows proposed retained trees and is colour-coded to indicate where arboricentric methods are proposed during the construction process.

PLEASE READ WITH PLAN REFERENCE 1-38-3689/P2, APPENDED.

**Method 1 : Supervision by an arboriculturist shall take place at key points in the construction process, and additionally whenever required by the architect or LPA. These key stages are :**

Any roots encountered shall be trimmed to the edge of excavation using a sharp edge tool such as handsaw or secateurs; the cuts shall be made at right angles to the long axis of the root, and in accordance with BS3998:2010, 8.6. An HDPE membrane shall be placed between any root-bearing soil and any wet concrete to be poured. The membrane shall be laid and secured locally by temporary weighting or as required. Pile casting shall take place without disturbing this protective layer.
