## **1.0 INTRODUCTION**

Clarke Nicholls Marcel (CNM) were engaged by University College London Hospitals NHS Foundation Trust (UCLH) to undertake a non-intrusive visual survey to assess the structural condition of the Former Royal Ear Hospital located at 21 Capper Street.

## **4.0 CONDITION SURVEY**

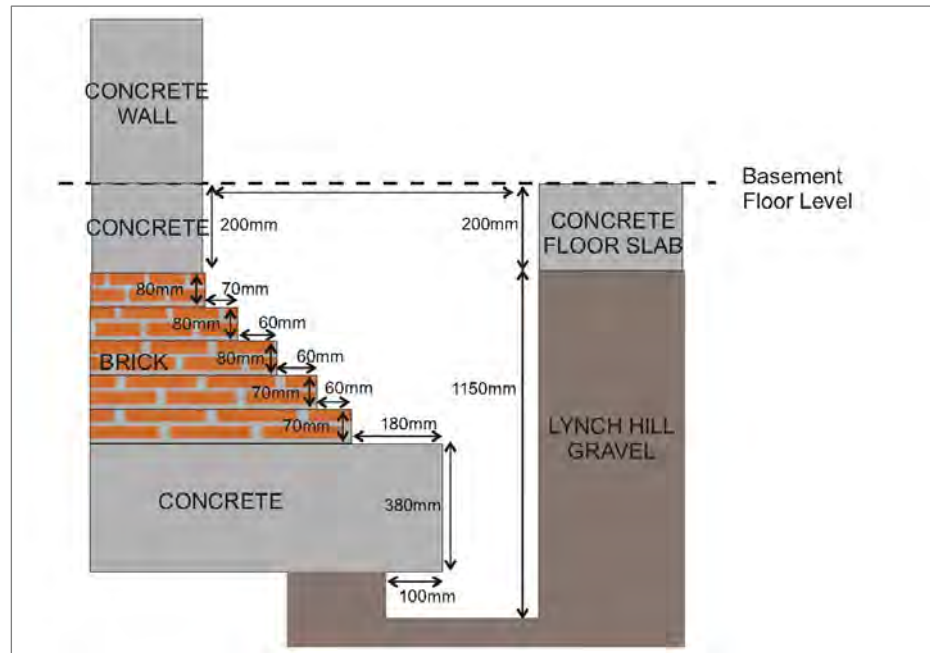
The information from the site investigation details a basement slab of approximately 200mm thick. This indicates a ground bearing slab with foundations under load bearing elements.

Due to the overall building height it is possible that piled foundations were used but more likely that mass concrete strip and pad foundations are located under external walls and internal columns.

**Figure 1 – Trial Pit Sketch of Façade foundation along Copper St**

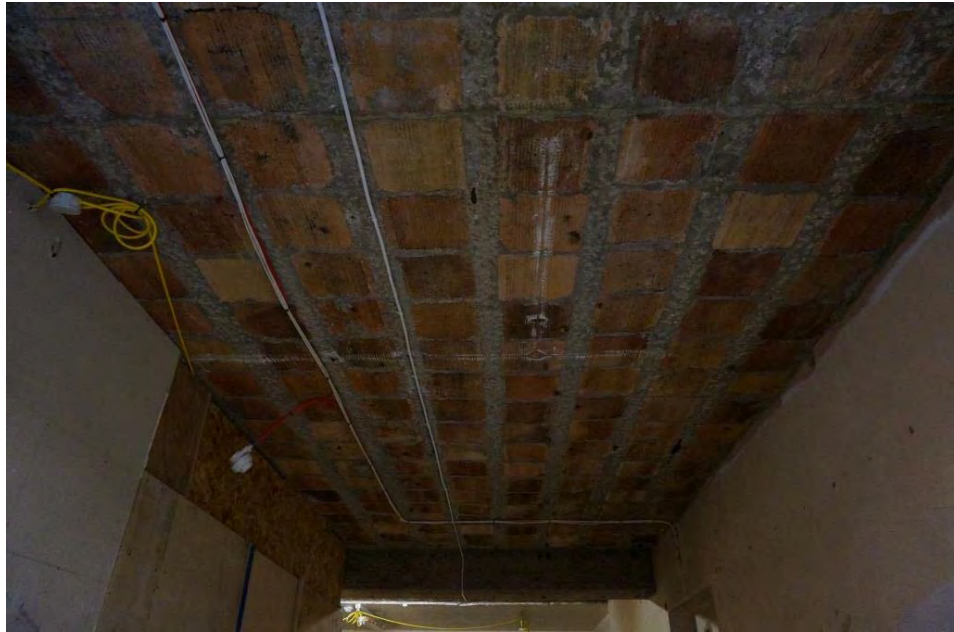
The floor structure of the building consists of a concrete slab with hollow pot infill. It was also noted that the hollow pot floors spanned a significant distance and would have limitations in regards to loading for any future change of use. This type of construction also greatly limits any future flexibility with regard to ceiling support services and penetrations.

Image 1: Typical hollow-pot floor structure of building. Taken at underside of ground floor.

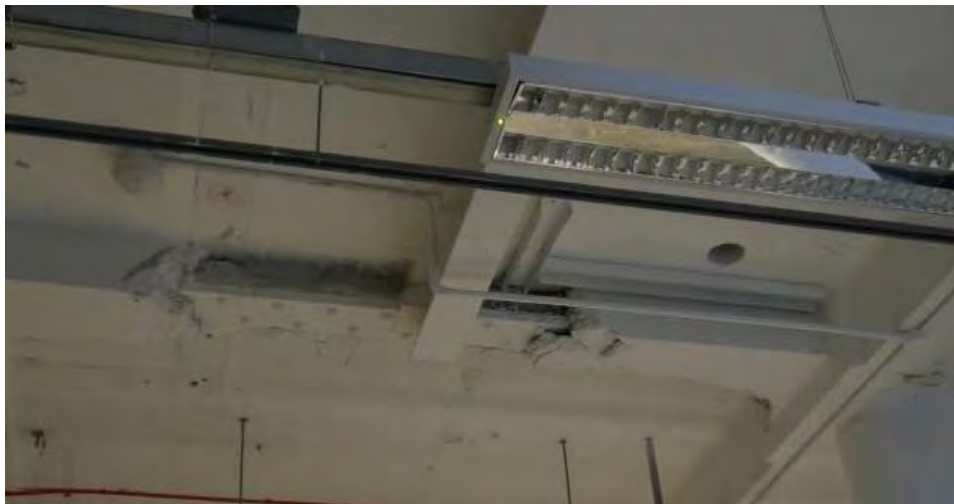
There are a number of sections of missing/spalling fire protection coating (Image No. 2, 5) that should be made good in accordance with the recommendations of a specialist repair contractor.

However some areas of the fire protection around the steel beams and columns had spalled or been broken out. This could affect the structural performance of the building in the event of a fire and would likely not comply with current standards.

Image 2: Typical exposed steel girder beam, supporting floor structure. (Cat 3)

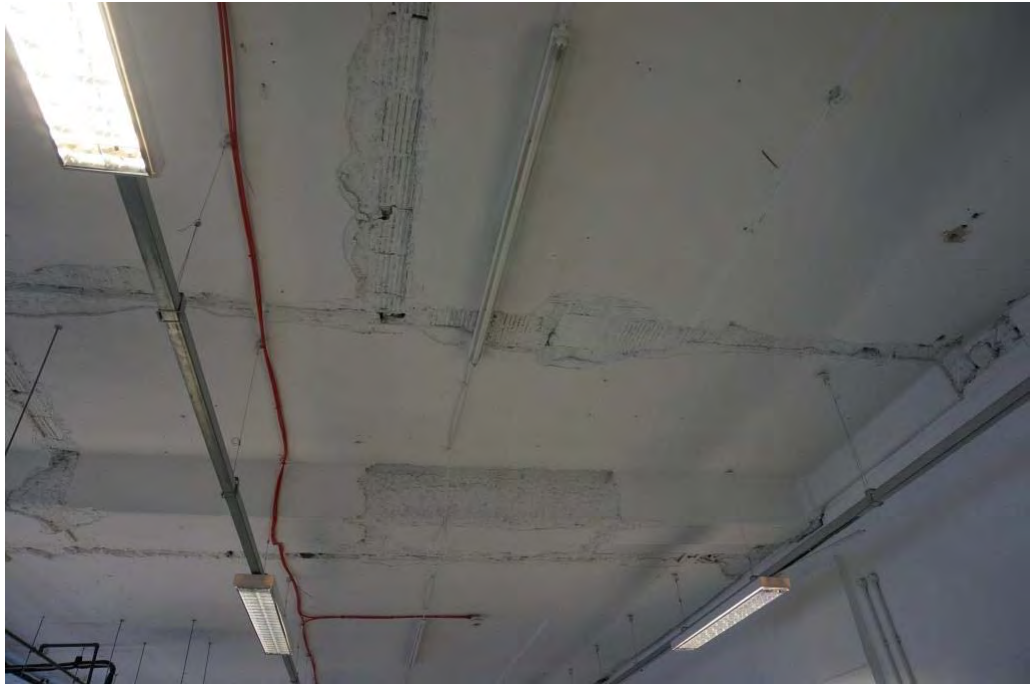
Image 3: Deterioration of finishes and fire proof cladding to structural elements. (Cat 3)

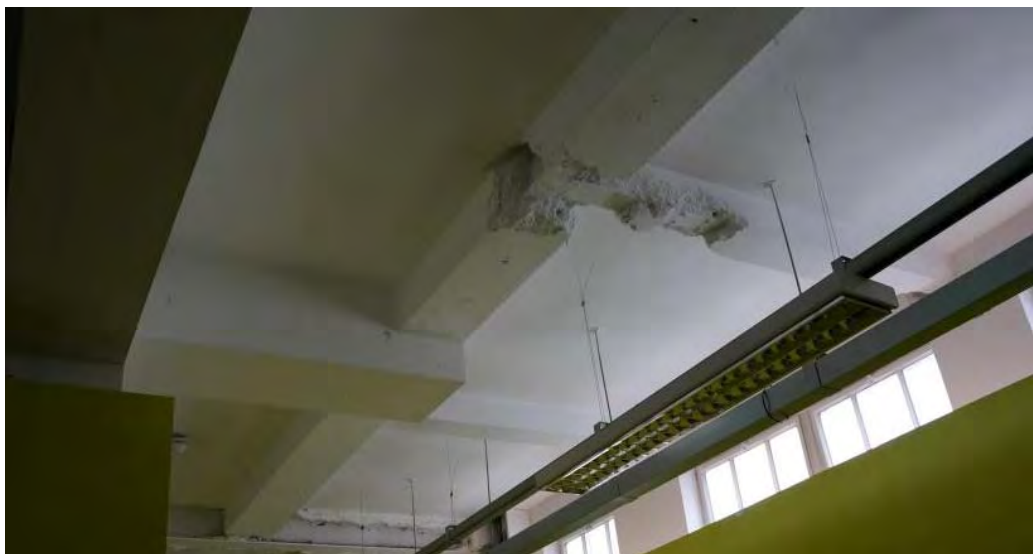
Image 4: Locally removed fire proofing of primary steel. (Cat 3)

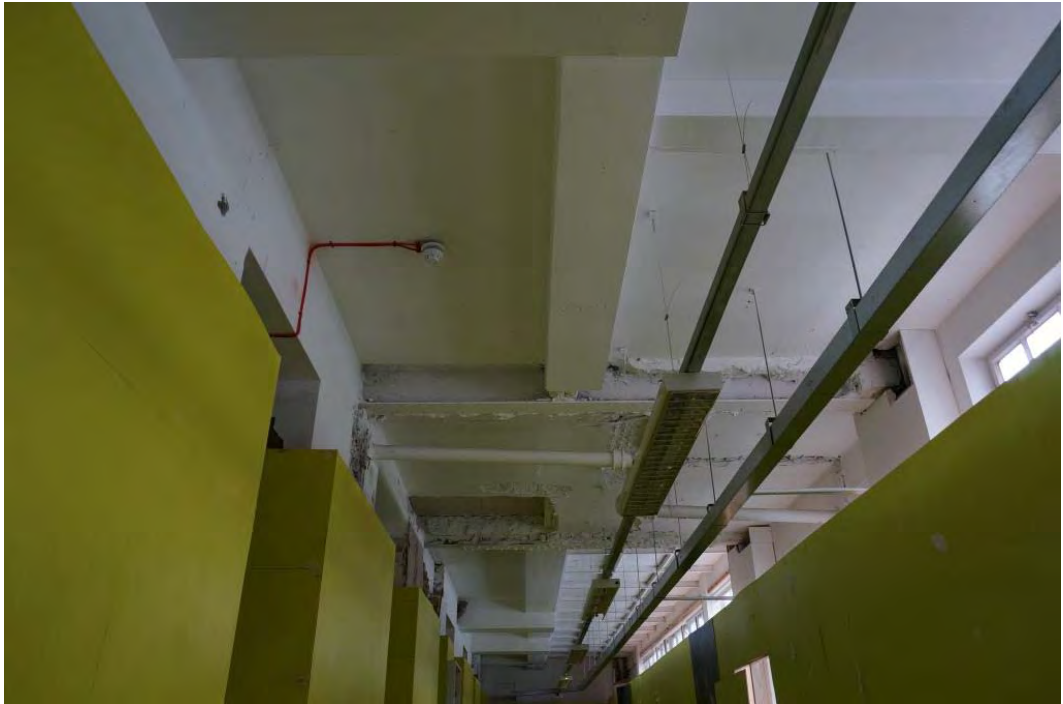
Image 5: Exposed primary steel structure (Cat 3)

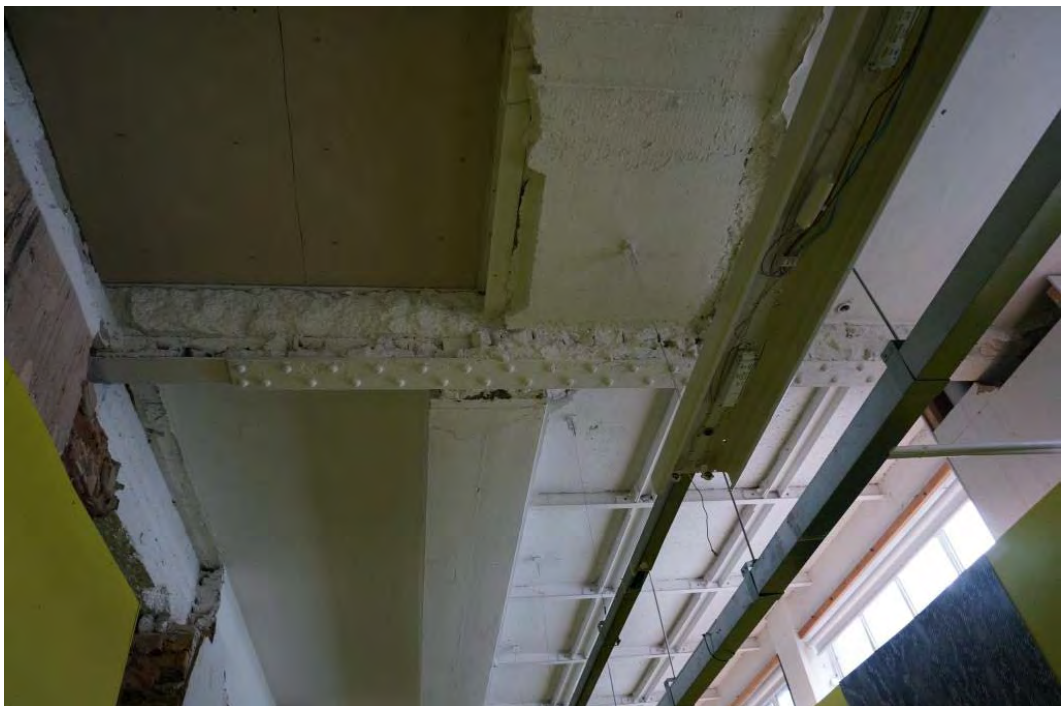
Image 6: Exposed steel grider beam with fire proofing cladding removed (Cat 3)

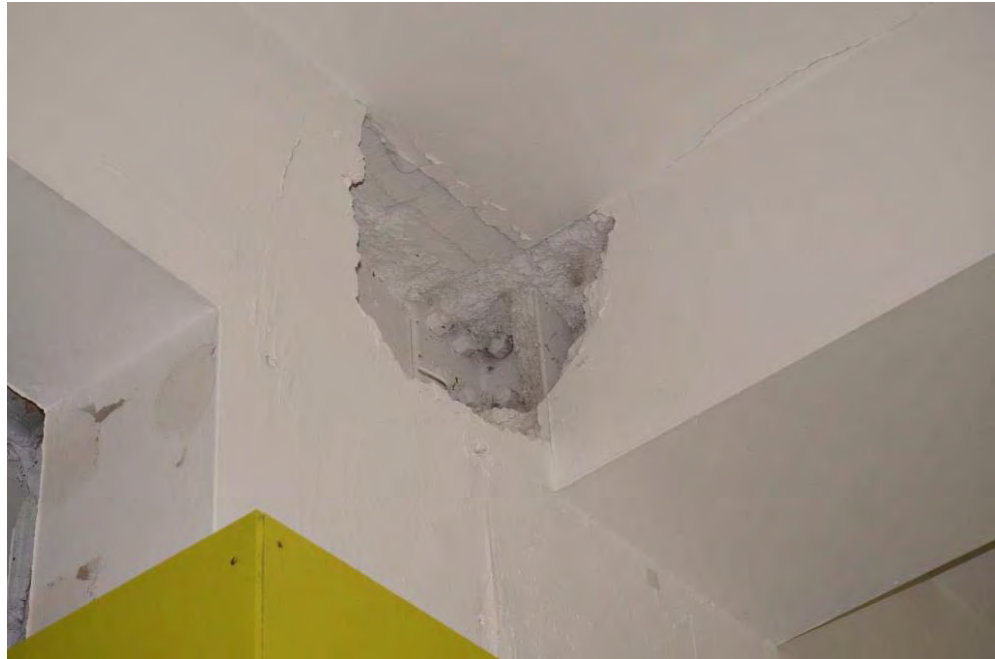
Image 7 Exposed steel beam to column connection. (Cat 3)

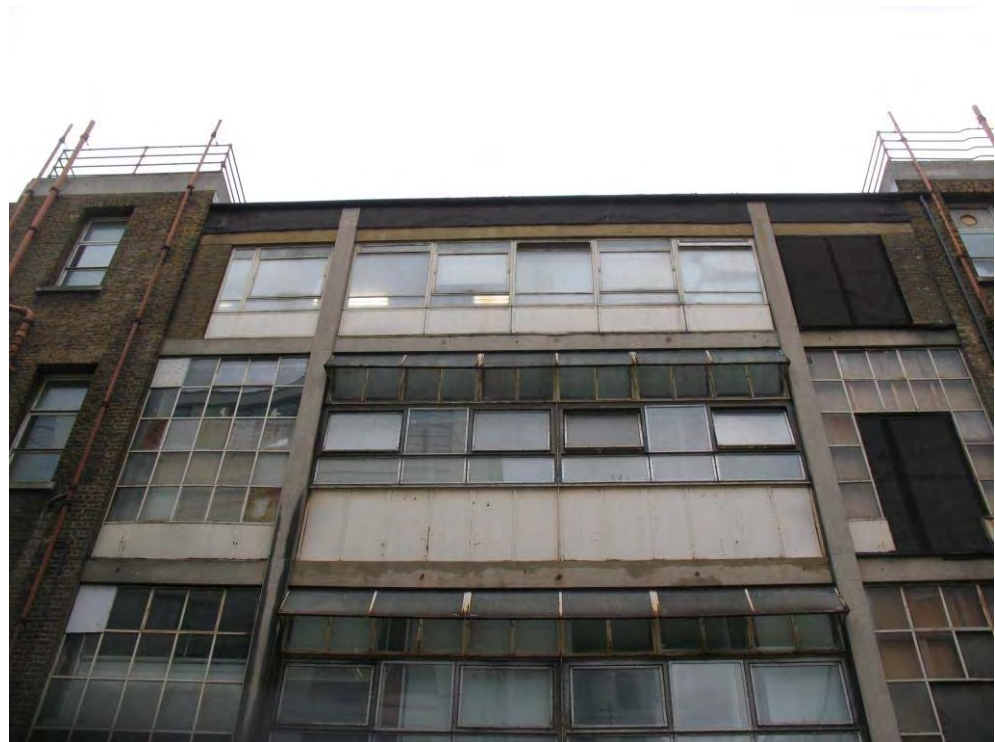
Image 8: External view of infill of original external balconies on Shropshire Place elevation

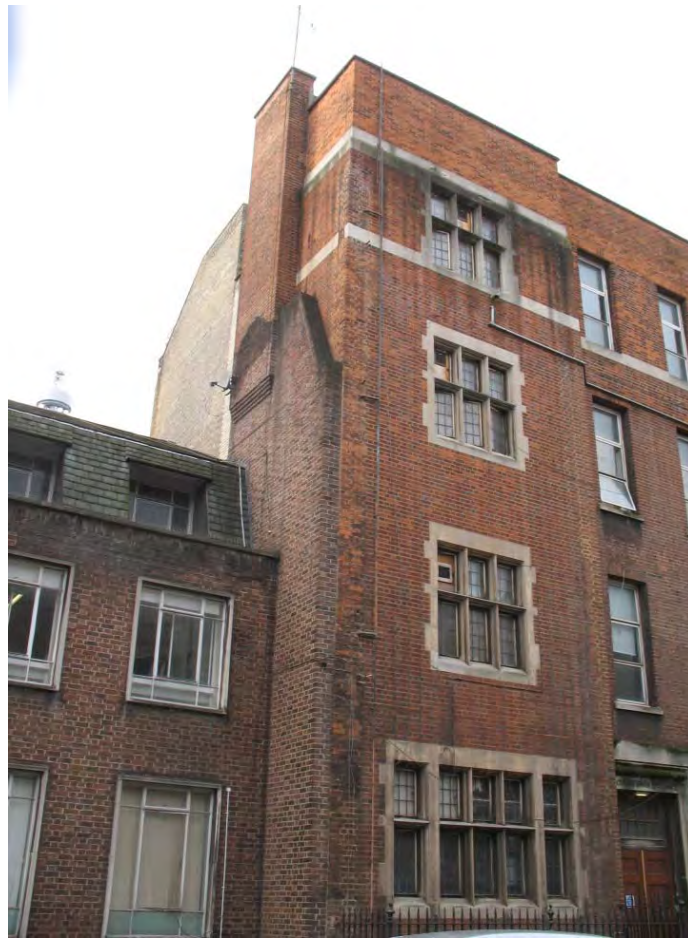
There a number of areas showing specific signs of local water staining (Image No. 9, 10, 11 13

Image 9: Huntley St elevation. Evidence of water staining and local brick repairs. (Cat 4)

and 17). In the case of obvious leaks from rainwater downpipes these should be investigated and the source of the leak repaired. Other areas should also be investigated to remedy the local cause of staining and the stained surface cleaned and made good.

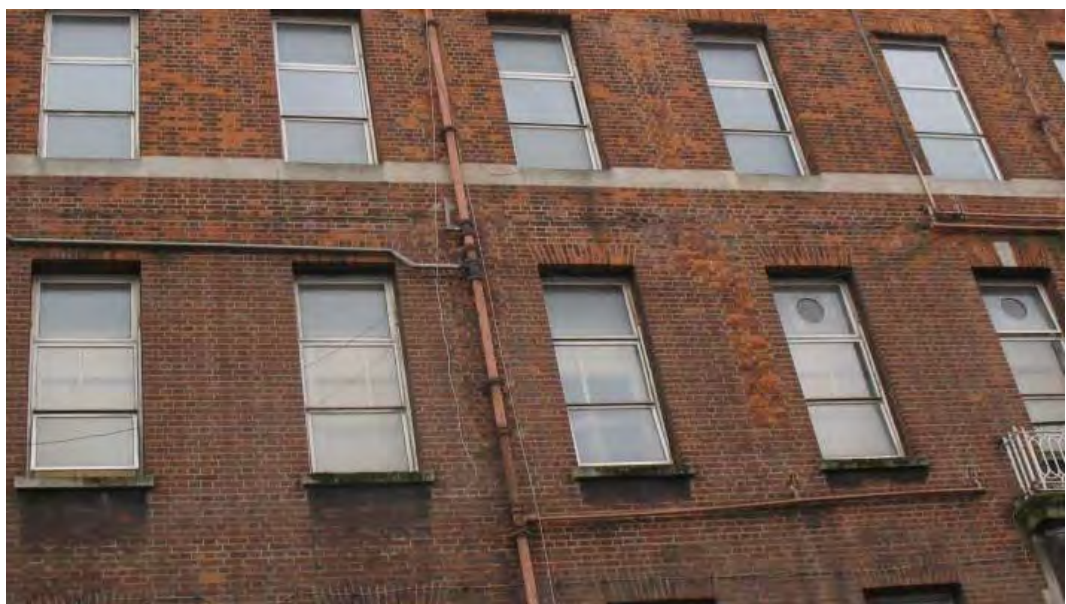
A number of cracks and open joints can be seen throughout the elevations (Image No. 10, 15, 18 and 21). These cracks will allow water ingress into the facade eventually leading to long term problems as a result of freeze/thaw action. These could lead to greater issues as outlined in the Category 1 defects.

Image 10: Huntley St elevation. Evidence of water staining and local brick repairs. Linear cracking in brick above 3rd floor windows. (Cat 2)

Where possible the joints/cracks would need to be raked out and filled with a suitable repair mortar or sealed with an appropriate flexible sealant to prevent water ingress into the joint/crack.

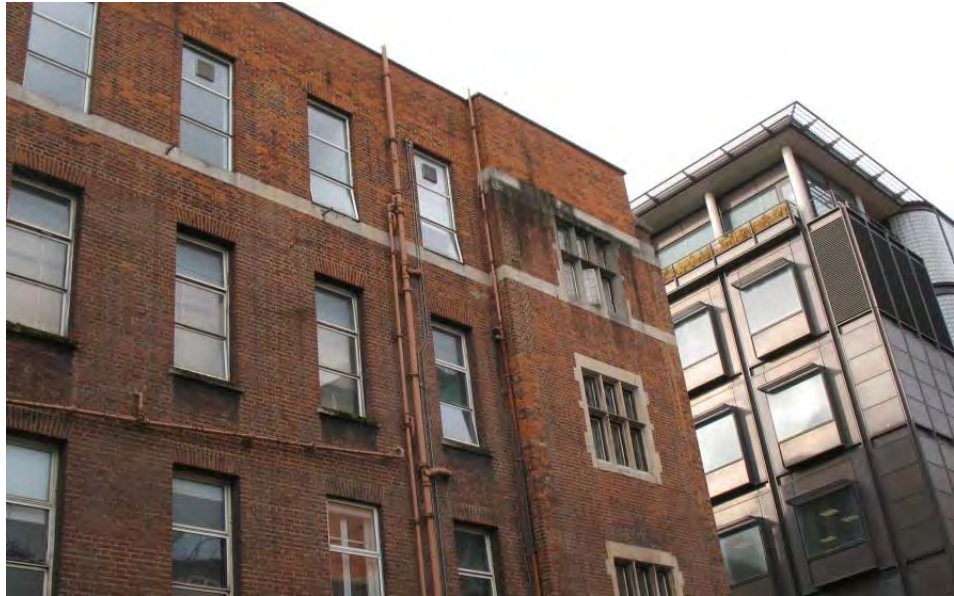
Image 11: Huntley St elevation. Evidence of water staining and local brick repairs on Copper St return. (Cat 4)

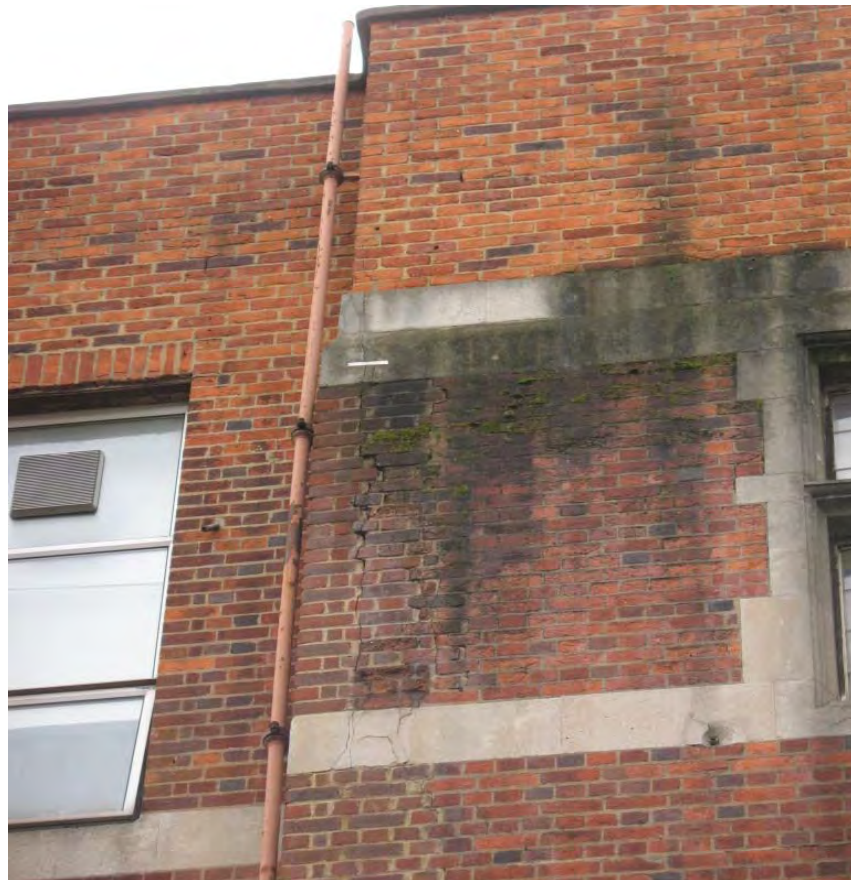
There are a number of locations where sections of brickwork and stonework are loose or show signs of imminent spalling with a subsequent risk to the general public (Image No. 12 and 19).

This is likely due to movement in the structure and/or water ingress. These defects could potentially be the result of water effects to the steel stations supporting and restraining the façade. This causes deterioration such as delamination of the steel from corrosion and specifically freeze/thaw action which can weaken the brickwork structure. This would greatly affect the structural integrity of the façade in this area and would need further investigation and repair following this.

In two specific areas, detailed in images 12 and 19 of Appendix B, there was significant movement and cracking in the brick and stone work. The two areas are located on the returns of the Capper Street façade. Deterioration such as delamination of the steel from corrosion and specifically freeze/thaw action has the potential to weaken the facades. This would affect the structure integrity of the façade in this area and would need further investigation and repair following this.

Image 12: Huntley St elevation. Significant defects in brick façade and visible water damage. Cracking of brick façade and bowing of damaged brick potentially caused by deterioration and likely delamination of steel support structure of façade. (Cat 1)

Where no other form of repair is possible, these sections of vulnerable masonry should be broken out back to a sound surface. A decision can then be made as to what other repair can be undertaken.

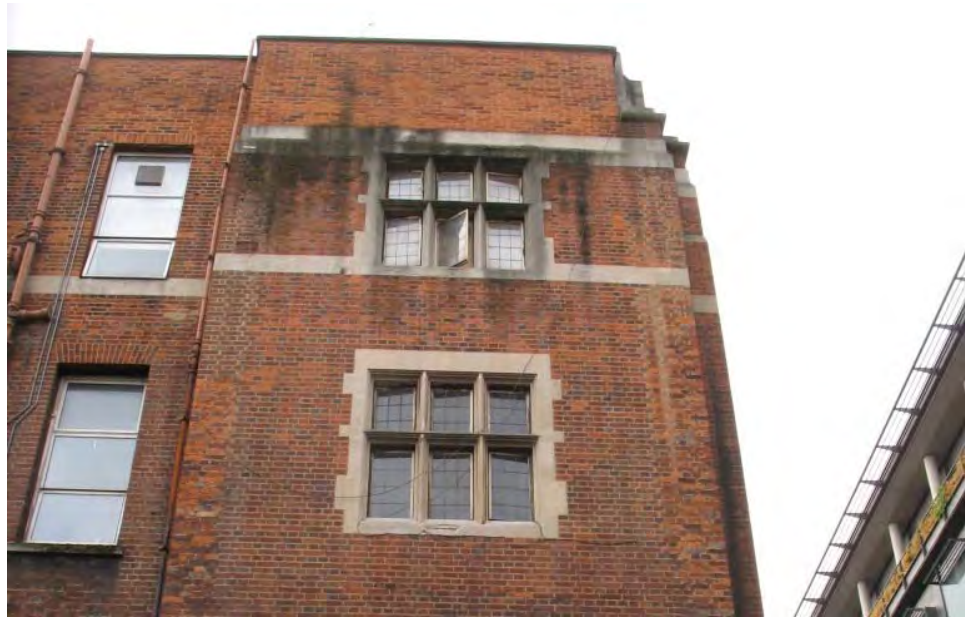
Image 13: Huntley St elevation. Evidence of water staining and local brick repairs on both corners of return. (Cat 4)

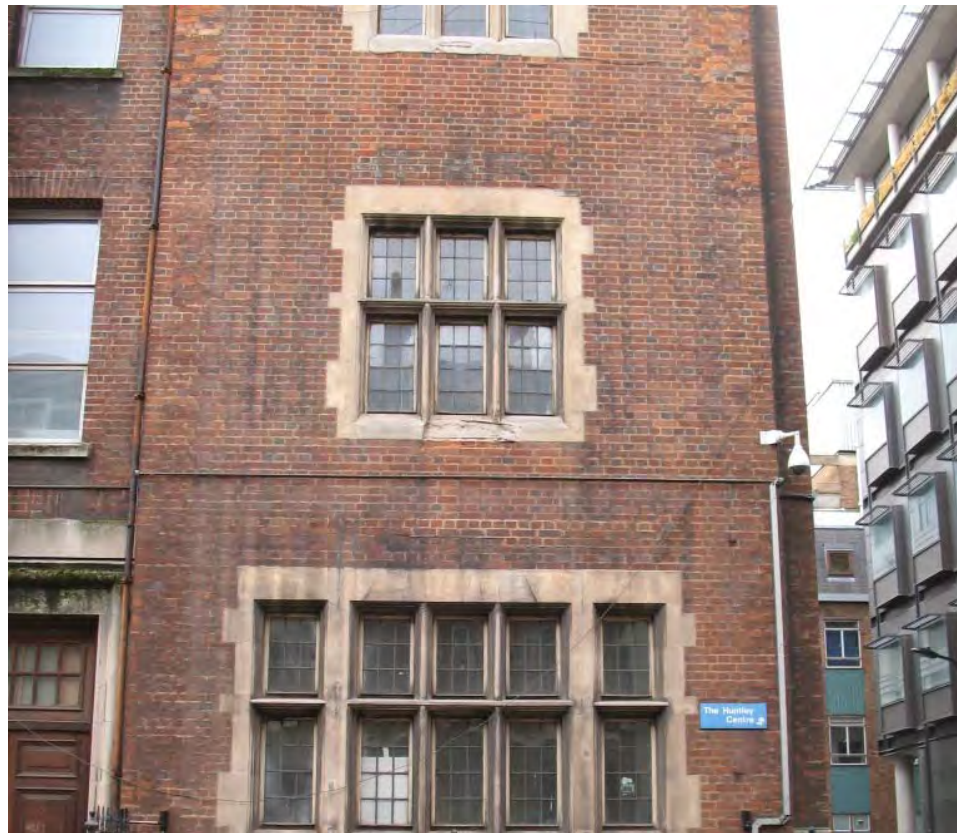
There are a number of sections of missing/spalling masonry (Image No. 14) that should be made good in accordance with the recommendations of a specialist repair contractor.

Image 14: Huntley St elevation. Evidence of water staining and local brick repairs on both corners of return. (Cat 4)

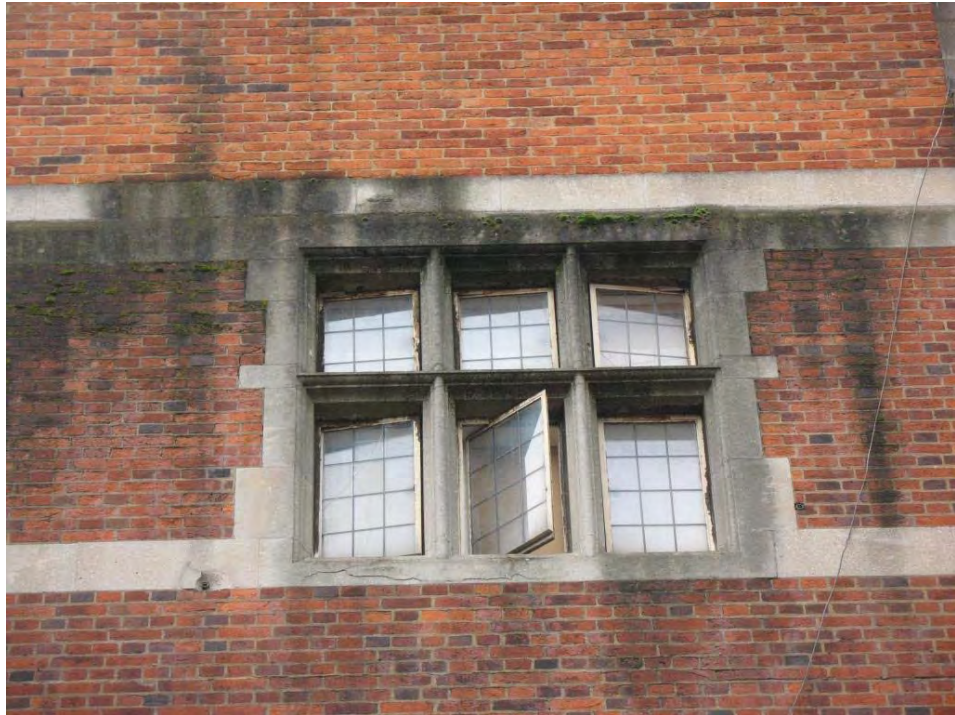
Image 15: Magnification of Image 13. Evidence of significant water damage. Possible spalling of concrete window sill and cracking of brick work. (Cat2/3)

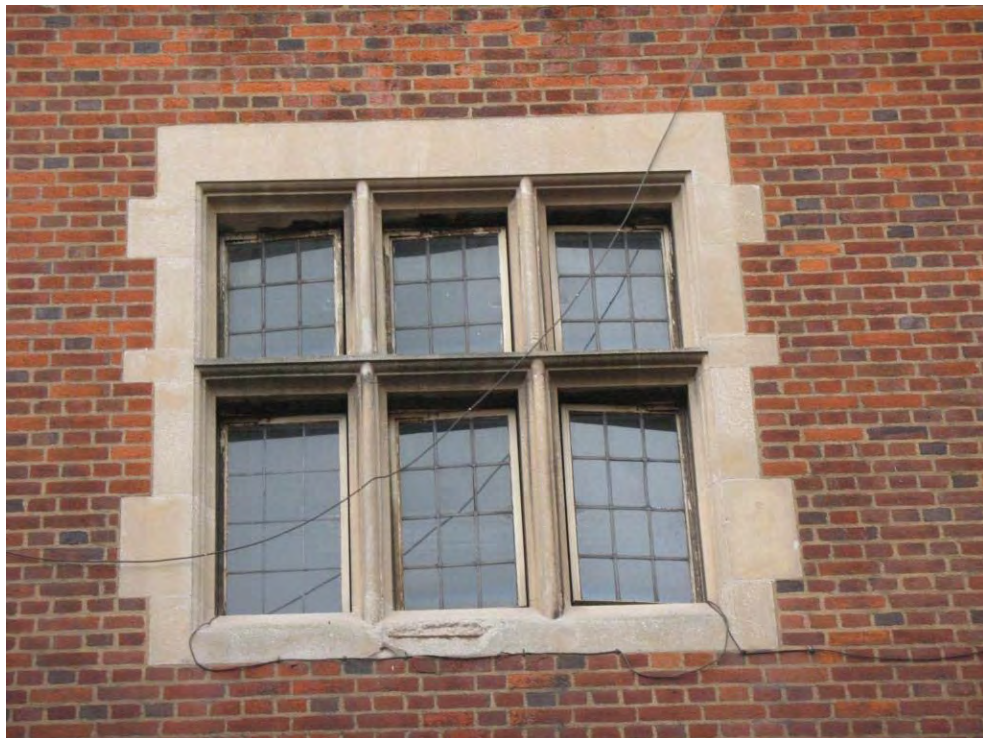
Image 16: Magnification of Image 14. Spalling of concrete window sill exposing reinforcement. (Cat 3)

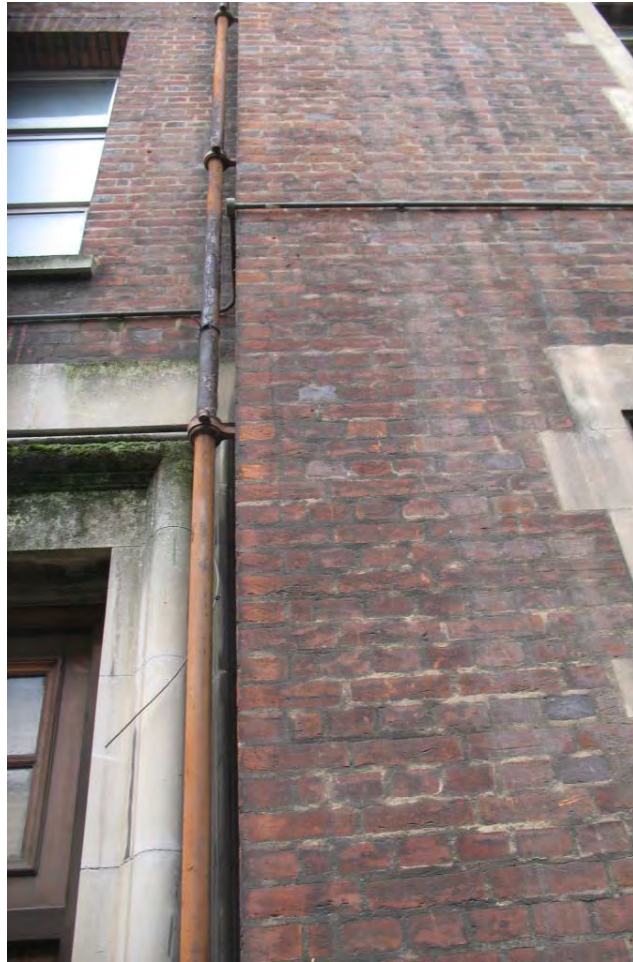
Image 17: Water effects along corner of façade return adjacent to downpipe. (Cat 4)

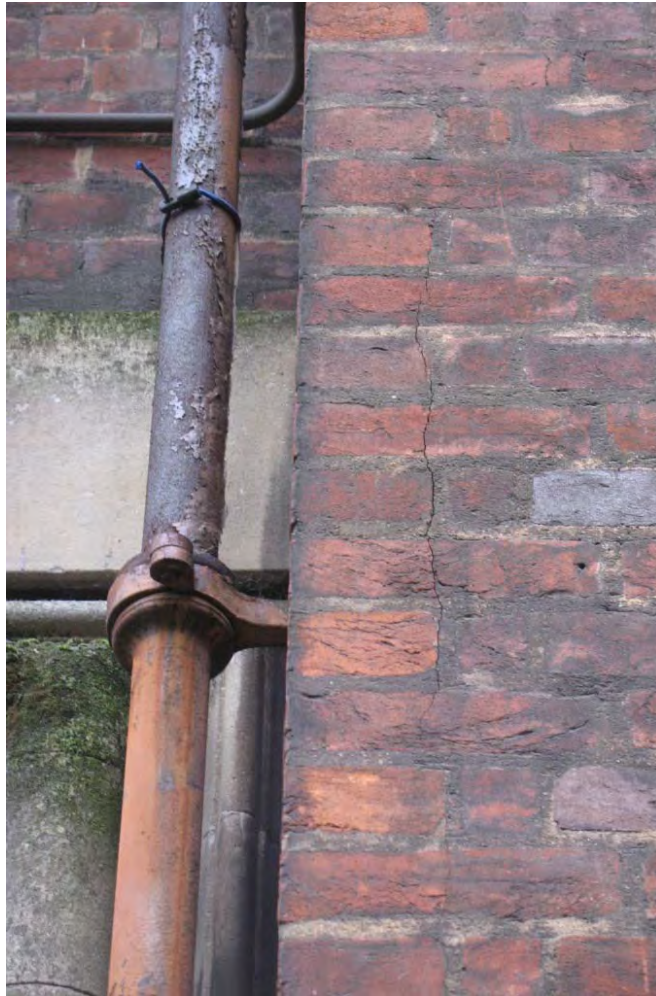
Image 18: Cracking in brick façade likely due to water ingress. (Cat 2)

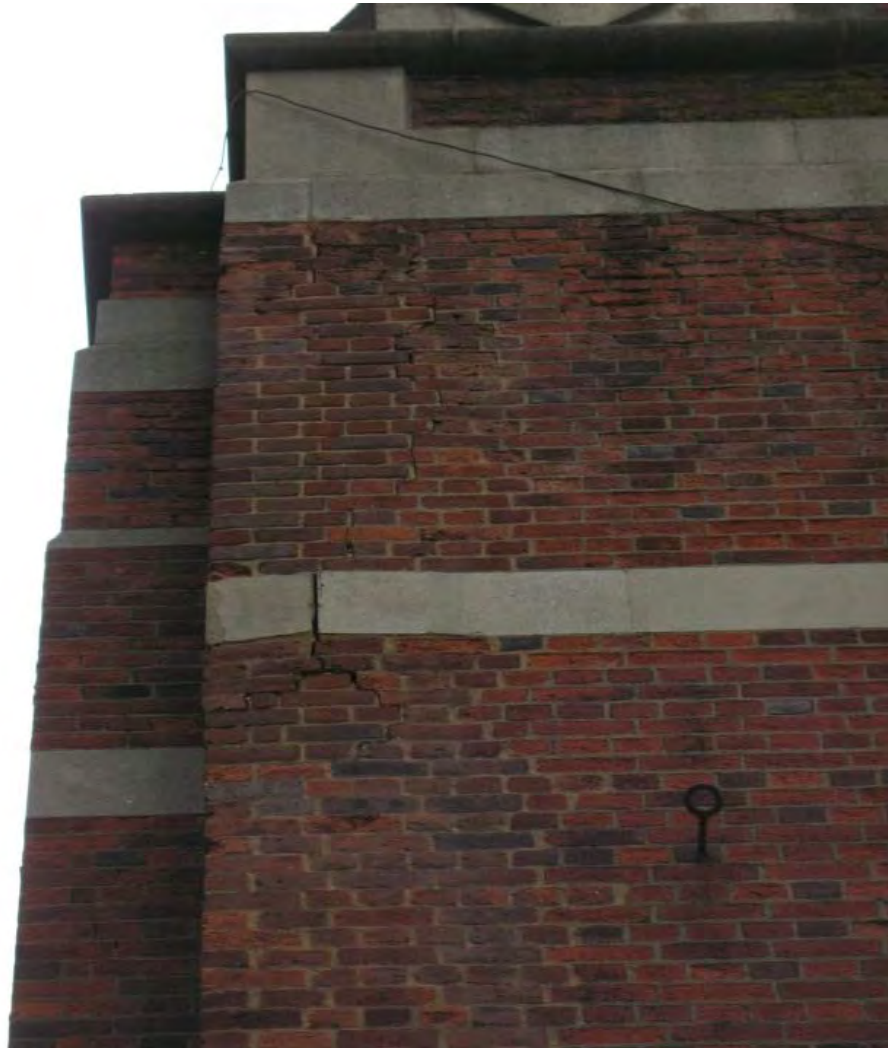
Image 19: Significant cracking and spalling brick and concrete. Likely deterioration of support structure with delamination of steel stansions forcing façade to crack and move. (Cat 1)

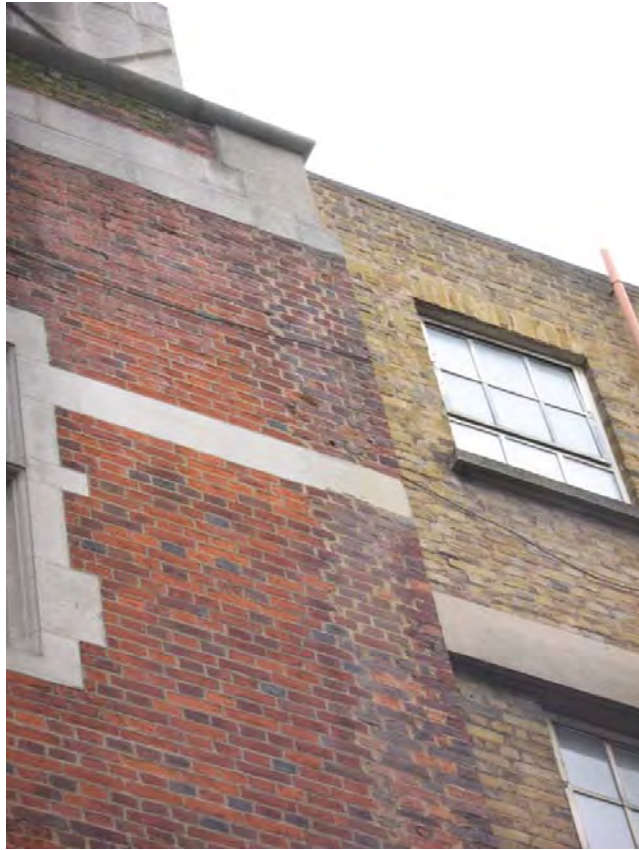
Image 20: Brick damage and possible local repairs (Cat 2)

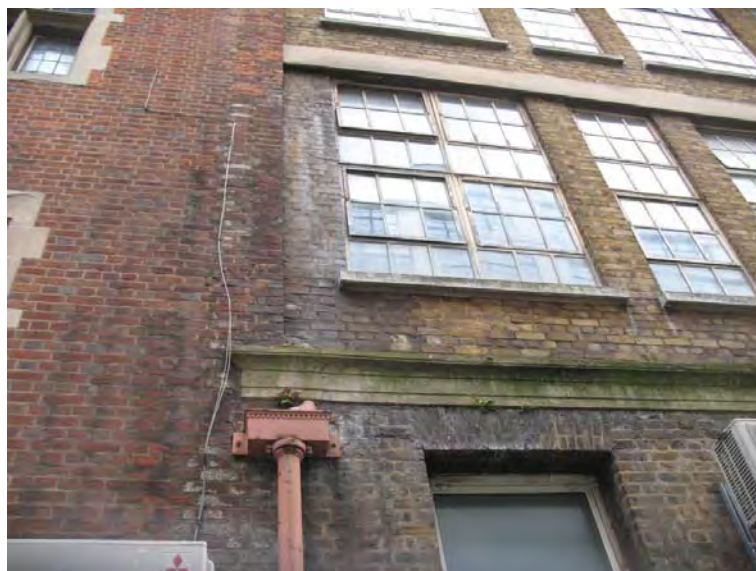
Image 21: Brick damage and possible local repairs (Cat 2)
