Arboricultural Assessment Report

Summary Report on Trees

For:	Client:	Oriel Services Limited
	Insurer:	[REDACTED]
Site:	Policyholder:	[REDACTED]
	Risk Address:	99 Greencroft Gardens, London NW6 3PG
Refs:	OCA Ref:	55750
	Client Ref:	7624361
	Insurer Ref:	8730475

Survey By:	Dave O'Connell		
Title:	Technician	Date:	10 March 2014
Report By:	Gemma Holmes		
Title:	Technician	Date:	27 March 2014

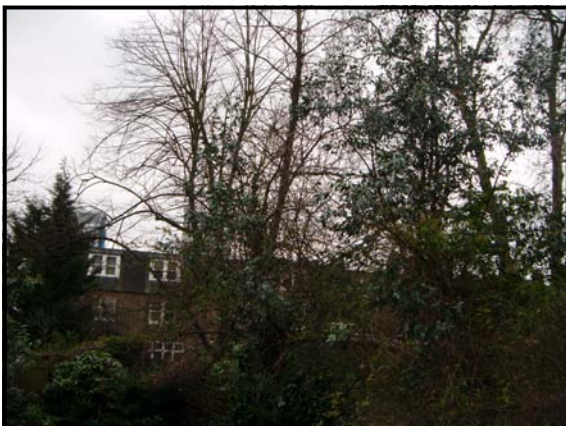
5. View of neighbouring property in No. 101

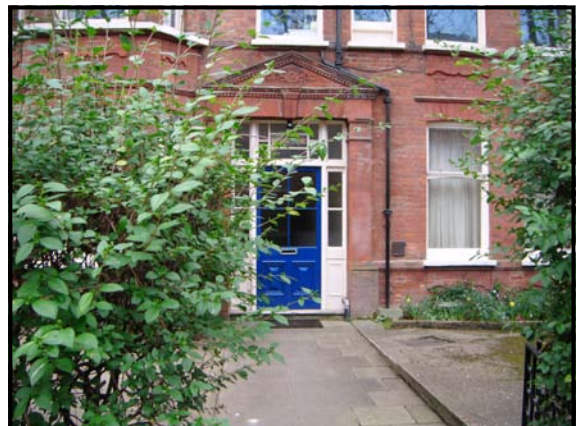
6. H1 Privet
