## SITE INVESTIGATION FACTUAL REPORT

Report No: 169984  
Client: Cunningham Lindsey - Maidstone  
Site: 99 Greencroft Gardens, London

Client Ref: 7498207-  
Date of Visit: 11/01/2014

# Underground Drainage Report

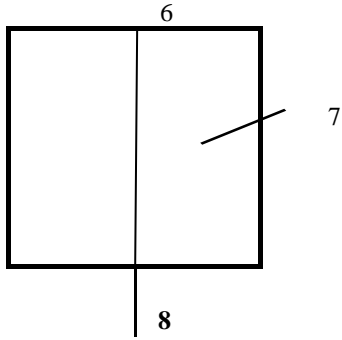
M/H: 3 Depth: 1000mm

As built

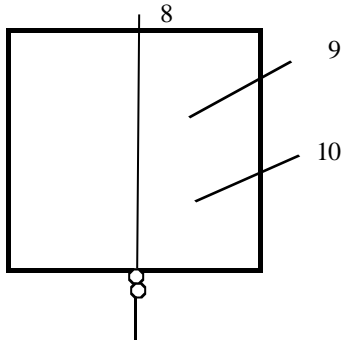
M/H: 4 Depth: 1250mm

As built
