Arboricultural Assessment Report

Summary Report on Trees

For:	Client:	Oriel Services Limited
	Insurer:	[REDACTED]
Site:	Policyholder:	[REDACTED]
	Risk Address:	99 Greencroft Gardens, London NW6 3PG
Refs:	OCA Ref:	55750
	Client Ref:	7624361
	Insurer Ref:	8730475

Survey By:	Dave O'Connell		
Title:	Technician	Date:	10 March 2014
Report By:	Gemma Holmes		
Title:	Technician	Date:	27 March 2014

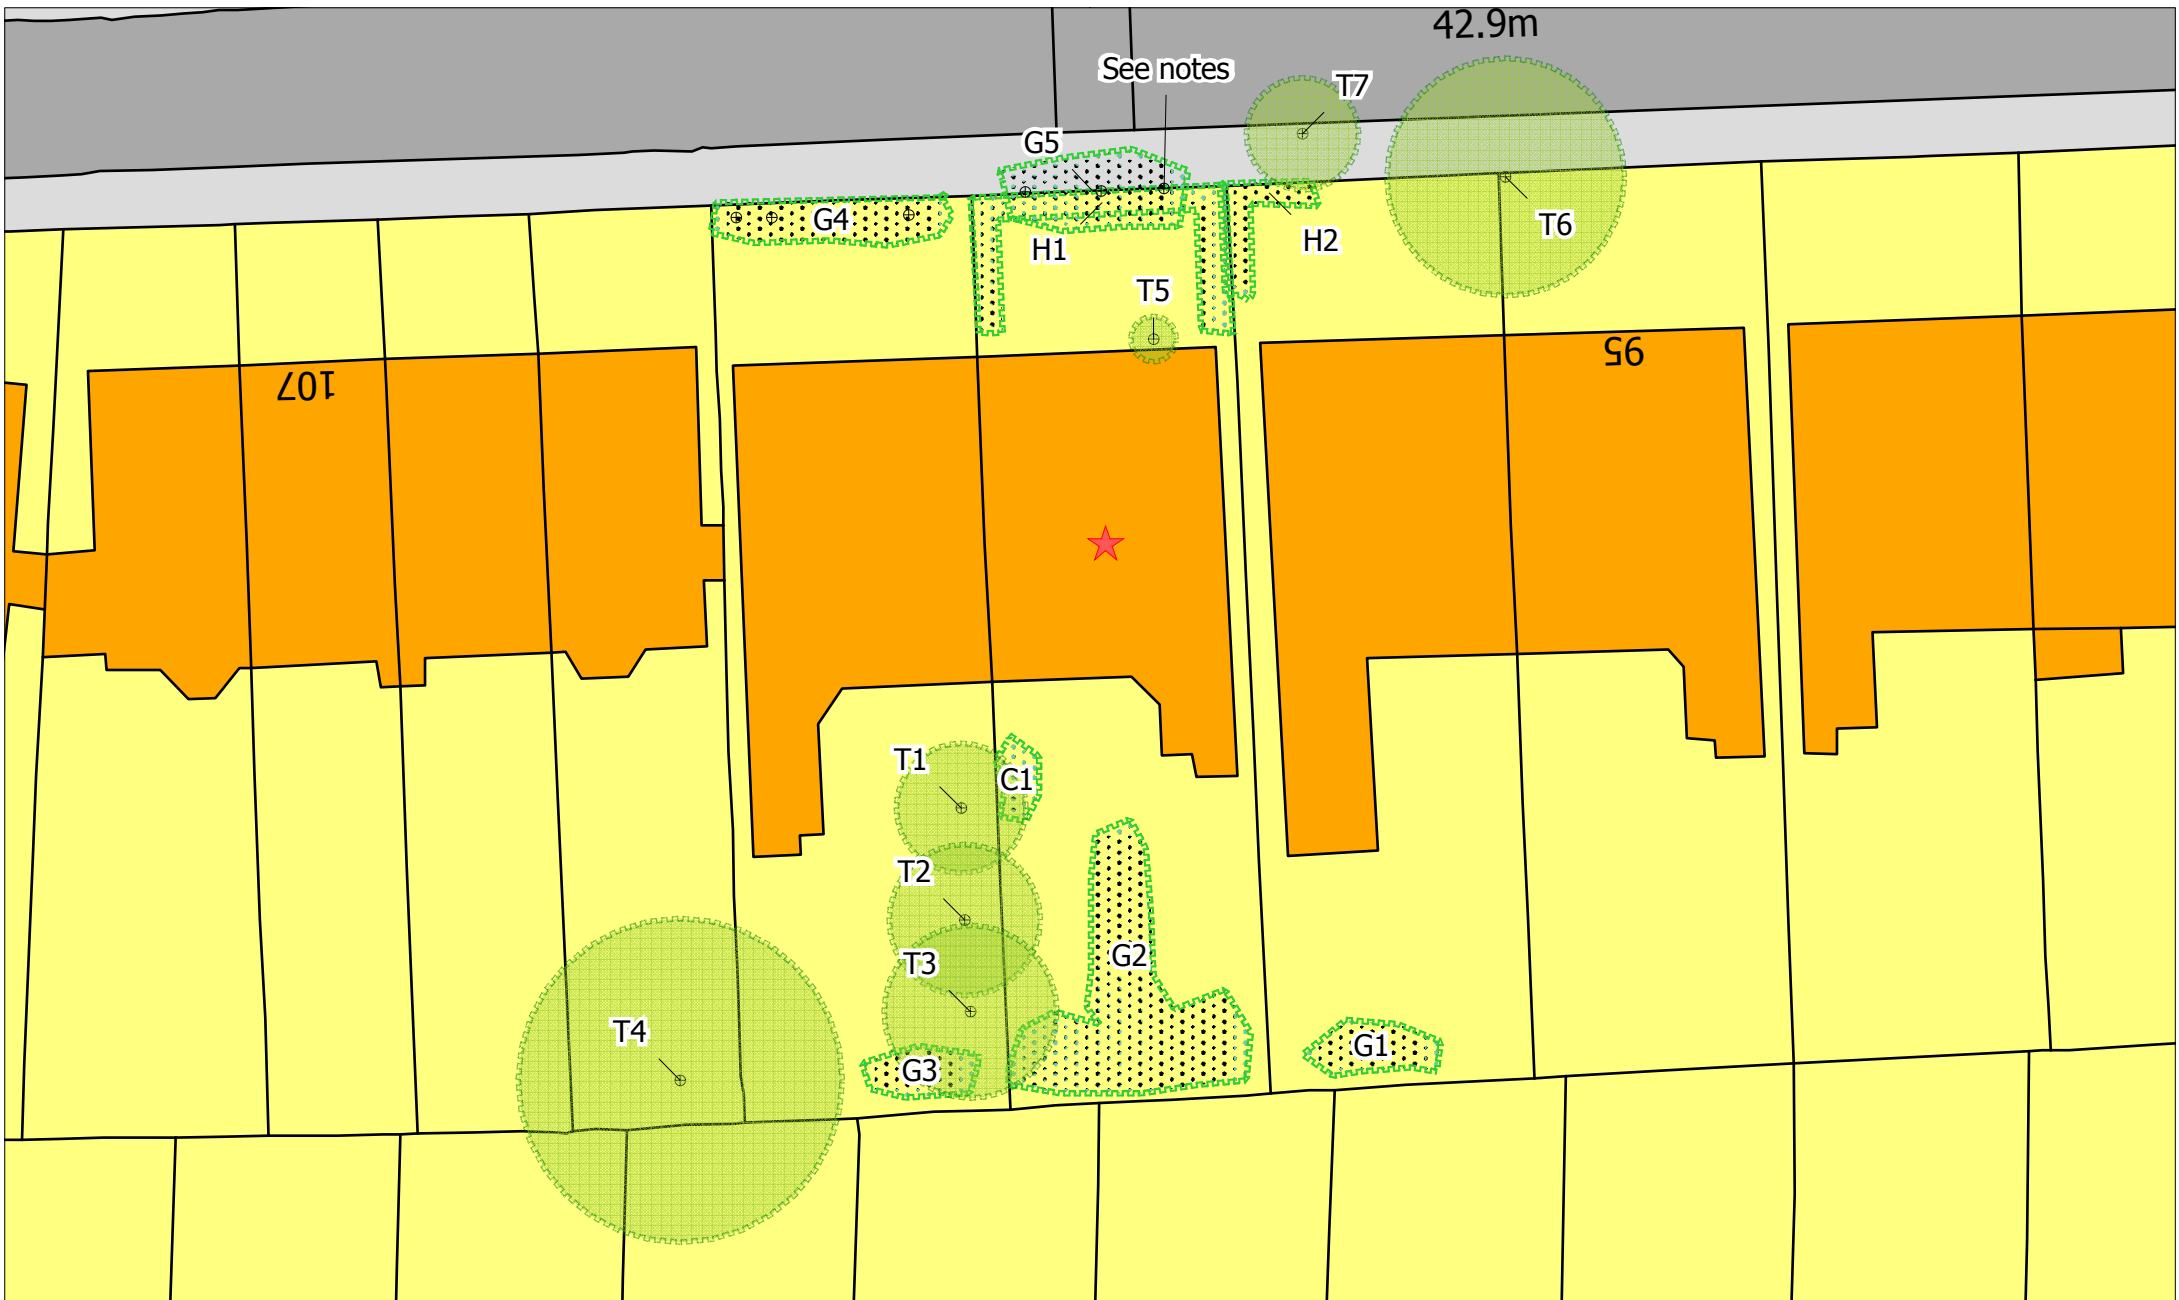
Location: 99 Greencroft Gardens, London, NW6 3PG
 Job Ref.: 55750
 Survey Date: 10/03/2014
 Scale: 1:350 @ A4

G4	Lime	EM	F	19.4	14	510	7.8	Reduced 5 years ago	Fell and treat stump	None		101 Greencroft Gardens, London NW6 3PG	P3P
G5	Lime	EM	F	22.1	9	590	6	No significant past tree works	Fell and treat stump	None	Policy holder advised that permission has been granted to have one tree removed as identified on the site plan.	99 Greencroft Gardens, London NW6 3PG	PH
H1	Privet	SM	F	4.2	2	10	0.01	Trimmed regularly	No work required.	N/A		99 Greencroft Gardens, London NW6 3PG	PH

Tree No	Common Name	Age Class	Condition	Height (m)	Crown Spread (m)	Stem diam. (mm)	Dist to bldg (m)	Pruning history	Recommendation	Tree work constraints	Notes	Owner address	Owner
H2	Privet	SM	F	3	2	10	3.4	Trimmed regularly	No work required.	N/A		97 Greencroft Gardens, London NW6 3PG	P3P
T1	Eucalyptus	SM	F	11	6	30	7.2	Pruned regularly	No work required.	N/A	Height and stem diameter estimated as no access.	101 Greencroft Gardens, London NW6 3PG	P3P
T2	Apple	EM	F	9	7	350	12	No significant past tree works	No work required.	N/A	Height and stem diameter estimated as no access.	101 Greencroft Gardens, London NW6 3PG	P3P
T3	Unidentified	EM	P	16.5	8	35	15	No significant past tree works	No work required.	N/A	Shows signs of crown dieback. Unidentified, possible Cherry	101 Greencroft Gardens, London NW6 3PG	P3P
T4	London Plane	EM	F	31.4	15	900	25	No significant past tree works	Fell and treat stump	None	Dimensions estimated as no access.	103 Greencroft Gardens, London NW6 3PG	P3P

Tree No:	Species	Works Required
G4	Lime	Fell and treat stump
G5	Lime	Fell and treat stump
T4	London Plane	Fell and treat stump

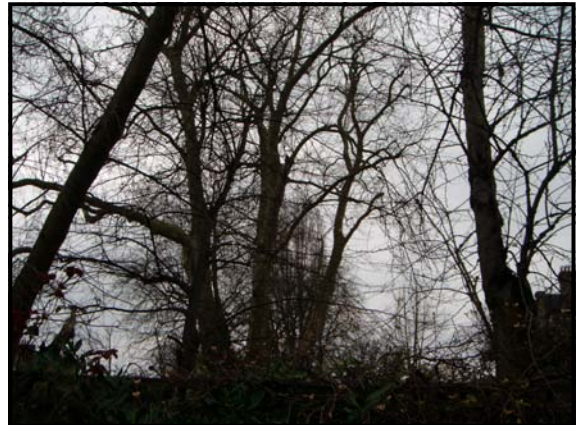
4. View through Limes G3 to London Plane T4

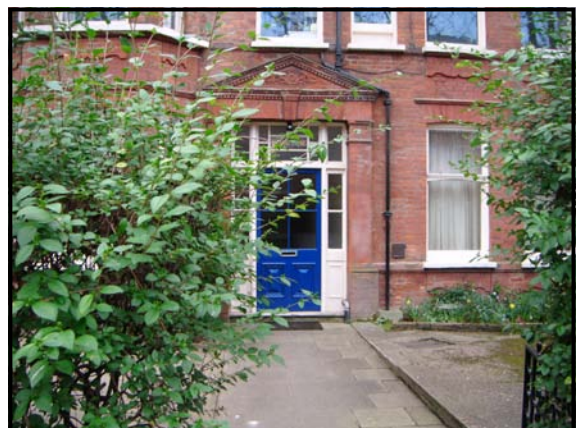
6. H1 Privet
