SITE INVESTIGATION FACTUAL REPORT

Report No: 169984
Client: Cunningham Lindsey - Maidstone
Site: 99 Greencroft Gardens, London

Client Ref: 7498207-
Date of Visit: 11/01/2014

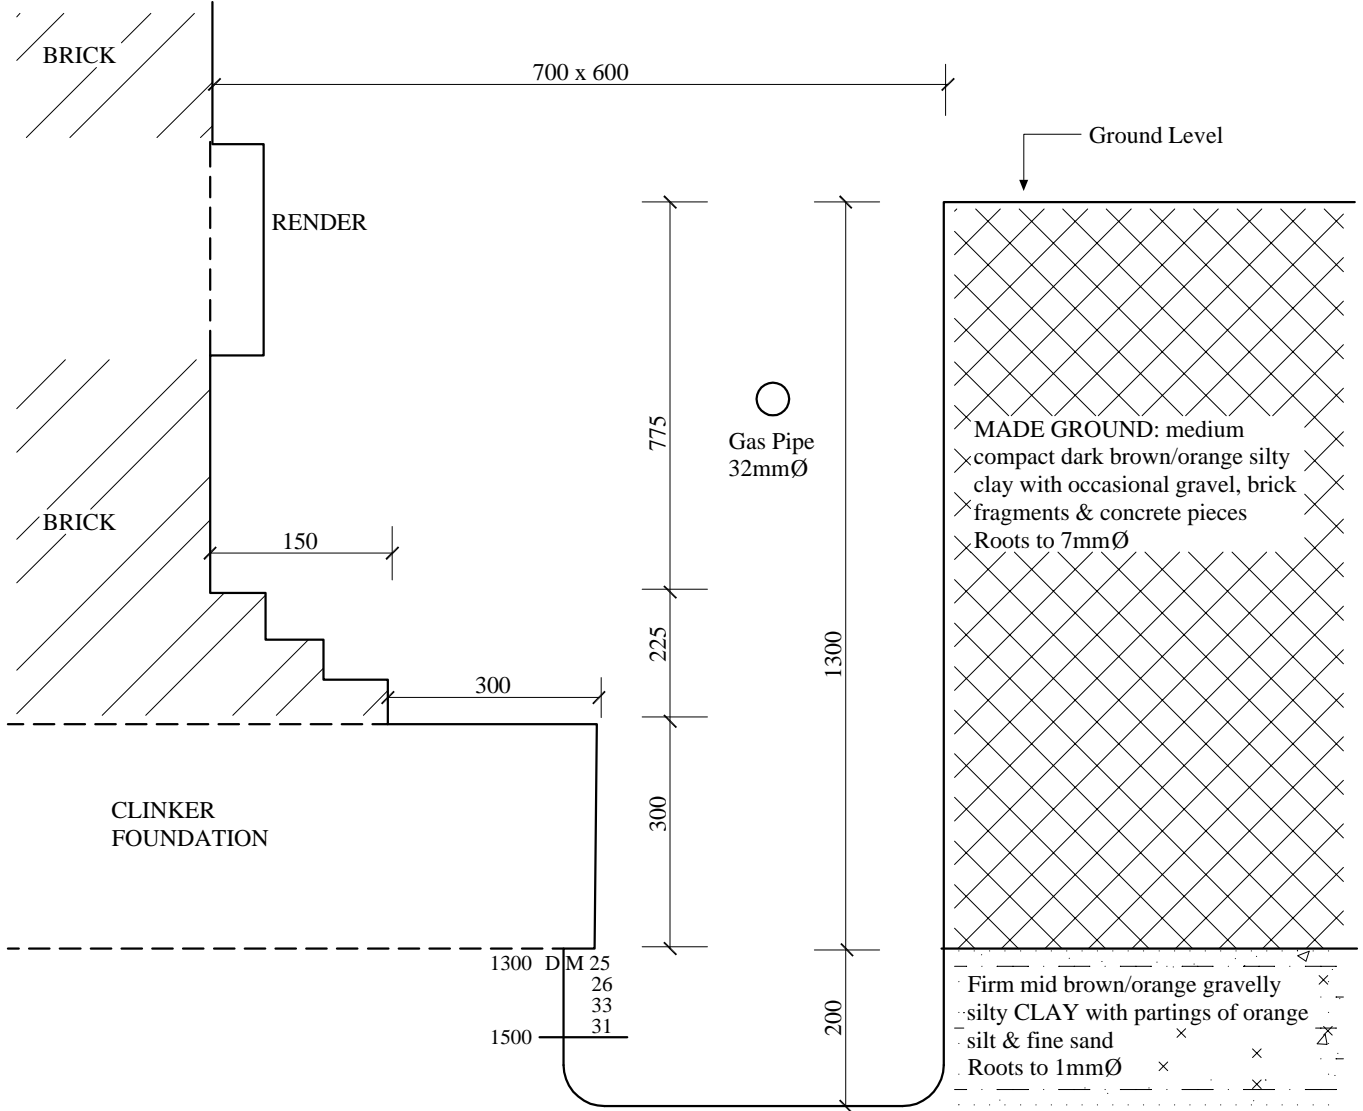
Trial Pit No: 1

FOR STRATA BELOW 1500mm SEE BH LOG 1

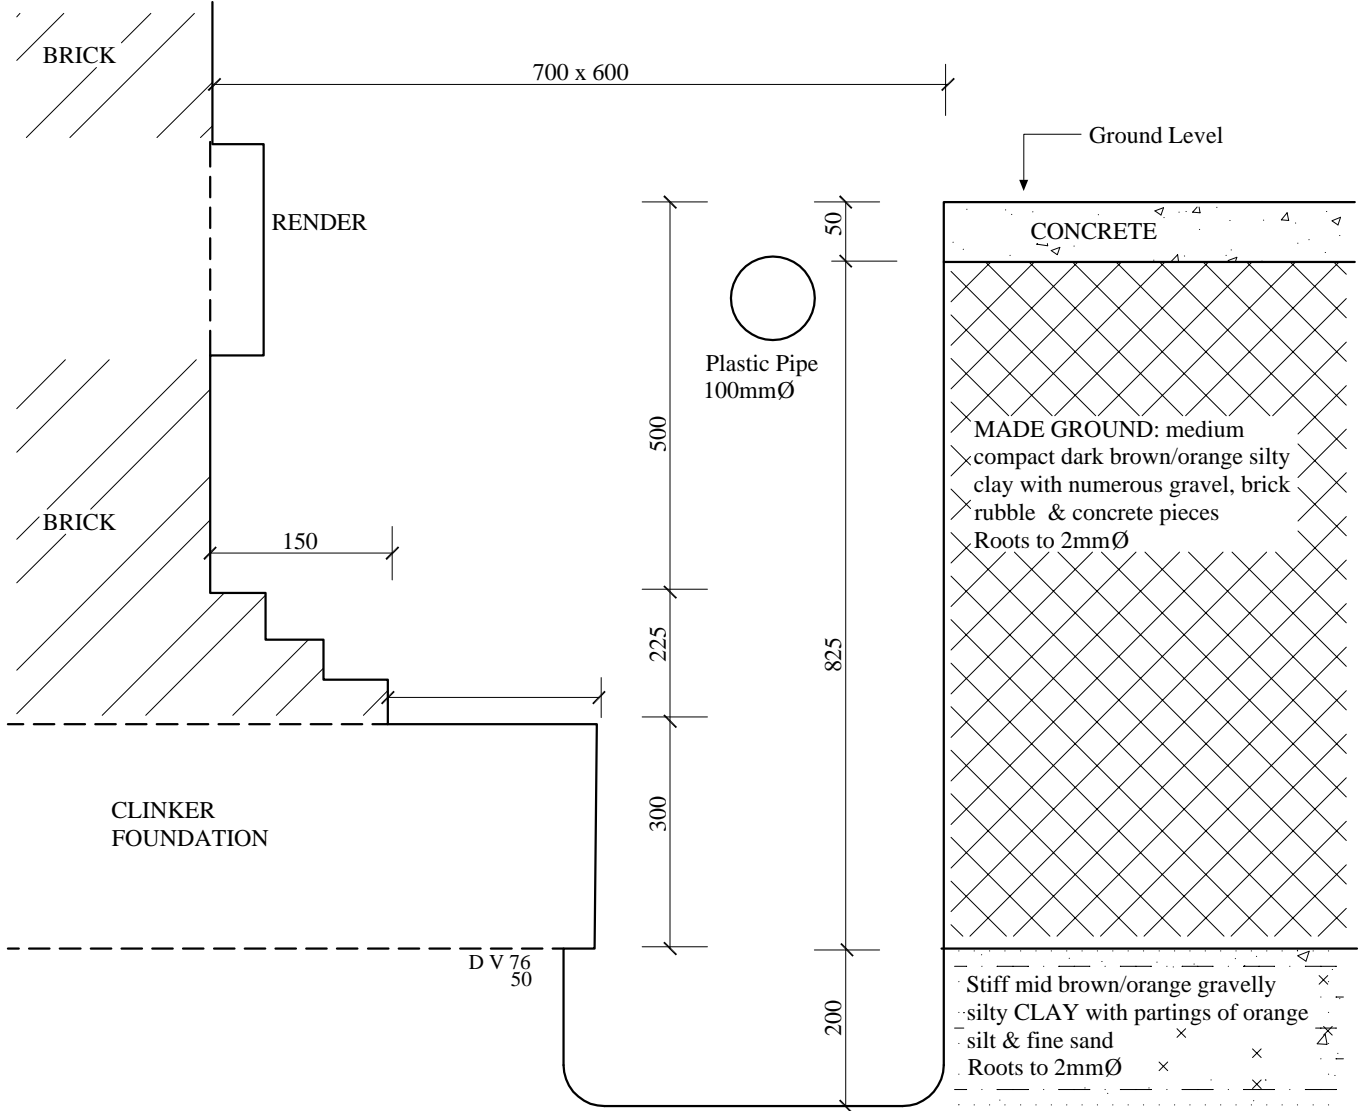
Trial Pit No: 2

FOR STRATA BELOW 1125mm SEE BH LOG 2

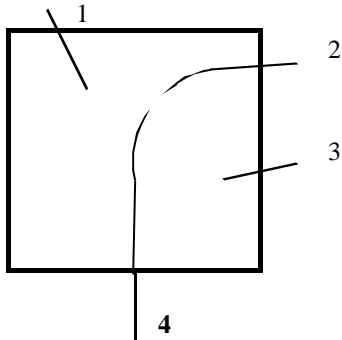
M/H: 1 Depth: 350mm

As built

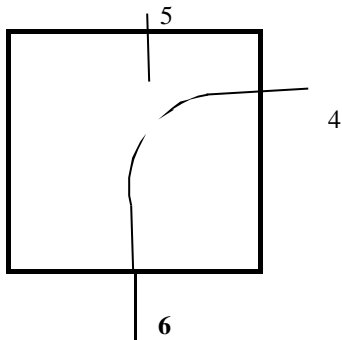
M/H: 2 Depth: 775mm

Run 5 500mm _____

As built

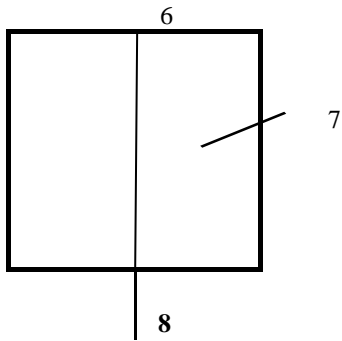
M/H: 3 Depth: 1000mm

As built

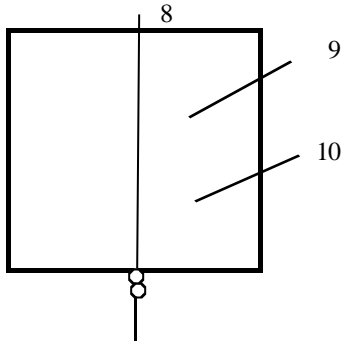
M/H: 4 Depth: 1250mm

As built
