Arboricultural Consultancy for Aviva

Insured	Mrs H Megarry	Address	43 Woodsome Road, London, NW5 1SA		
Client	Infront Innovation	Contact	Dayna Riley	Claim No.	IFS-AVI-ROF-13-0046234
MT Ref	NL/1212131146/TP-REV1	Consultant	Thomas Peppiatt	Contact No.	08702 416 180
Report Date	10/01/2014 revised 17/11/2014

Scope of Report: To survey the property and determine significant vegetation contributing to subsidence damage, make recommendation for remedial action and assess initial mitigation and recovery prospects. The survey does not make an assessment for decay or hazard evaluation.

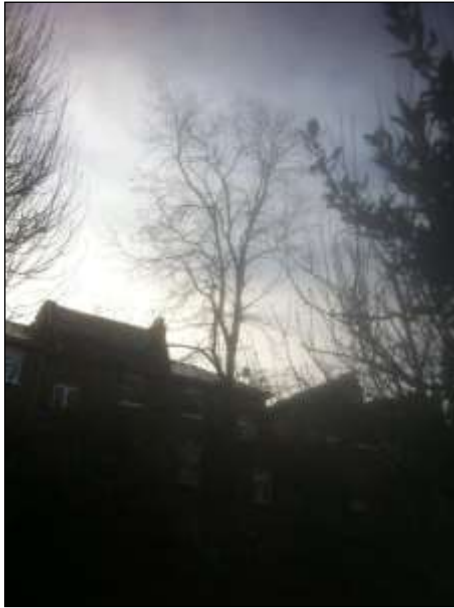
T5 - False Acacia

Leguminoeae spp roots have also been found in TP/BH1. It was our original opinion that these roots could originate from T5 (False Acacia); however, it has since been brought to our attention that these roots could originate from a Wisteria climber not noted in our Arb report.

T5	False Acacia	1	15	18*	D - Unknown	Action to avoid future risk	Do not allow to exceed current dimensions.
T6	Lime	1	13.5	16.5	A - Third Party 47 Woodsome Road. London. NW5 1SA.	Action to avoid future risk	Do not allow to exceed current dimensions.
T7	Pear	1	7.5	11.5	A - Third Party 39 Woodsome Road. London. NW5 1SA.	Action to avoid future risk	Do not allow to exceed current dimensions.

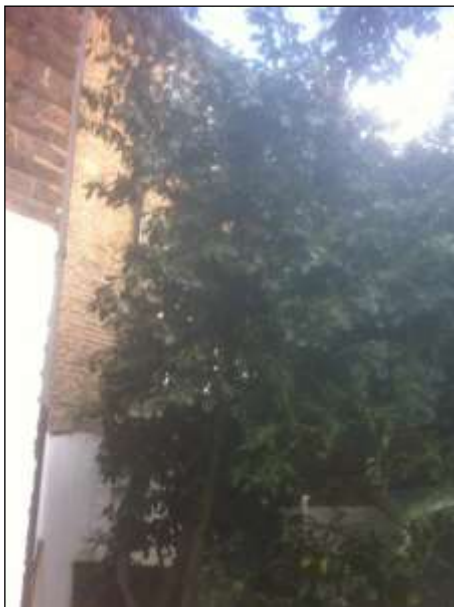
T3 - Camellia

There is currently no positive root identification to implicate T3 (Camellia), however based on our assessment on site we consider that the footings of the subject property fall within the anticipated rooting zone of this vegetation.

T3 (Camellia) is also considered to retain a contributory influence.

Tree No.	Species	Age Cat	Approx. Height (m)	Distance to Building (m)	Ownership	Action	Requirement
TG1	Mixed species group (x2 Apple, x1 Bay).	1	5	2.2	C - Insured	Maintain as detailed	Remove closest Apple to rear of the insured property and manage stump to inhibit regrowth. Do not allow remaining Apple and Bay to exceed current dimensions. <i>Note – do not chemically treat stump due to translocation risk. Cover stump with dark or opaque plastic material or remove regrowth as it emerges.</i>
T3	Camellia	1	6	2	C - Insured	Remove	Remove and treat stump to inhibit regrowth.

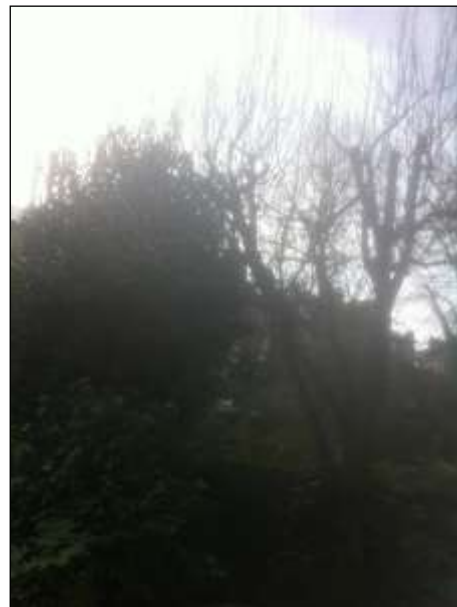
TG1 - Mixed species group

Roots recovered from TP/BH1 have been formally identified as Pomoideae gp. The most likely origin of the roots is the closest Apple to the rear of the property located in TG1 (Mixed species group)

Such circumstances confirm the potential for the closest Apple tree located in TG1 (Mixed species group) to influence soil volumes and to contribute to the damage observed.

In assessing the potential drying influence of the vegetation on site TG1 (Mixed species group) is considered the dominant feature and accordingly we have identified them as the principal cause of subsidence.
