Engineer's Report

Our Reference	IFS-AVI-SUB-13-0046234
Claim Reference	13NU602531
Prepared for	Aviva

Report Date	15 October 2013
Policyholder	Mrs Megarry
Address	43 Woodsome Road, London, NW5 1SA

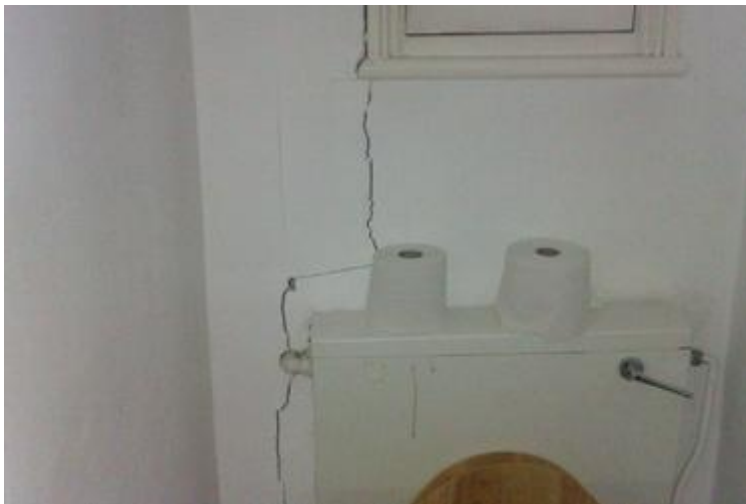
Tapering vertical cracks in excess of 2 mm were recorded to the surrounds of the singular window, commencing from the wall ceiling junction and continuing for roughly one meter.

FIGURE 03 Tapered cracking recorded to ground floor toilet

Generally cracks 1 mm wide or less will be filled (internal) or re-pointed (external). Internally, where the cracks are wider than 1 mm, but less than 5 mm the underlying brickwork or blockwork will be exposed and prior to making good the plaster finishes the cracking will be covered with expanded metal lath. Where cracks are 5 mm across or wider, some form of bed joint reinforcement will be introduced.

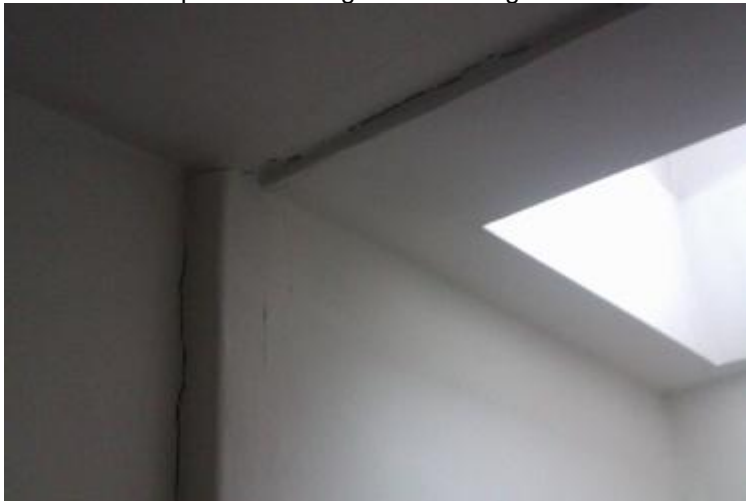
Vertical and horizontal cracks in excess of 1 mm were recorded at the abutment between the main frame house and two storey rear addition.

At the abutment between the main frame house and two storey rear addition, tapering vertical cracks in excess were recorded, commencing from high level and continuing for roughly one meter.

FIGURE 04 Horizontal and vertical cracking recorded at abutment to main frame house

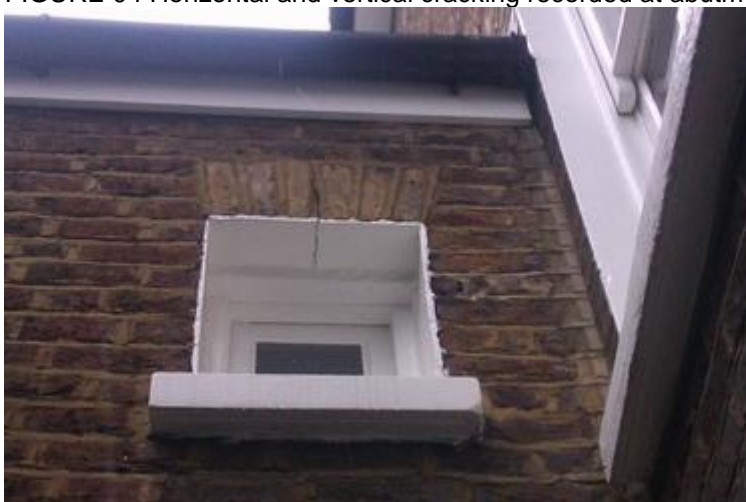
Vertical tapering cracks in excess of 1 mm were recorded above and below the first floor toilet window. This damage was mirrored internally.

FIGURE 05 Cracking recorded above and below toilet window

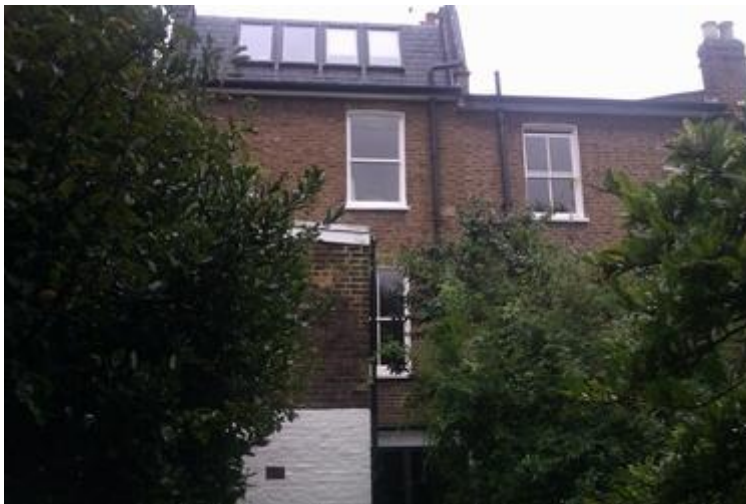
FIGURE 06 Rear Elevation

The diagonal aspect of the cracks, together with the fact that they increase in width with height is indicative of subsidence as a result of shrinkage of the clay subsoil due to the moisture extracting influence of insured and third party vegetation.

The indicated mechanism of movement is a downwards rotational movement of the two storey rear addition.
