GEOTECHNICAL

43 Woodsome Road, London, NW5 1SA

Client: Infront Innovation
 Client Contact: Paula Sheldon
 Client Ref: IFS-AVI-SUB-13-0046234
 Policy Holder: Mrs H Megarry
 Report Date: 8 November 2013
 Our Ref: C9399G4125

DRAINAGE

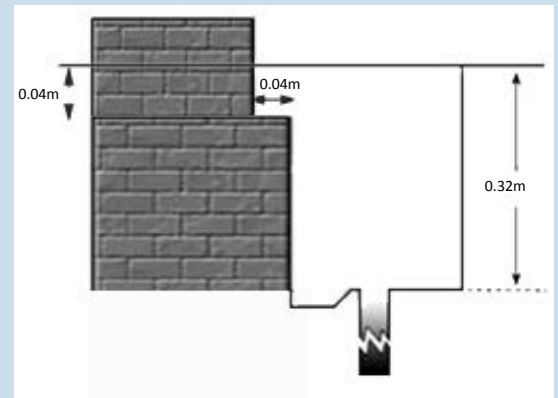
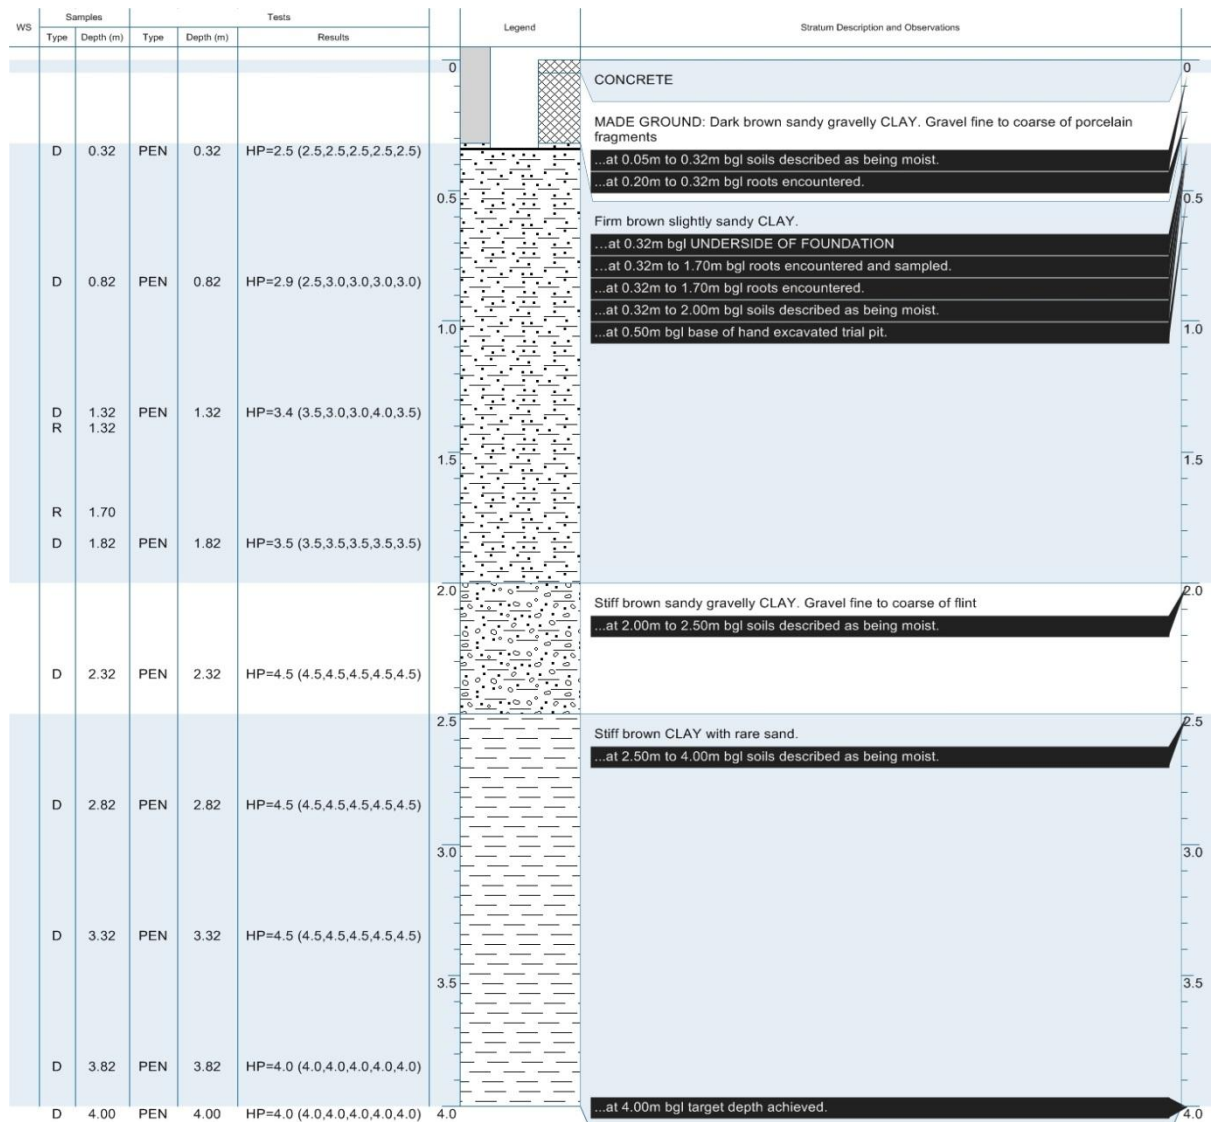
TP/BH1 Foundation Detail and Borehole Log

Foundation comprised continuation of brick wall to 40mm bgl, bearing on brick to 320mm bgl, projecting 40mm from the brick wall. Underside of foundation exposed to 100mm back from the face of the brick. Borehole completed by Hand Held Percussive Window Sampler. Groundwater strikes not encountered.

Property foundations were exposed and underside confirmed in TP/BH1.

Roots encountered in TP/BH1.

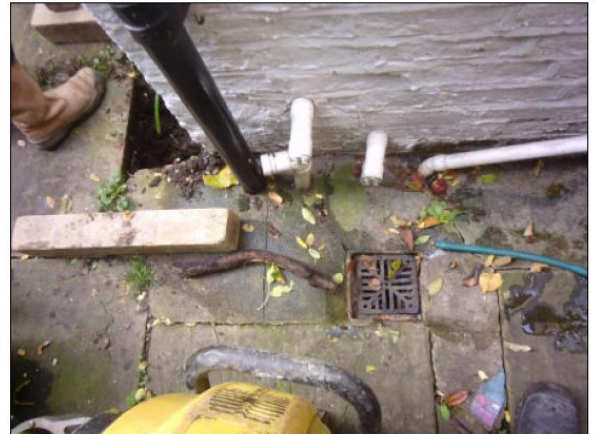
RWP & FWG

CCTV Survey Result: Fractured and cracked sections of pipework

1. To excavate and replace FWG and pipework downstream to FMH1, reinstating all surfaces upon completion.
